SECTION 2 – SCOPE AND EXTENT

2.1 OVERVIEW

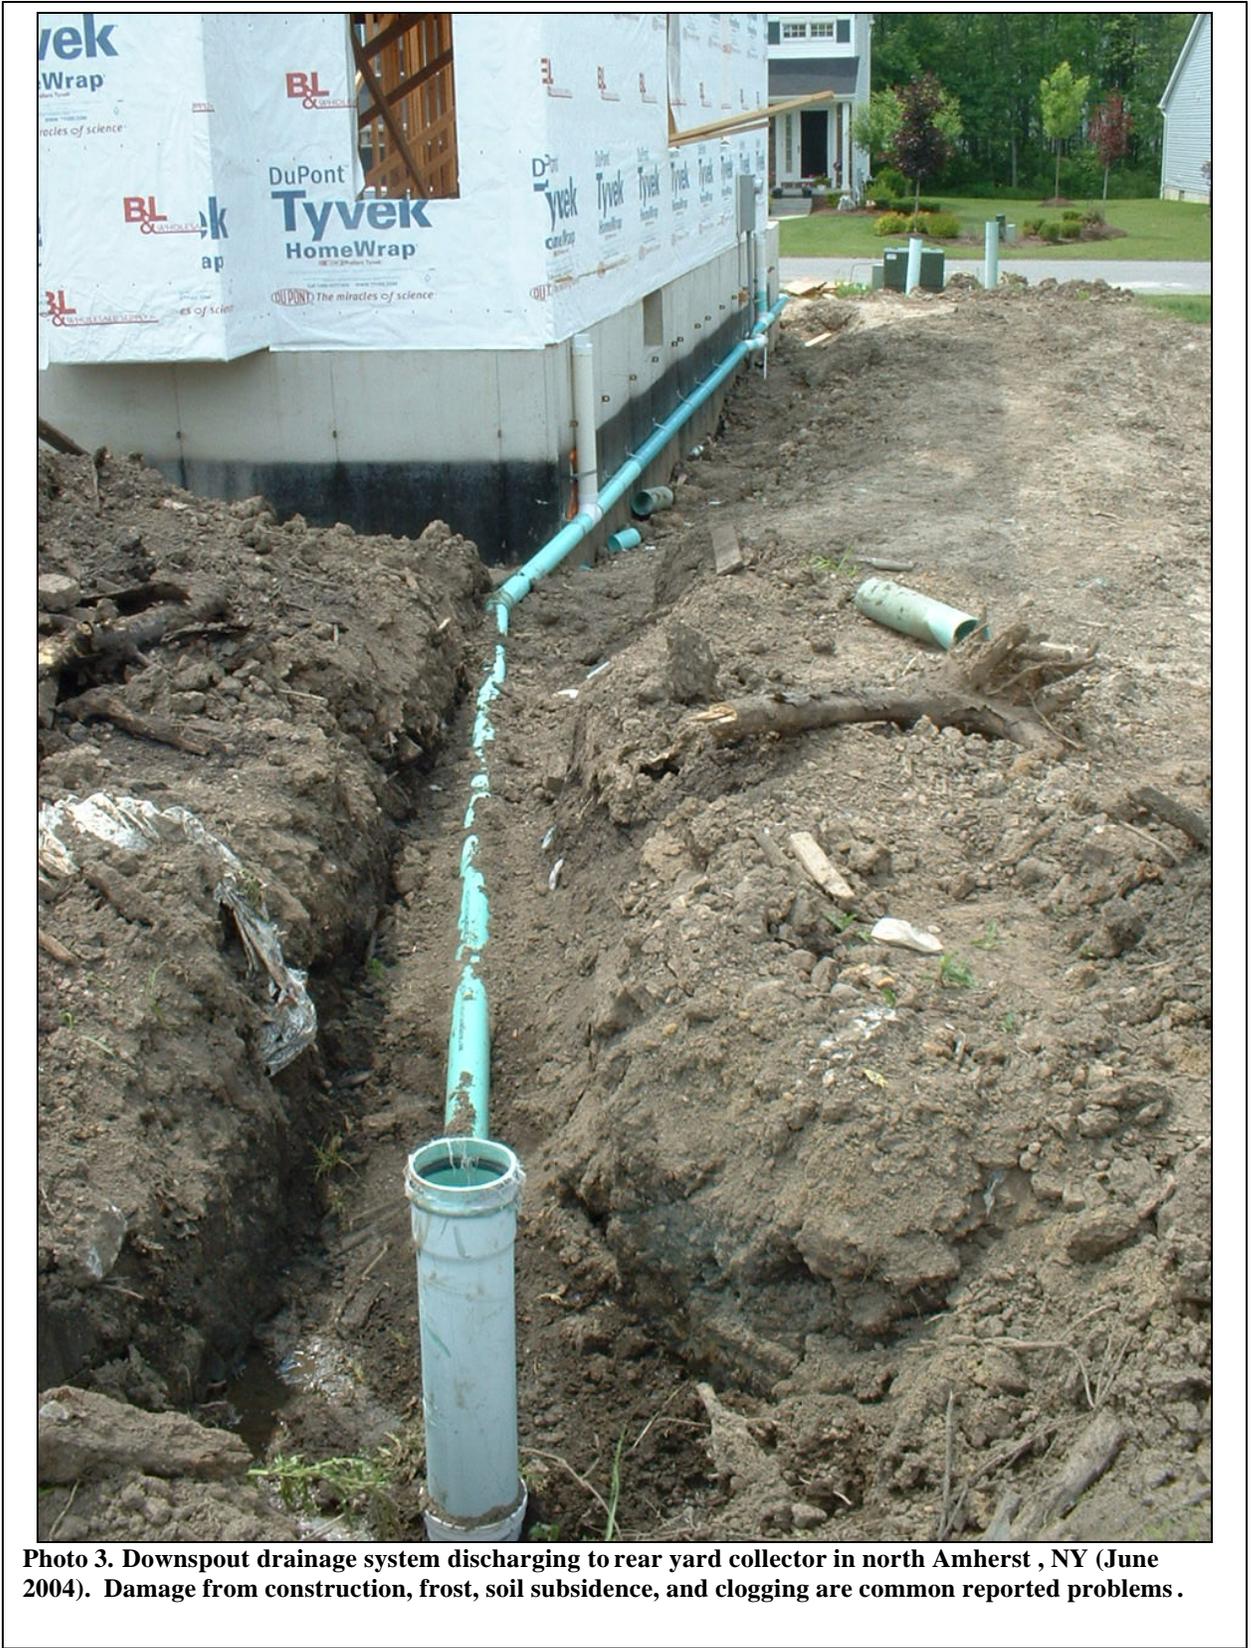
Problems with downspouts are very common. Nearly 24 of 33 respondents have rebuilt, repaired, snaked, and/or extended portions of the downspout drainage system. Clogging is usually caused by tree roots, debris, or collapse. In a few cases the clog causes the sump pump to recycle water that erodes and saturates the soils along the foundation. Photo 3 shows a typical downspout system. The segmented pipe is vulnerable to frost, construction damage and soil subsidence along the exterior wall.

Photo 3. Downspout drainage system discharging to rear yard collector in north Amherst , NY (June 2004). Damage from construction, frost, soil subsidence, and clogging are common reported problems .

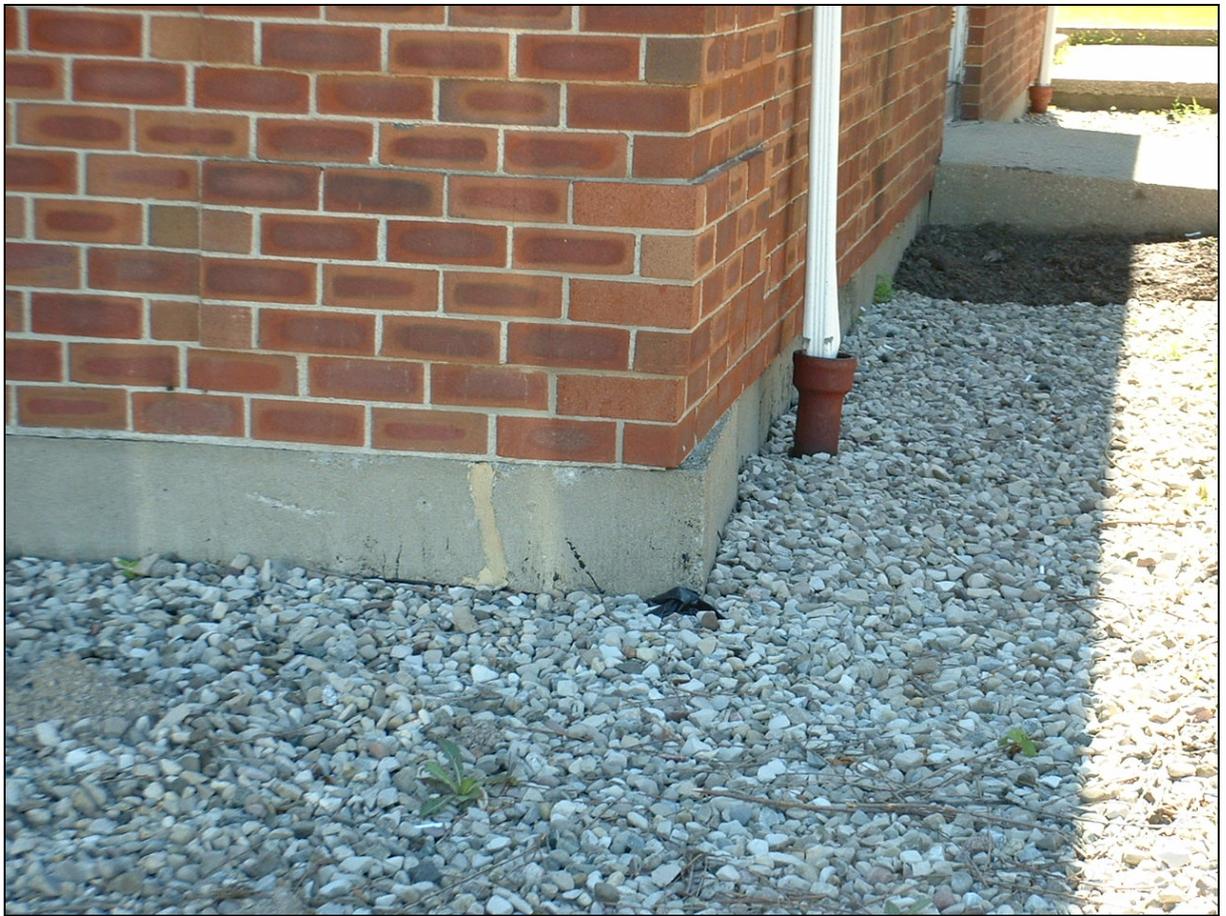
Many multi-family apartment buildings are built with basements and are experiencing foundation damage. We did not inspect the interior of these buildings but observed the exterior of more than 20 buildings. These two-story, often brick veneered structures showed significant lateral pressure damage and some settling. In extreme cases, the brick veneer has fallen away and been replaced. Photo 4 shows an apartment complex with typical damage in south-central Amherst. These damages never appear to be dangerous to occupants, nevertheless, owners are reluctant to discuss their repairs.

Photo 4. Lateral pressure damage to multi-family apartment complex in south central Amherst (June 2004). Basement walls have corner cracks (patched), and corner block is rotated out. Perimeters soils have settled and pitch into basement wall,; down spouts are often extended and step is settling.
