Project Code: W7B01e

October 7, 2021

RE: 669 Youngs Road – Habitat Assessment & Tree Survey  
Town of Amherst  
Erie County, New York

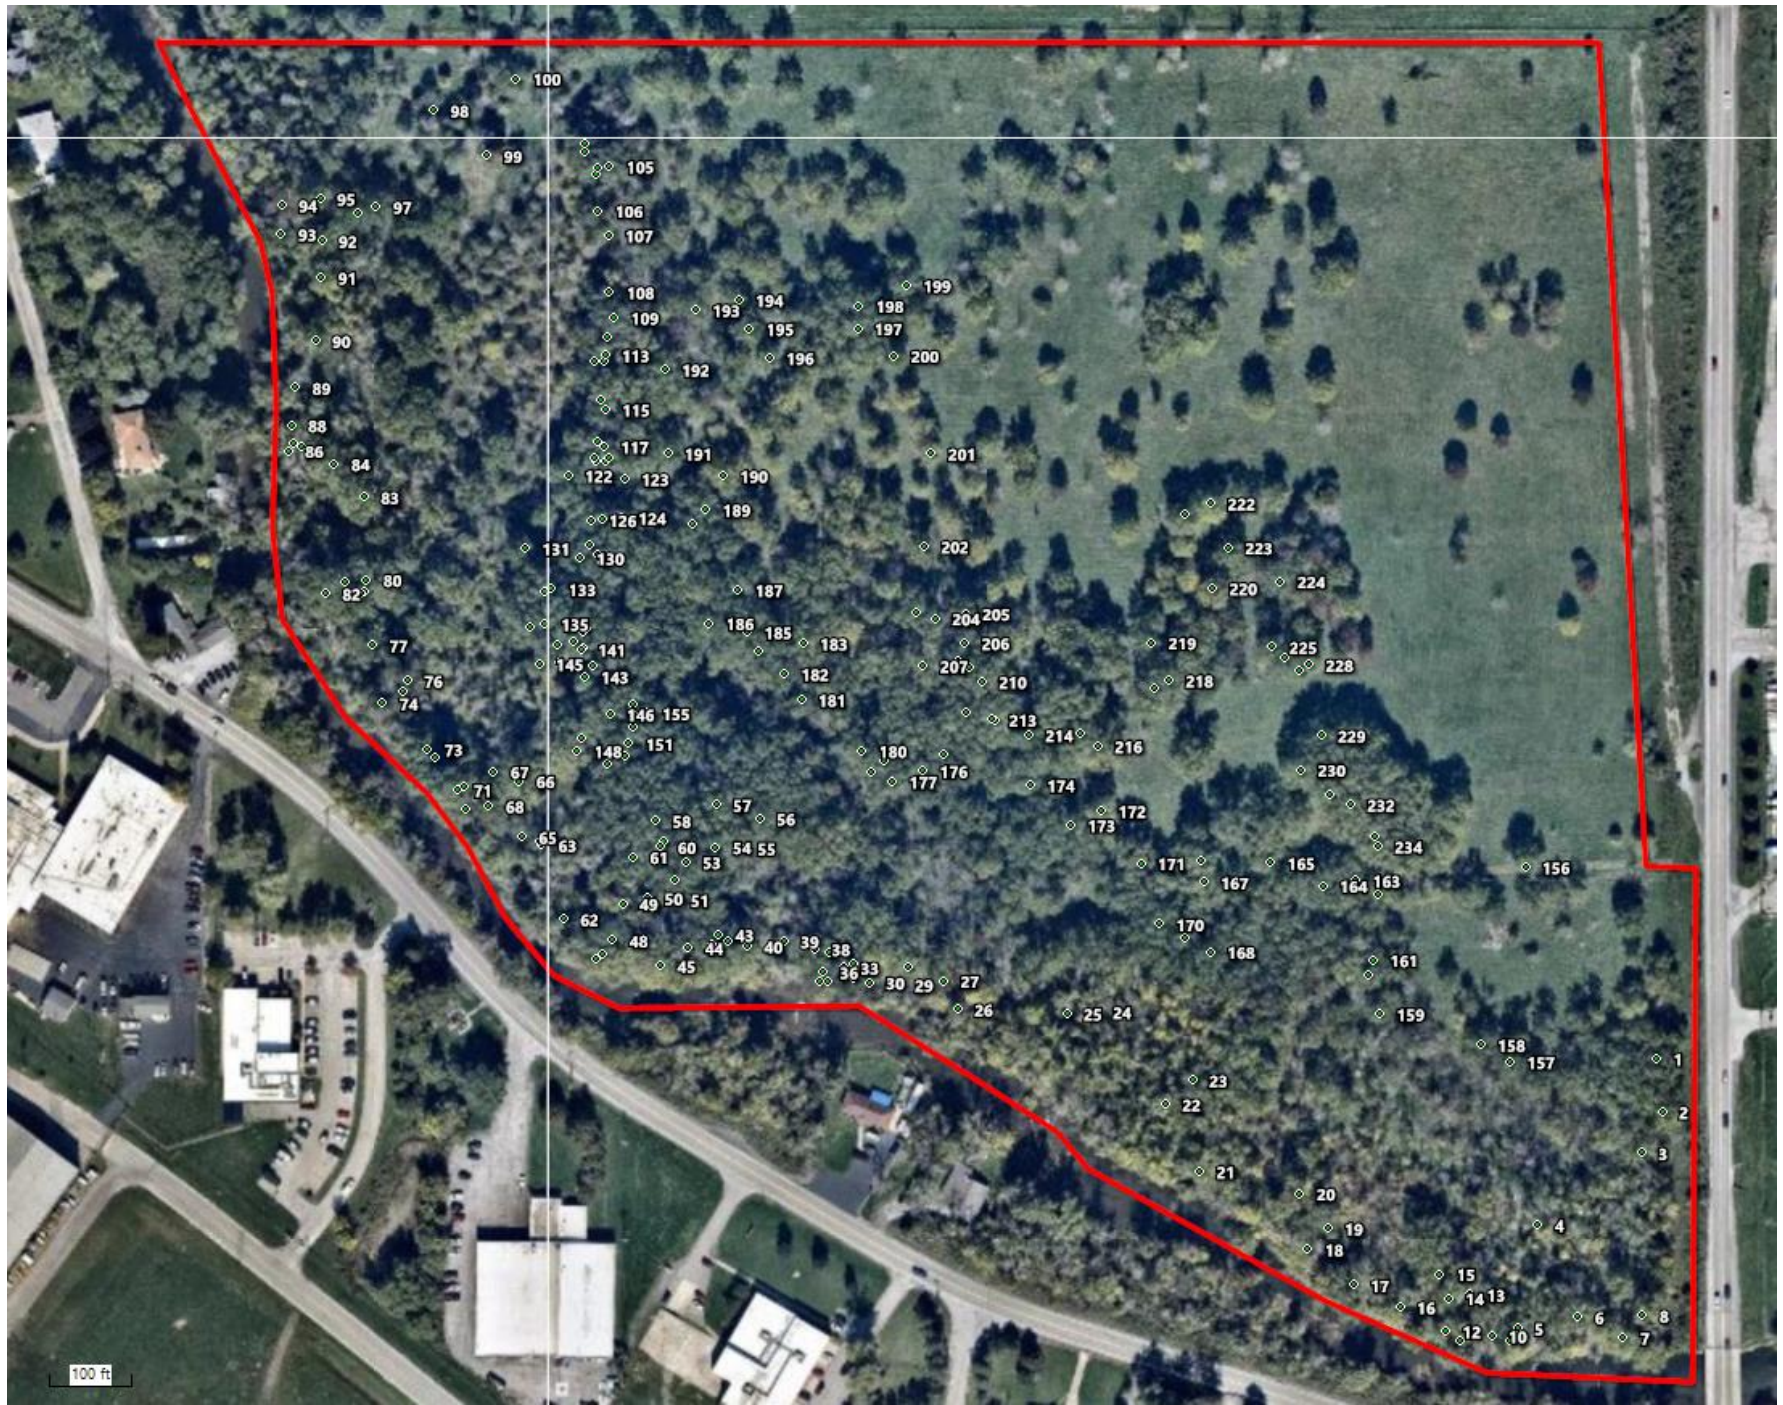
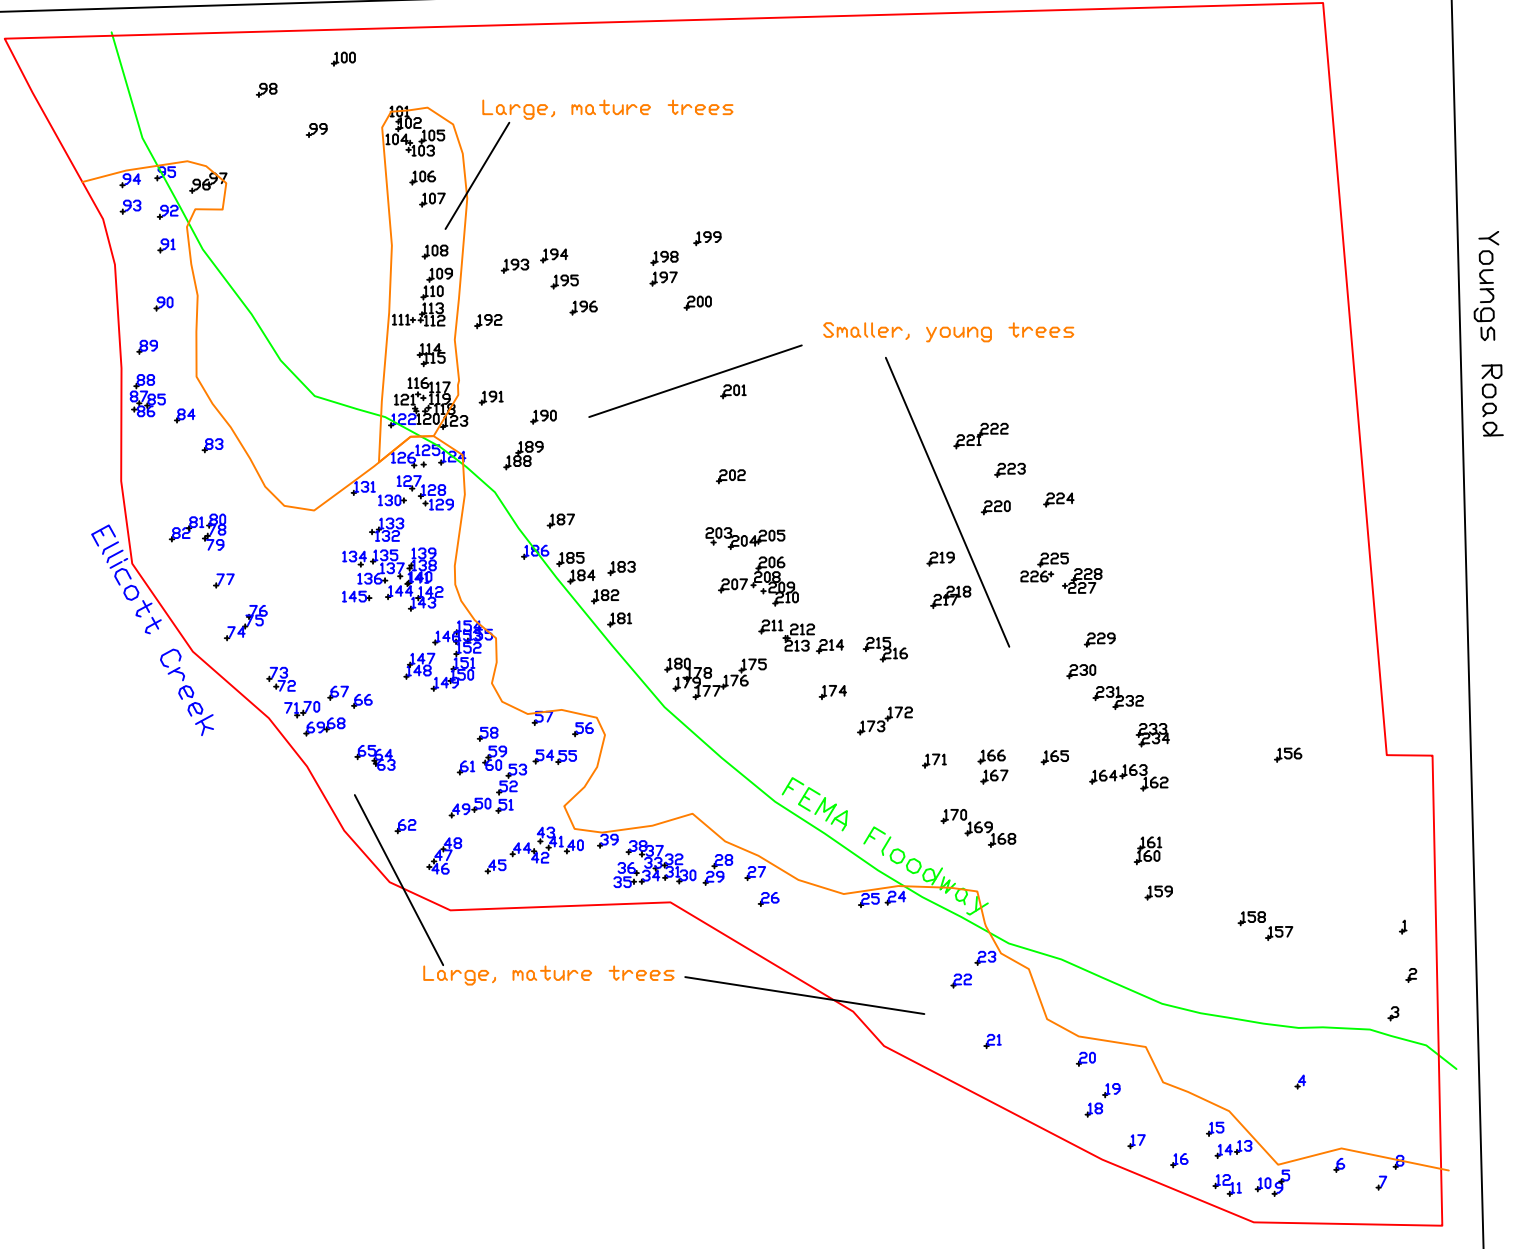
# Habitat & Tree Location Map

The floodway along Ellicott Creek contains the largest and oldest trees (54% of all trees), as depicted on the Habitat & Tree Location Map. The floodway contains very large crack willow (15 trees) and eastern cottonwood (4 trees), with higher amounts of black walnut (89 trees) further from Ellicott Creek. Lesser amounts of basswood (11 trees), pignut hickory (5 trees), black cherry (1 tree) and Norway maple (1 tree) are scattered within the floodway.

The area outside of the floodway is dominated by black walnut (87 trees) that are of generally good health. A strip of larger, older trees (appeared to be a historic hedgerow) are located within the area outside of the floodway, identified as tree numbers 101 through 122. Trees in this area are dominated by red oak (12 trees) with scattered black walnut (5 trees), white oak (2 trees) and shagbark hickory (1 tree). The forested communities onsite are dominated by trees common to Western New York, and no significant habitats or ecosystems were identified.
