**TOWN OF AMHERST, NY –
AMHERST CENTRAL PARK**

**DRAFT SUPPLEMENTAL GENERIC
ENVIRONMENTAL IMPACT STATEMENT**

October 12, 2023

Prepared by:
Stantec Consulting Services Inc.
61 Commercial Street, Suite 100
Rochester, NY, 14614

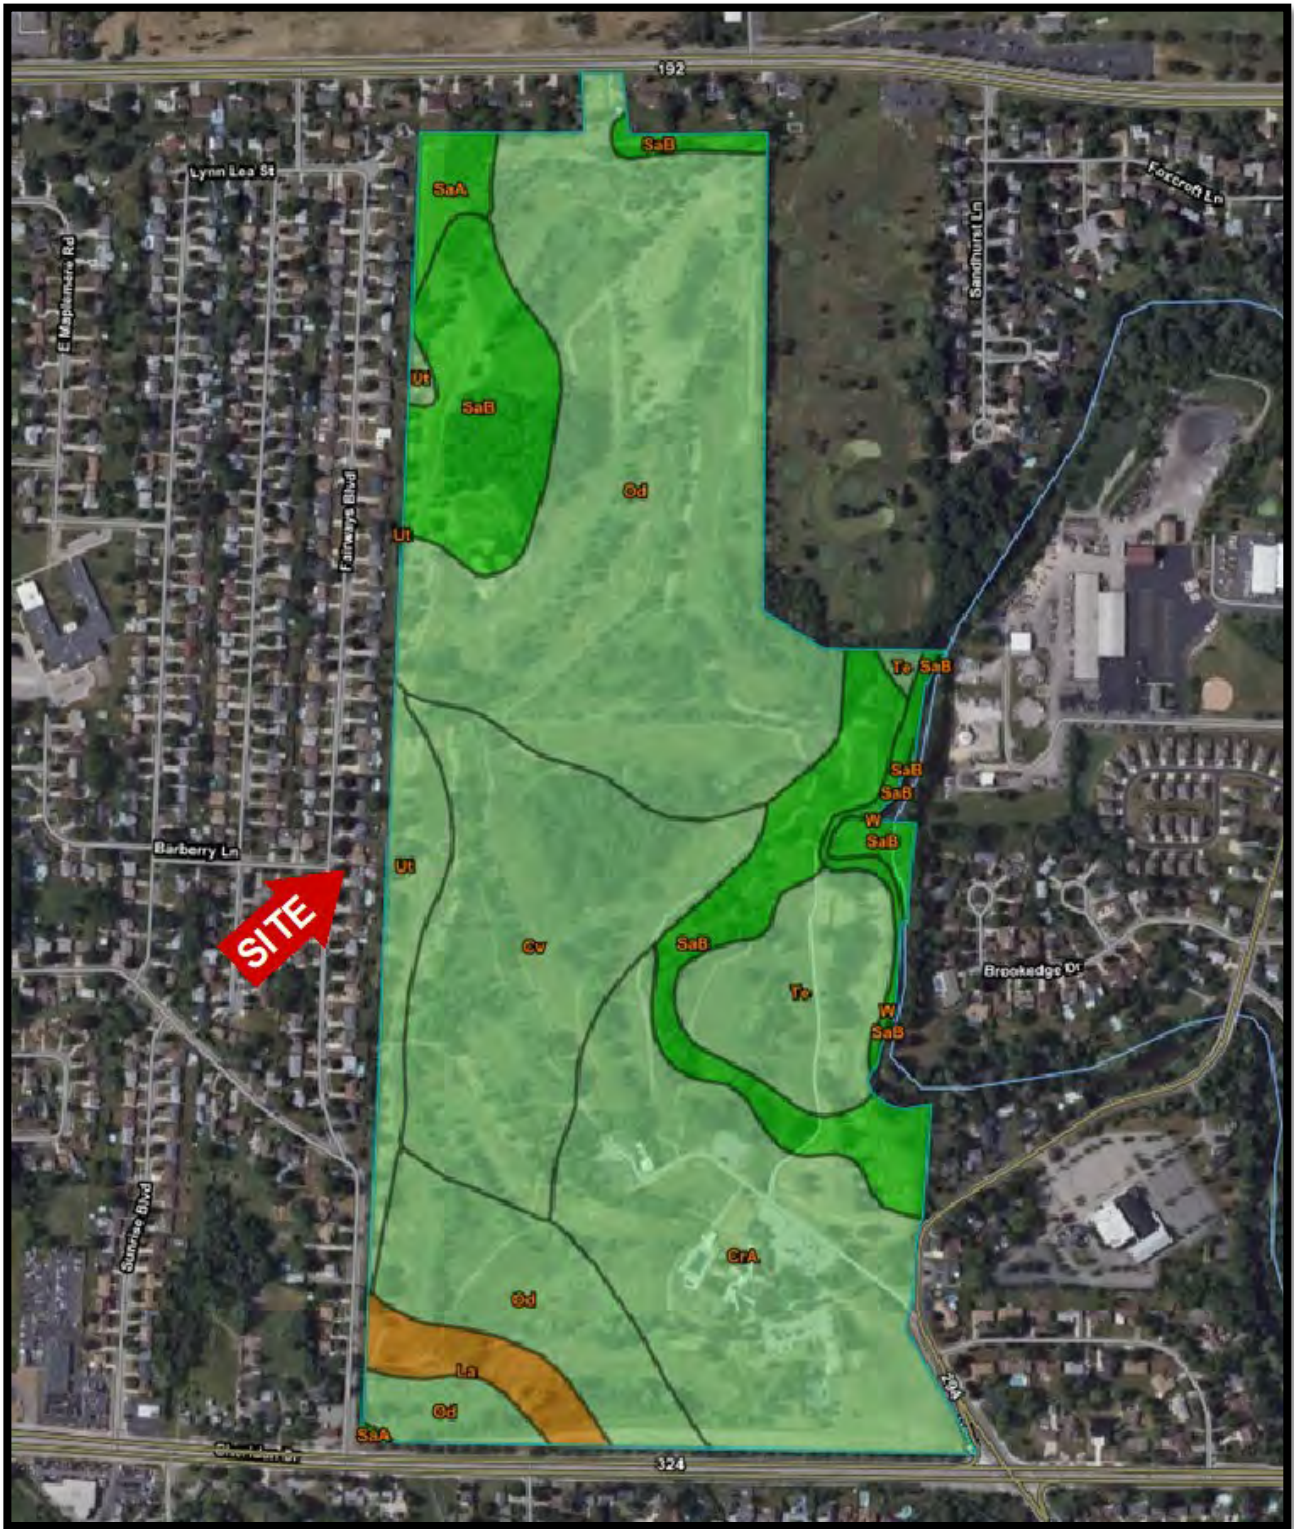
FIGURE 3: NRCS SOIL SURVEY MAP

Map unit symbol	Map unit name	Rating	Acres in AOI	Percent of AOI
CrA	Claverack loamy fine sand, 0 to 3 percent slopes	5	30.2	17.8%
Cv	Cosad loamy fine sand	10	25.9	15.2%
La	Lakemont silt loam, 0 to 3 percent slopes	95	4.0	2.4%
Od	Odessa silt loam, 0 to 3 percent slopes	5	64.4	37.9%
SaA	Schoharie silt loam, 0 to 3 percent slopes	0	2.3	1.4%
SaB	Schoharie silt loam, 3 to 8 percent slopes	0	23.5	13.8%
Te	Teel silt loam	5	10.3	6.1%
Ut	Urban land-Odessa complex, 0 to 3 percent slopes	5	7.5	4.4%
W	Water	0	1.9	1.1%
Totals for Area of Interest			170.1	100.0%

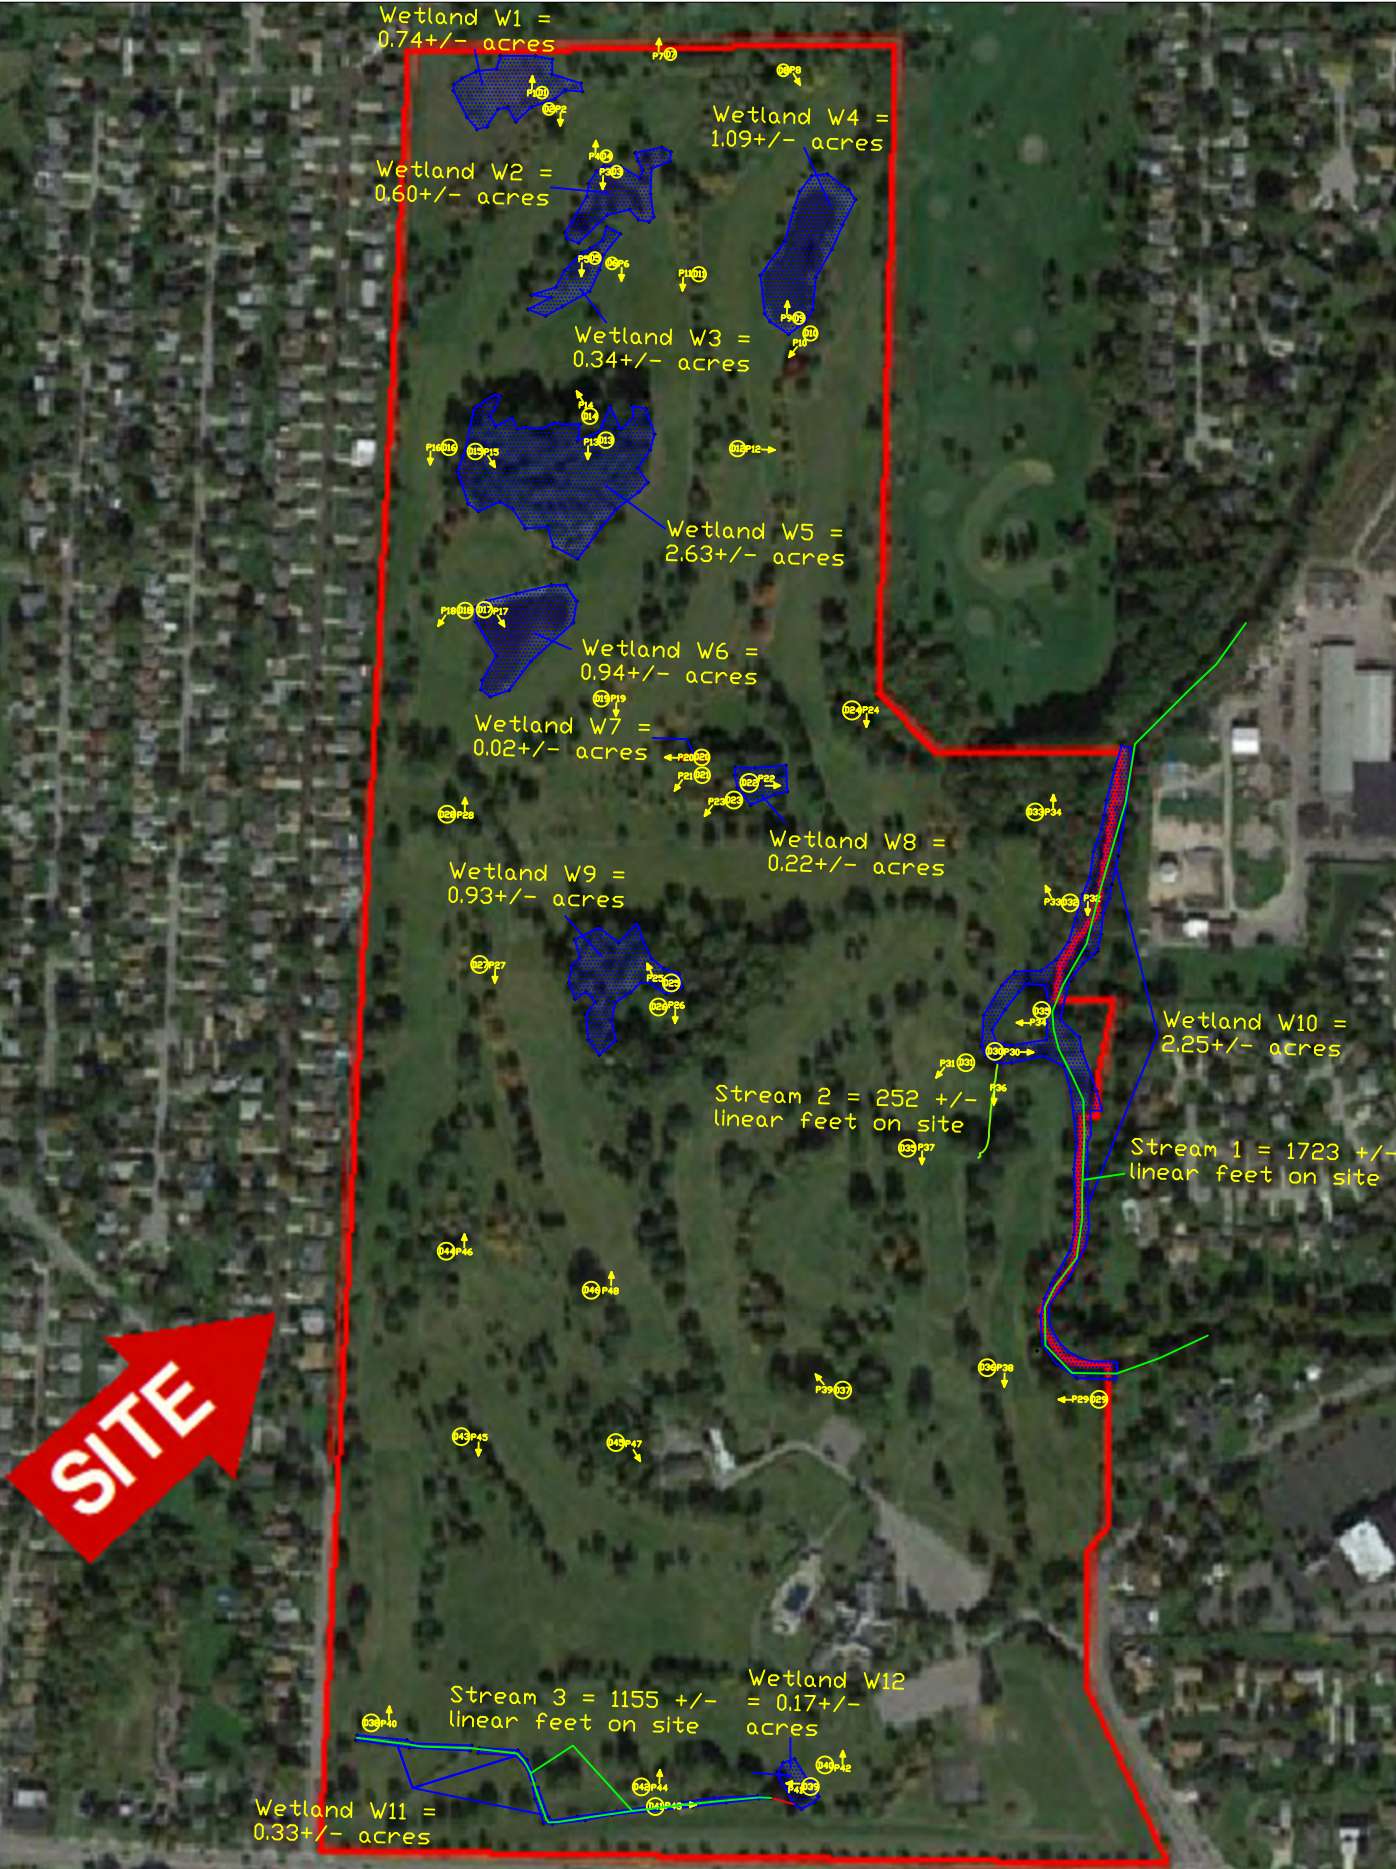
Figure 9: Aerial Photo With Wetlands
 GoogleEarth.com (Visited 5/24/23)
 Amherst Central Park
 Town of Amherst, Eric County, New York

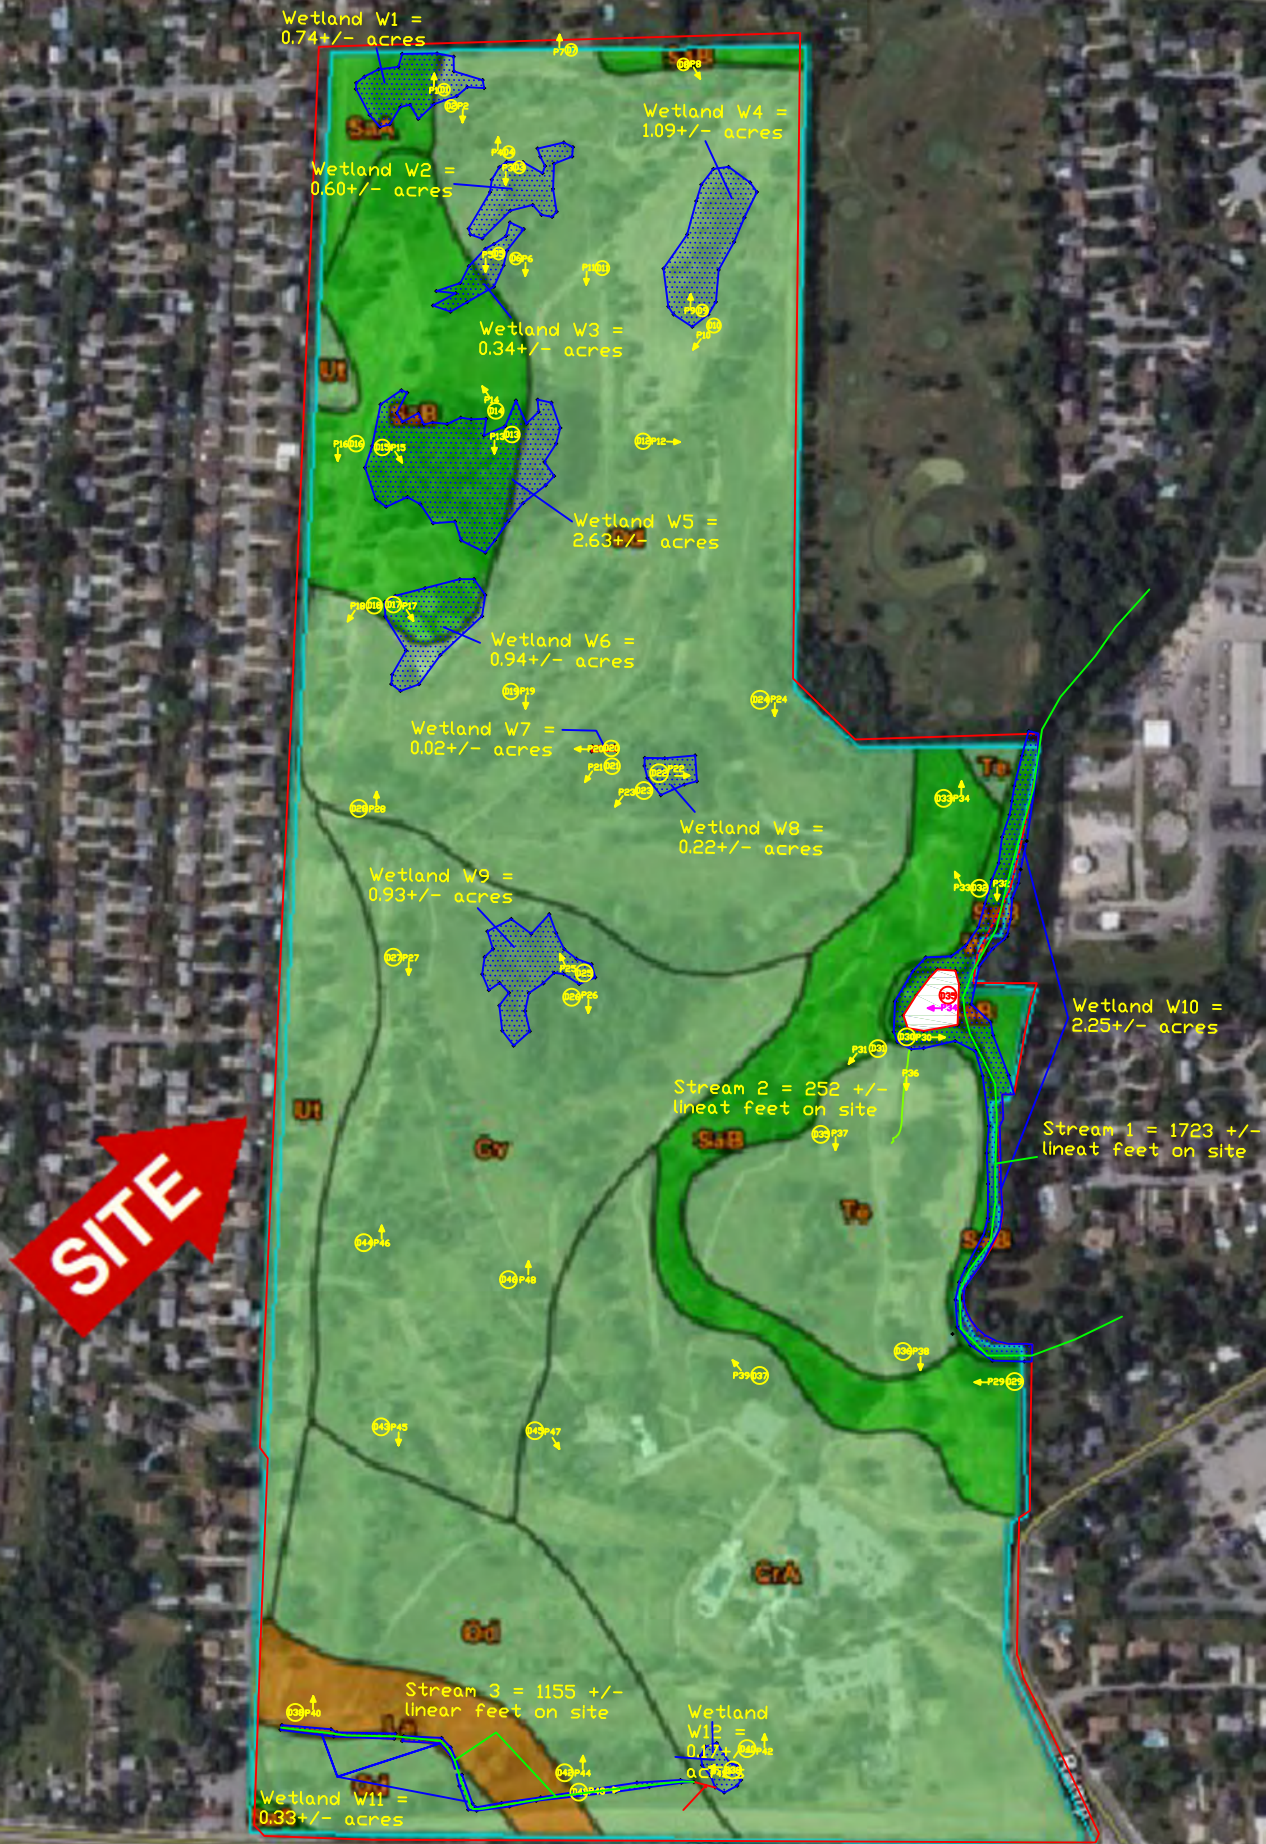
Figure 10: Soils Map With Wetlands
 GoogleEarth.com (Visited 5/24/23)
 Amherst Central Park
 Town of Amherst, Erie County, New York

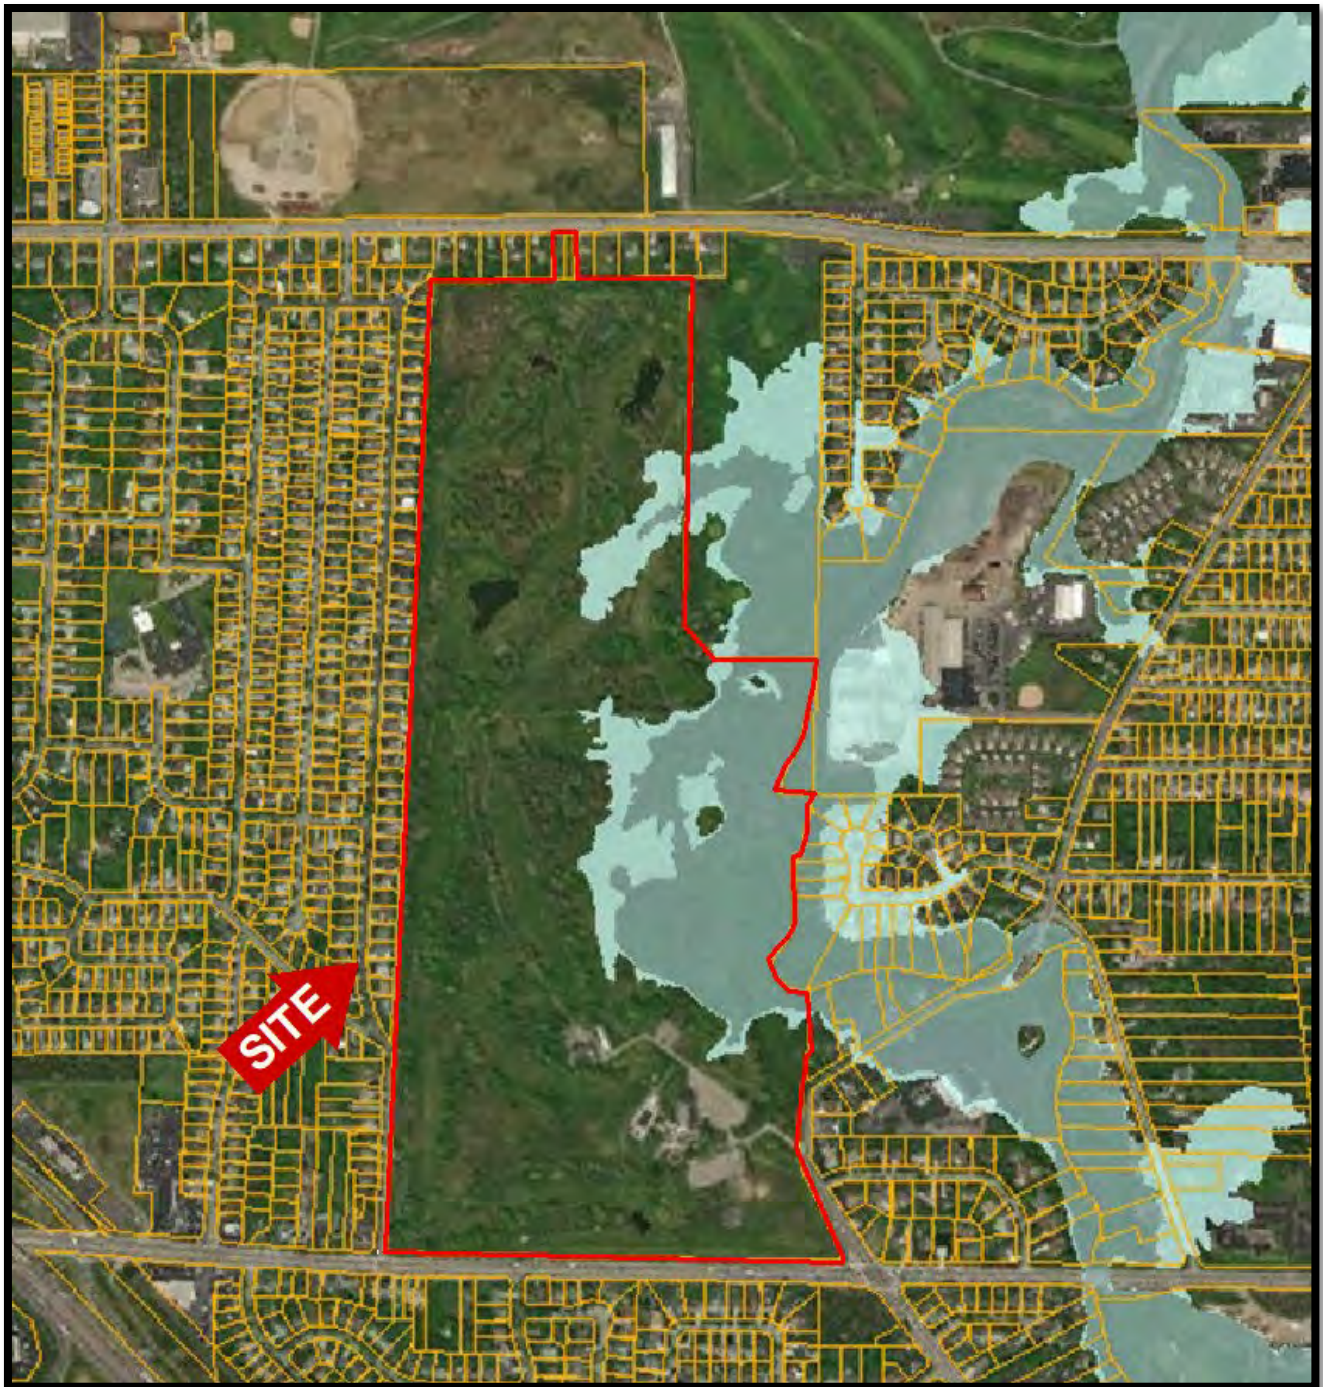
FIGURE 11: FEMA MAP

Agency (“FEMA”). The map provided in Appendix D illustrates the current location of the 100-year and 500-year flood hazard zones on the eastern portion of the Property.

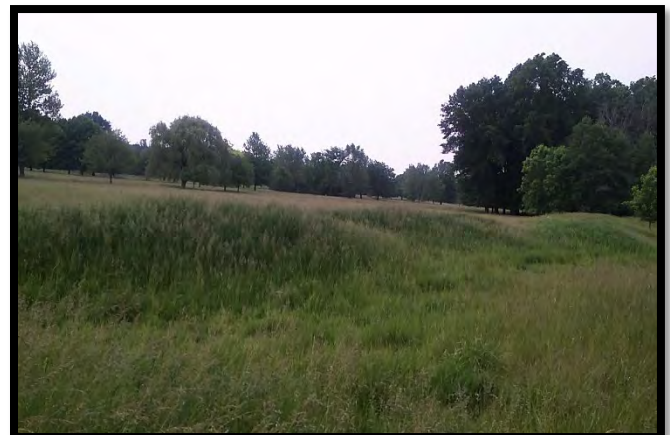
Photo 6 (6/5/23): Facing south. Depicts the successional old field community at data point D6.

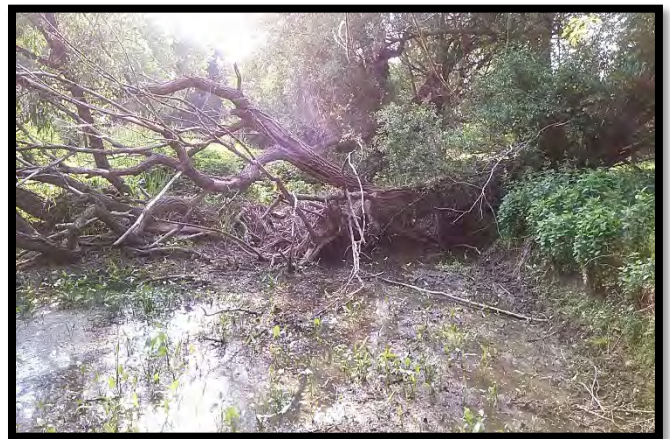
Photo 30 (6/6/23): Facing east. Depicts the shallow emergent marsh community of W10 at data point D30.

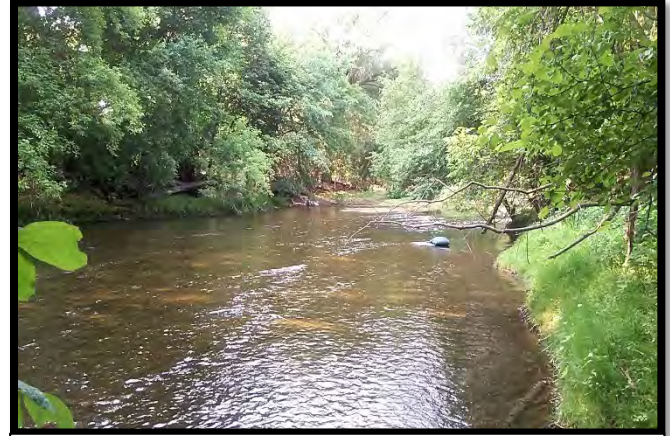
Photo 32 (6/6/23): Facing south. Depicts stream 1.

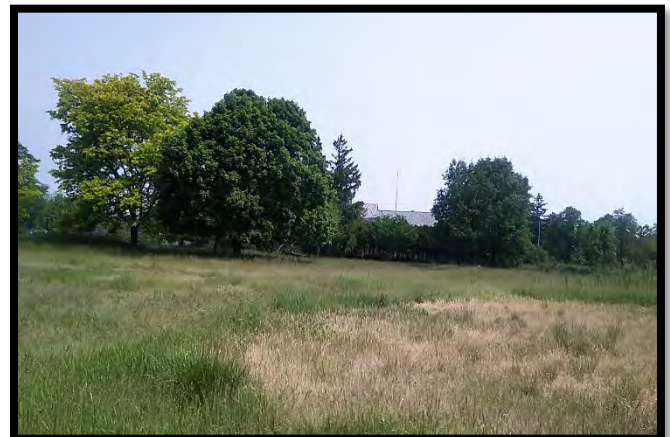
Photo 42 (6/6/23): Facing north. Depicts the successional old field community at data point D40.

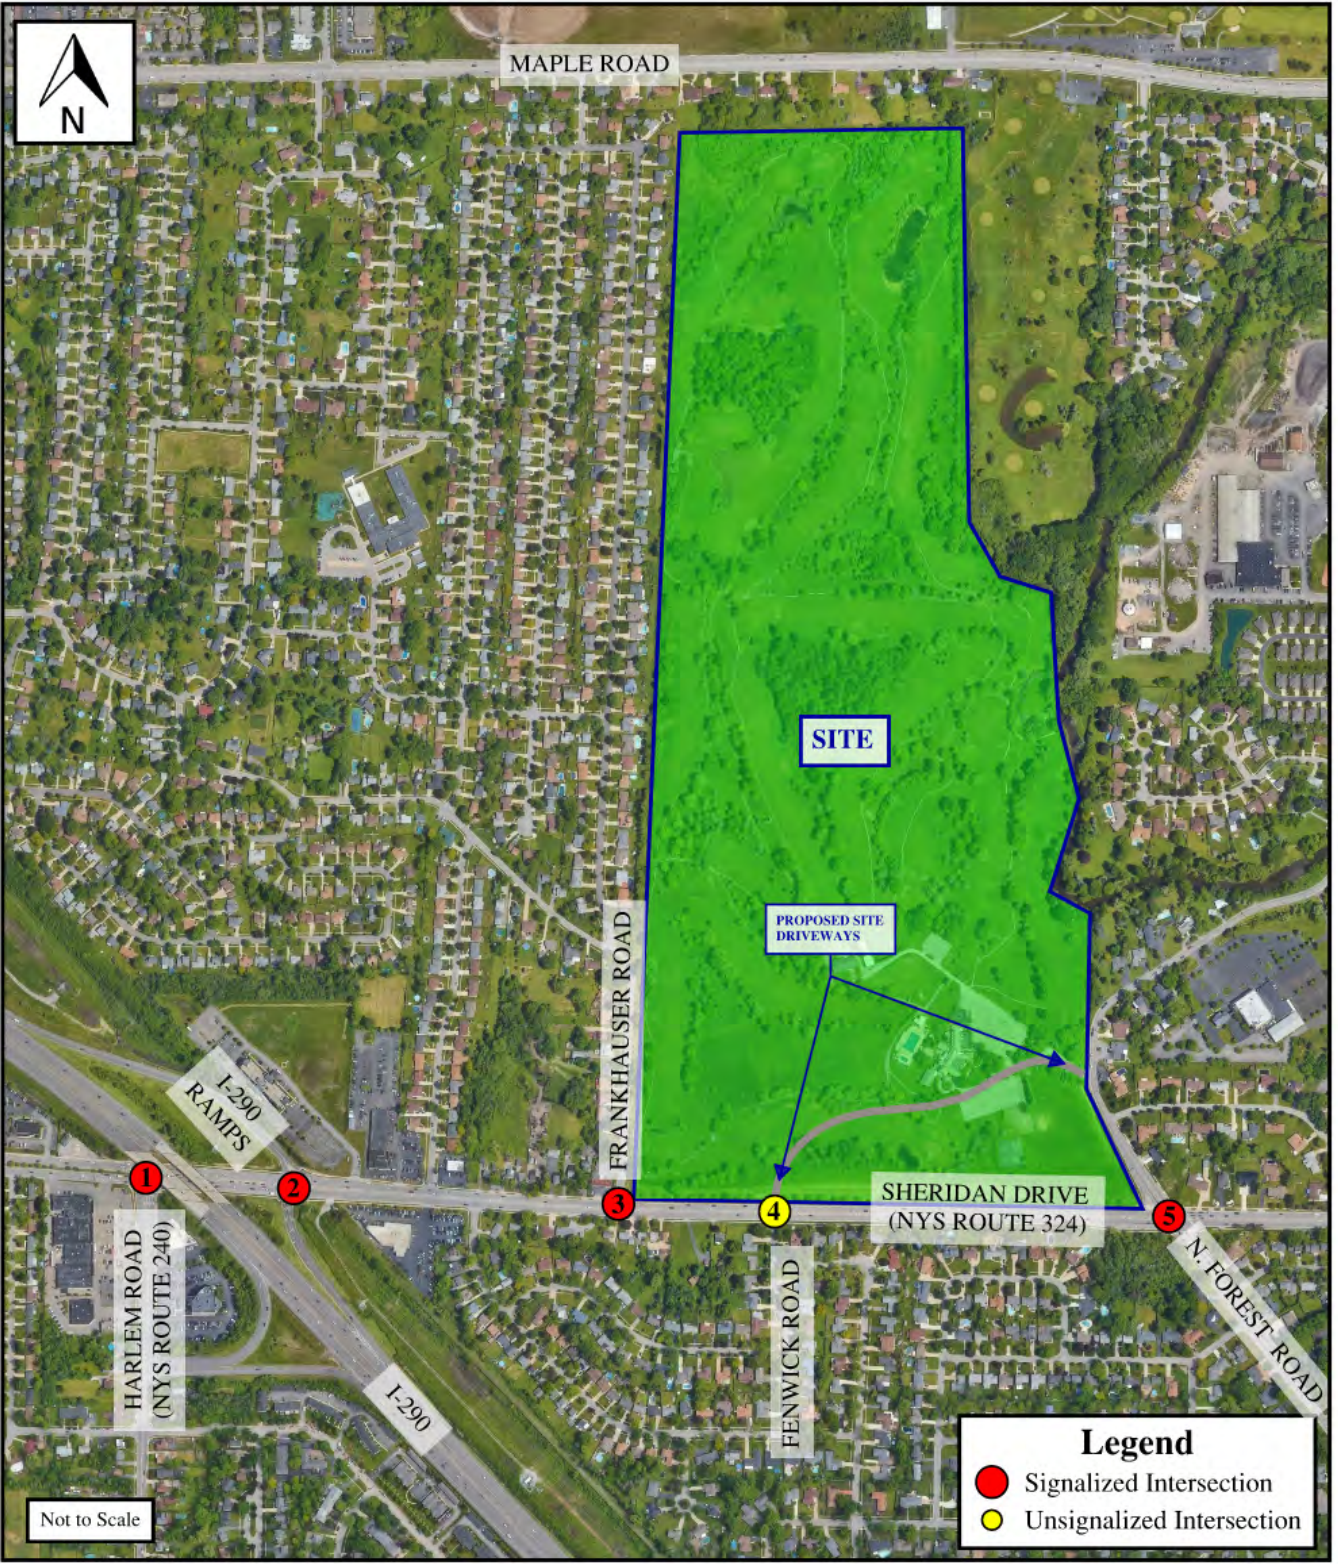
Figure 1: Study Area Map

- 1) Sheridan Drive (NYS Route 324) at Harlem Road (NYS Route 240)
- 2) Sheridan Drive (NYS Route 324) at I-290 Ramps
- 3) Sheridan Drive (NYS Route 324) at Frankhauser Road
- 4) Sheridan Drive (NYS Route 324) at Fenwick Road
- 5) Sheridan Drive (NYS Route 324) at N. Forest Road

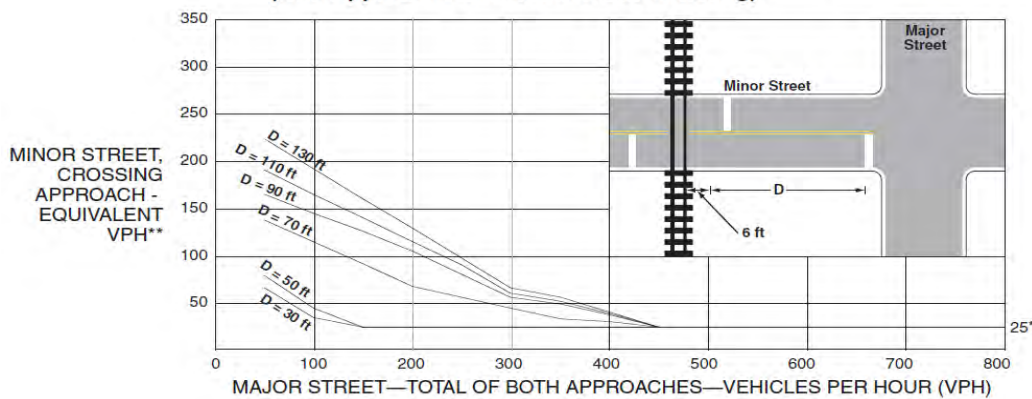
Figure 4C-9. Warrant 9, Intersection Near a Grade Crossing (One Approach Lane at the Track Crossing)

* 25 vph applies as the lower threshold volume
** VPH after applying the adjustment factors in Tables 4C-2, 4C-3, and/or 4C-4, if appropriate
