TOWN OF AMHERST
SOILS AND RESIDENTIAL FOUNDATION STUDY

October 2005

U.S. Army Corps of Engineers

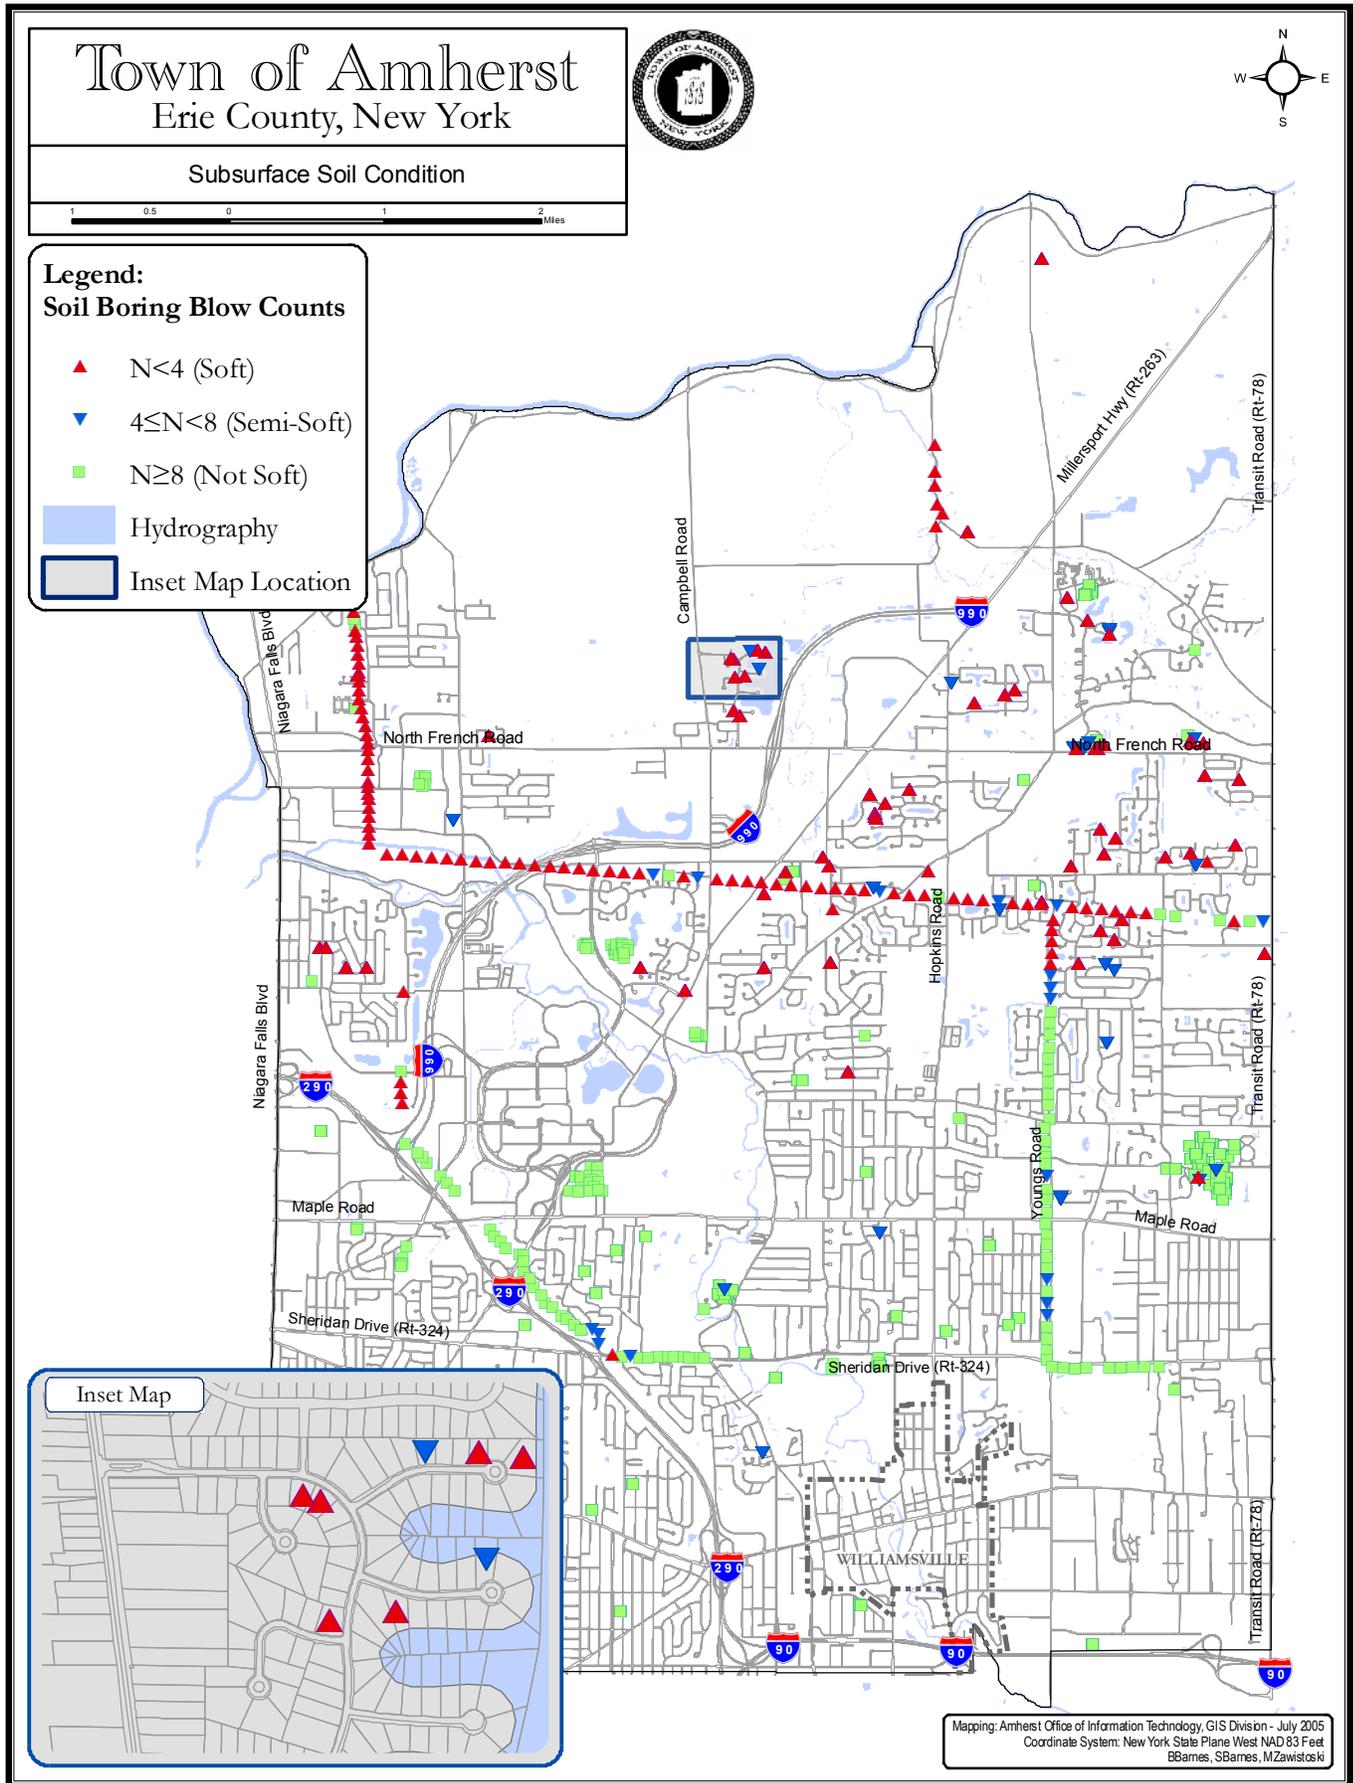
Figure 6: Location of boreholes and the presence of “soft,” “semi-soft,” or “not soft” strata. These designations are based on the N-values (blow counts). The soft stratum generally consists of silty clay. In general, the northern portion of Amherst is underlain by the soft stratum, but the inset shows variability at parcel level.

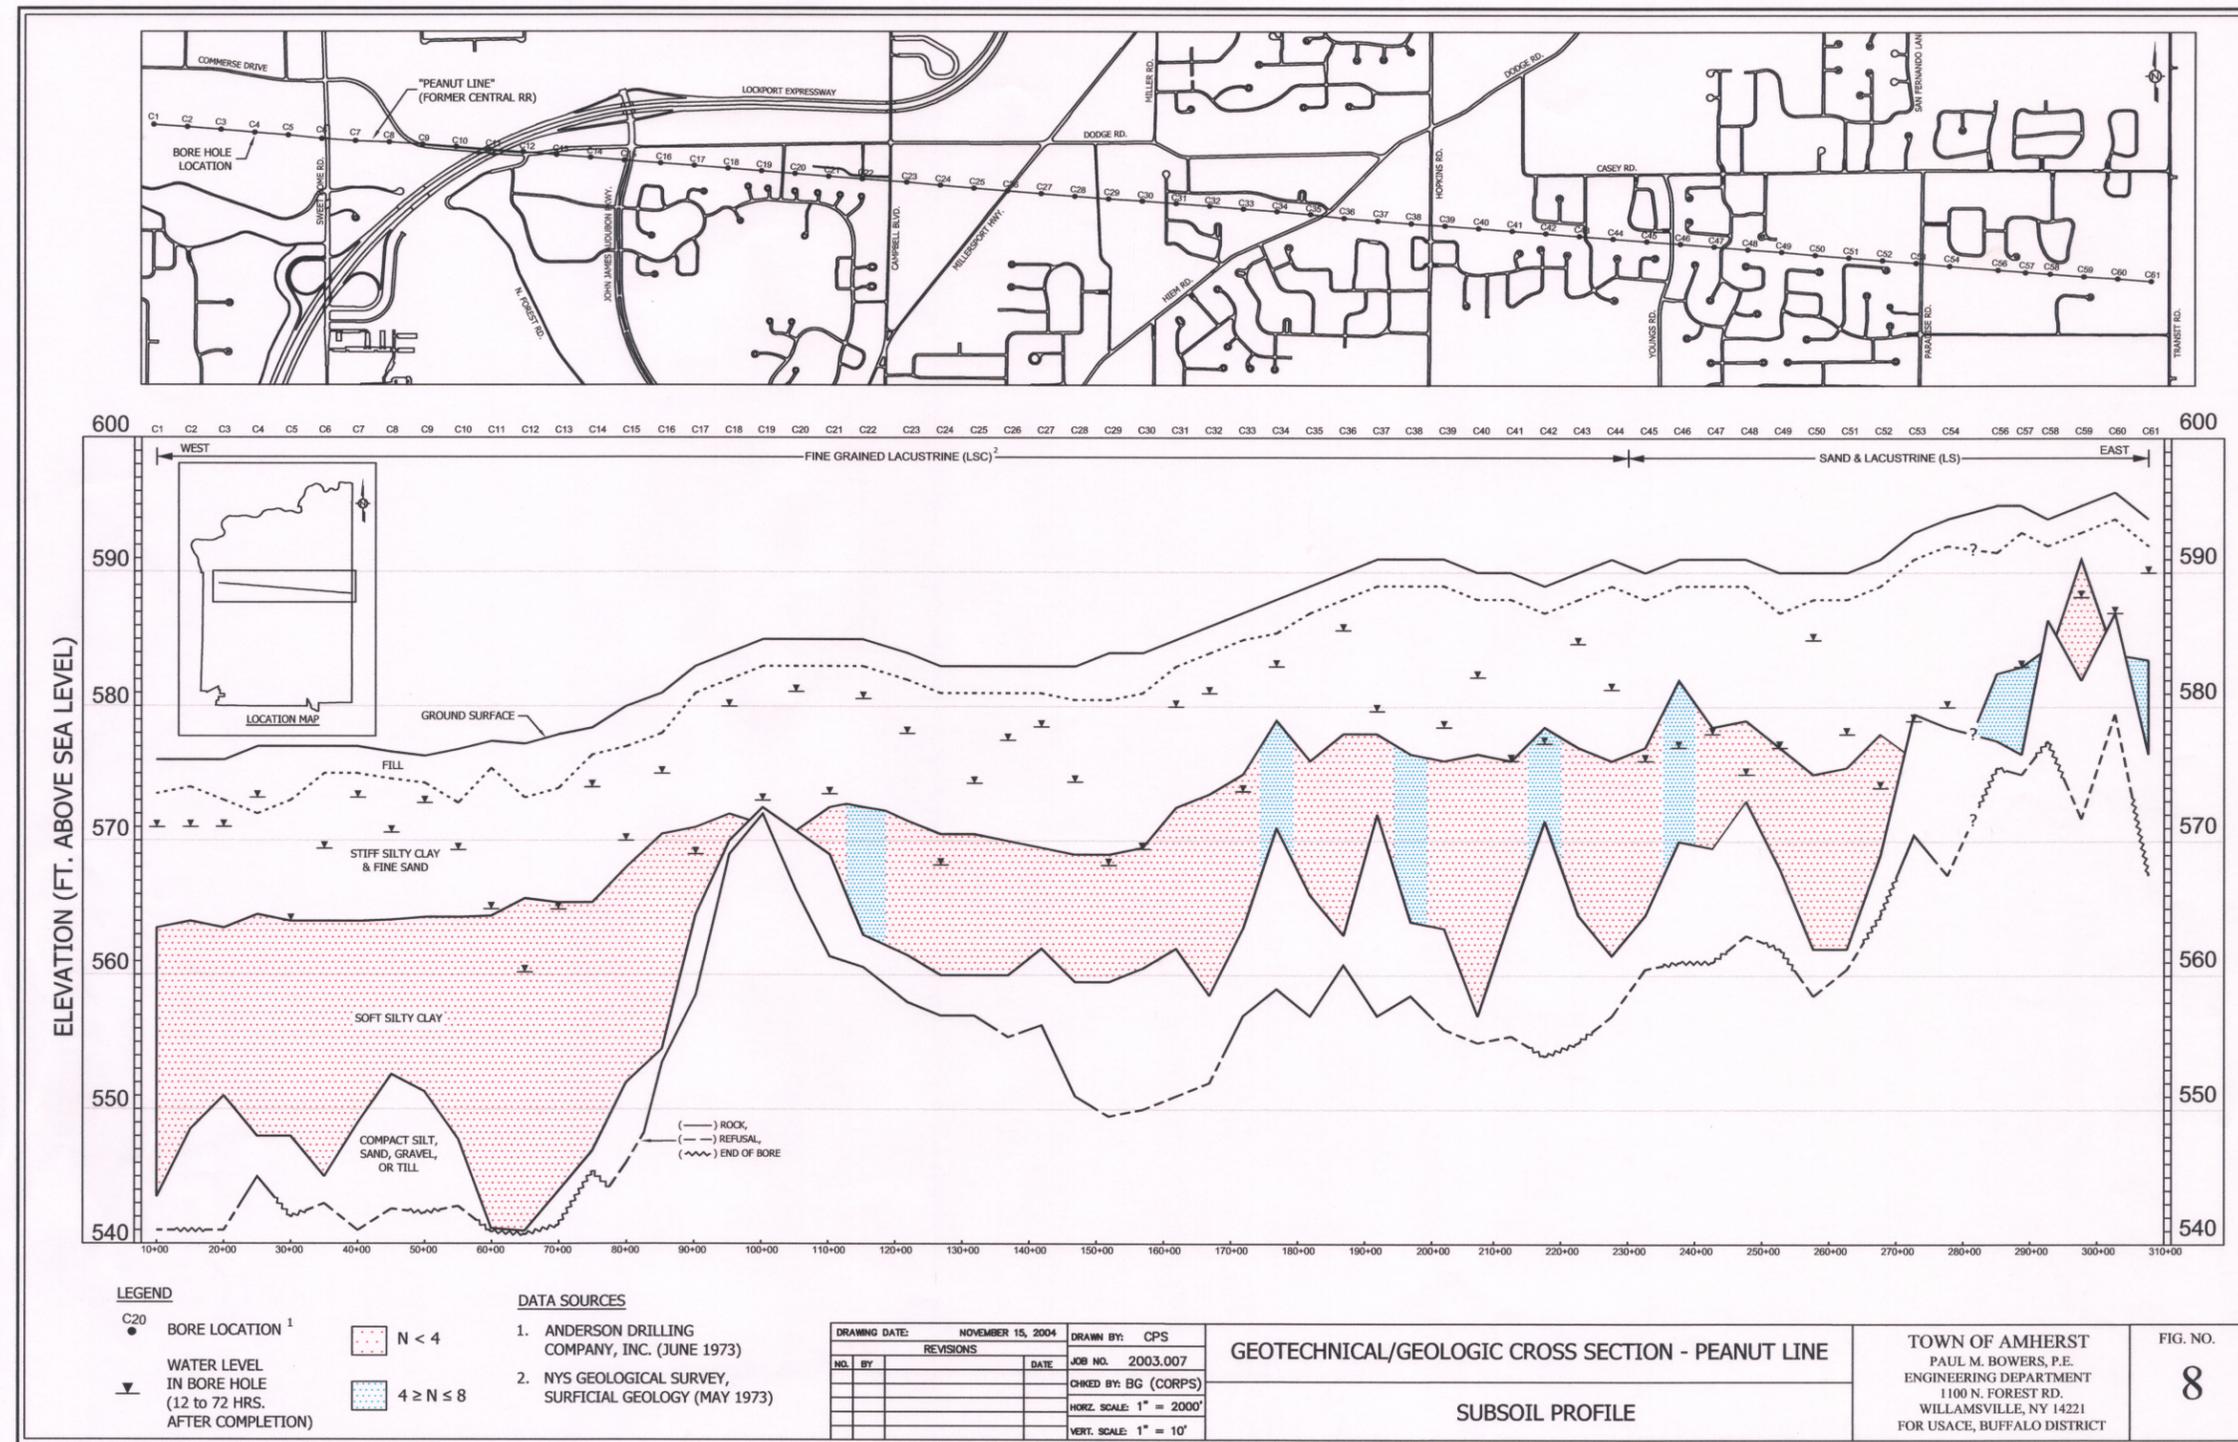
Figure 7. Geotechnical/geologic cross-section through central Amherst along former New York Railroad, or "Peanut Line." Upper section shows aerial view of borehole locations. Cross-section shows elevation of ground surface and depths of fill, soft stratum (if present), till, and borehole termination (end-of-borehole, refusal, or rock). Stippling shows thickness of soft stratum (red) and semi-soft stratum (blue), generally silty clay. Micro-topography of the bedrock and surface appear to influence the location of softer stratum. Subsurface condition becomes more heterogeneous in east towards Clarence.

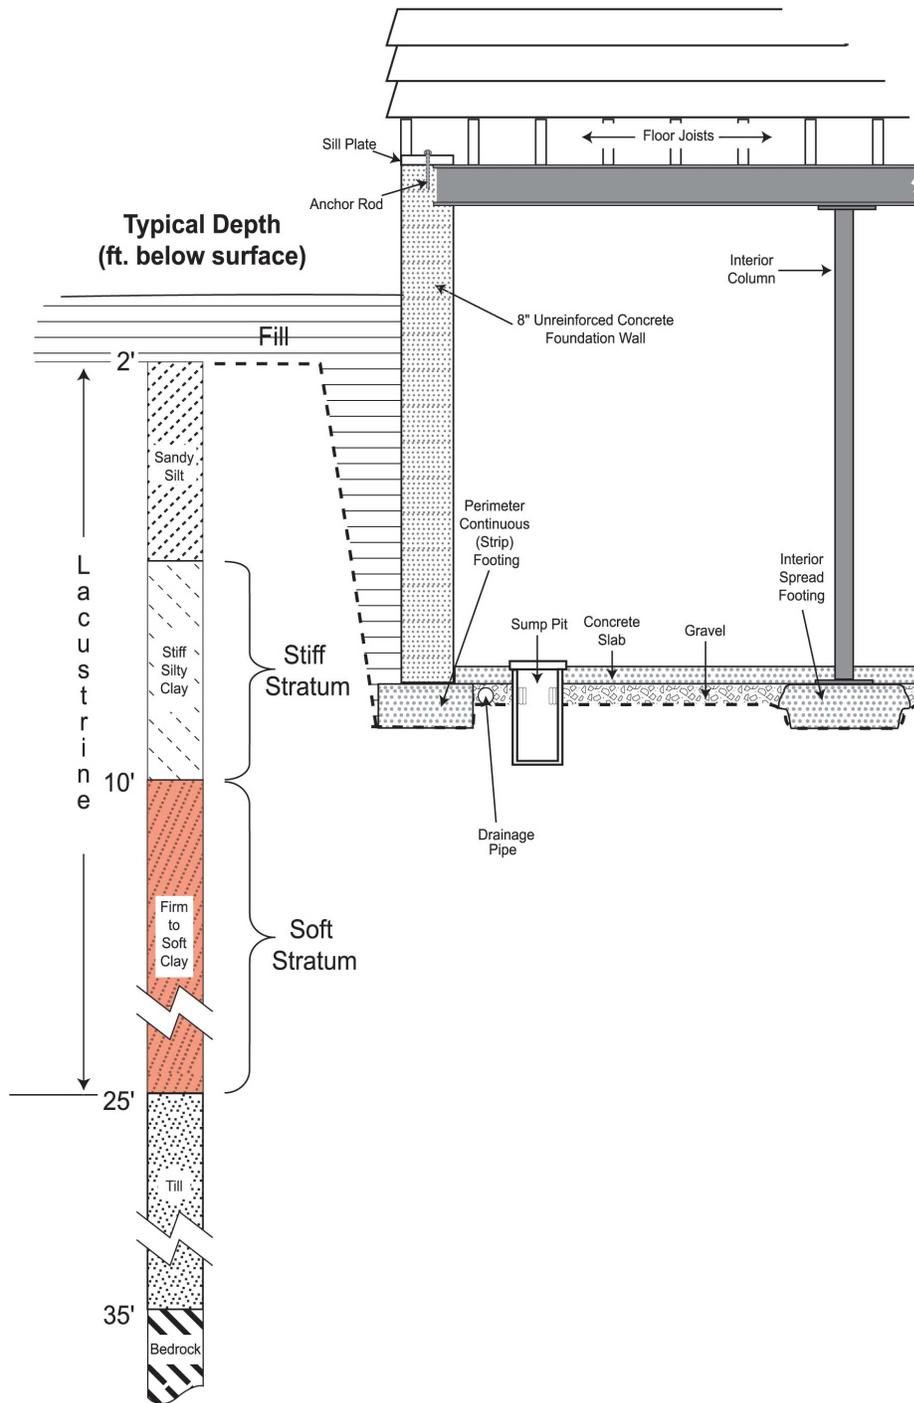
Figure 8. Schematic stratigraphic soil profile in central and northern Amherst showing typical construction of older houses. Many footings rest on a stiff stratum that overlies a soft stratum. Fill consists of remolded native material.

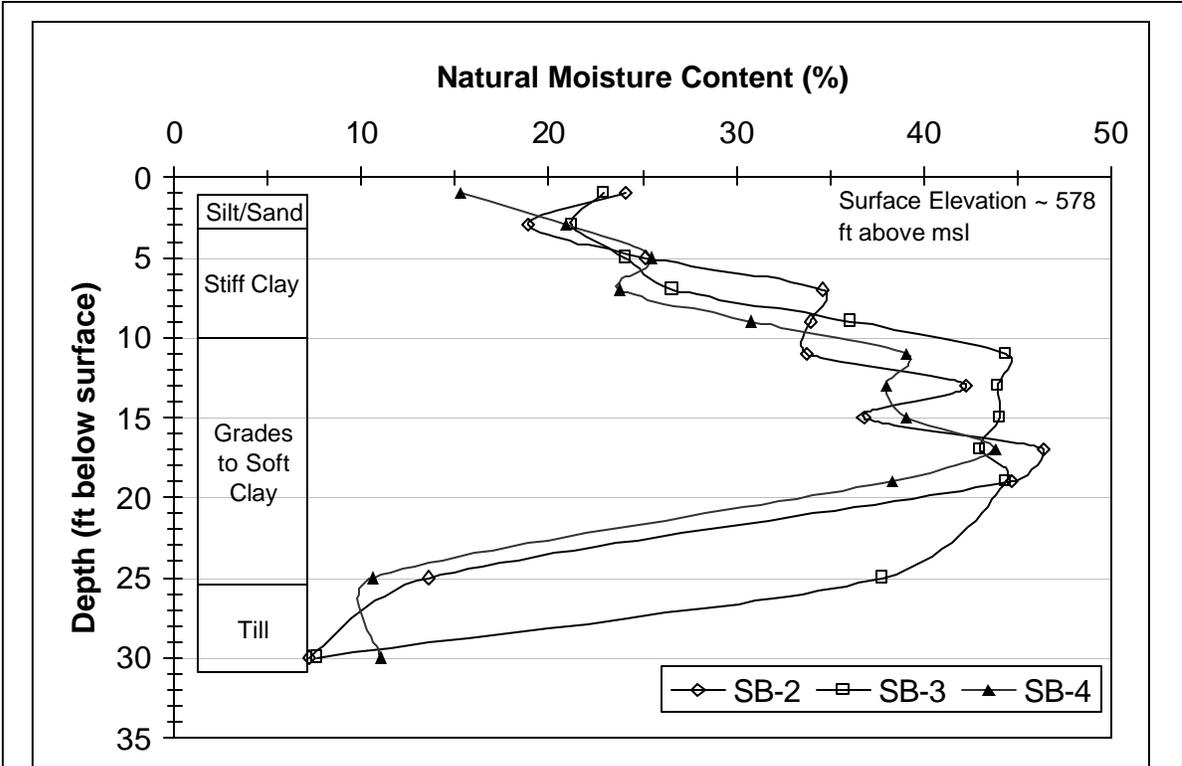
Figure 9. Typical soil moisture content profile from three soil borings at sewage treatment plant in northwestern Amherst. Data from Ward (1973).

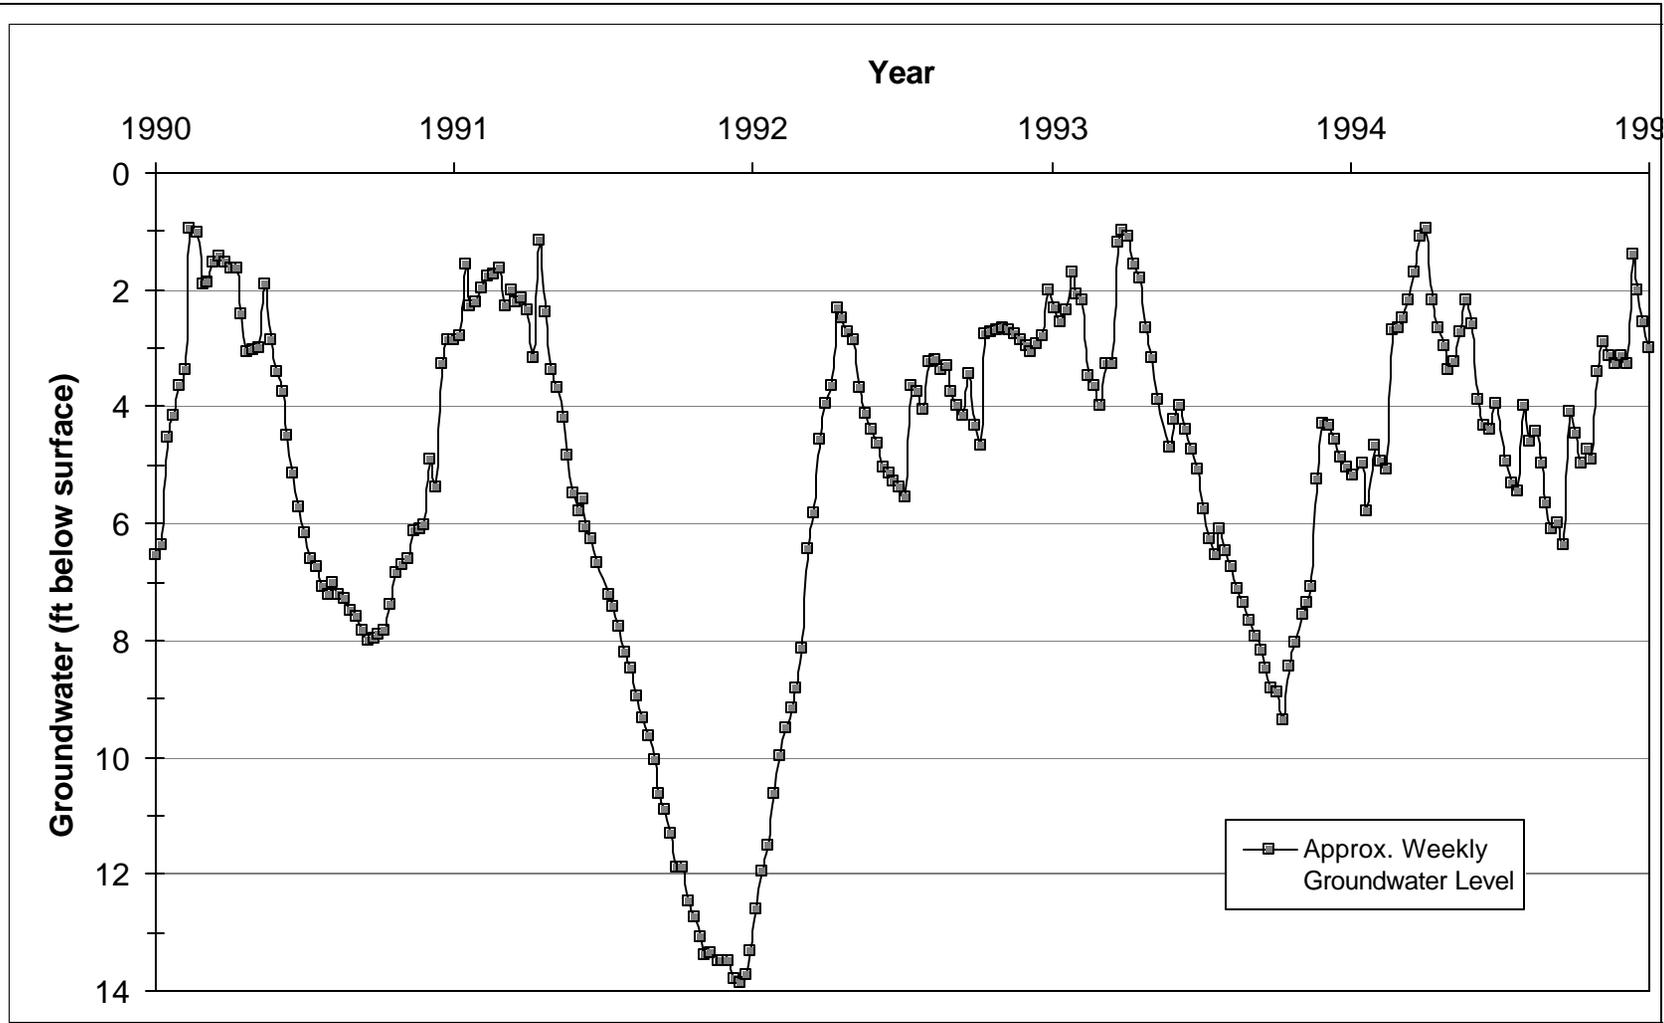
Figure 13. Hydrograph of Ransomville well, near Buffalo, NY, showing weekly groundwater levels in dug well (~25 ft deep) in possible sandy clay stratum. Dry and wet years correspond to 1991 and 1992. Data collected by the USGS (Well No. NI-70).

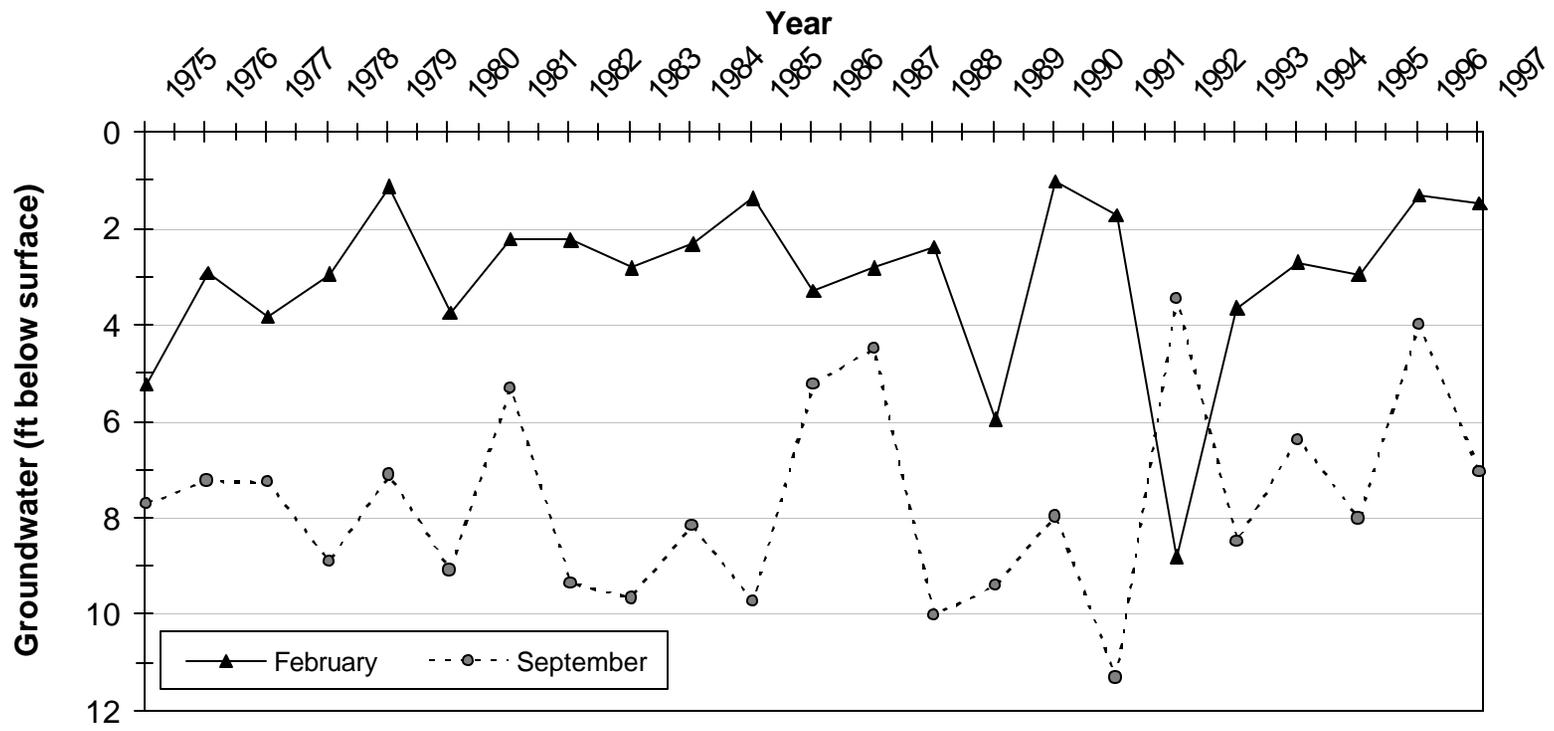
Figure 14. Hydrograph of Ransomville well, near Buffalo, NY, shows qualitatively the annual change in storage from late-February to late-September (1975-96). The dug well is 25 foot-deep and the subsurface may be sandy clay. Data collected by the US GS (Well No. NI-70).

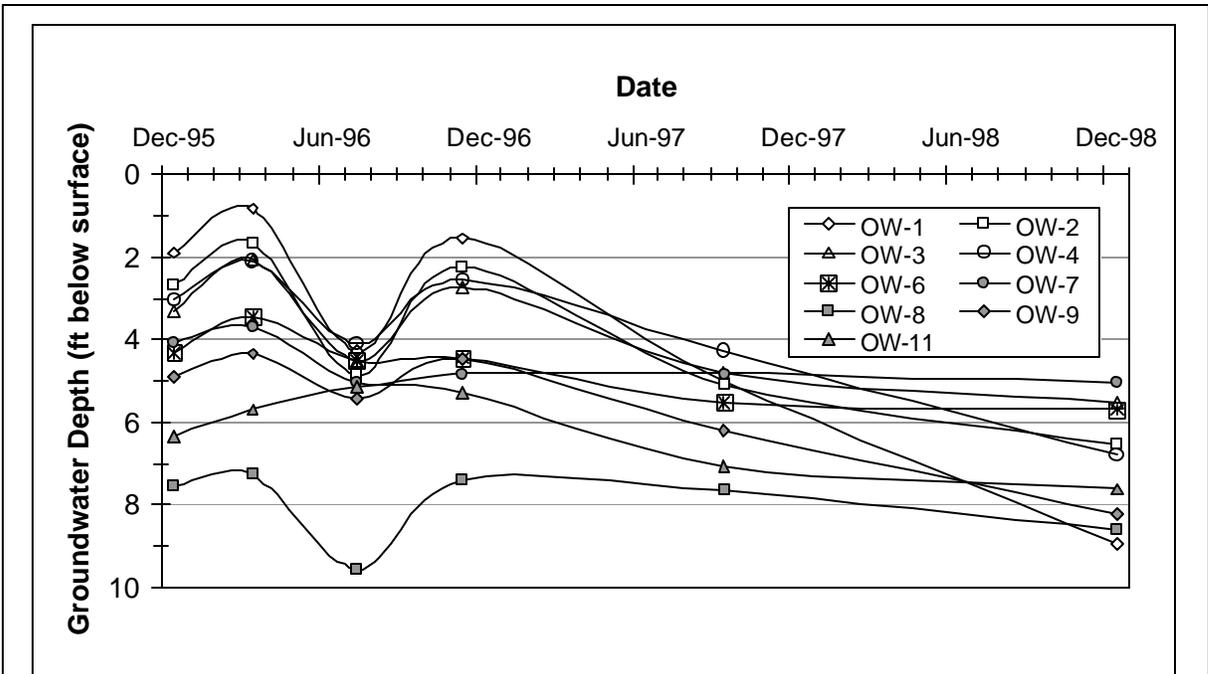
Figure 15. Groundwater levels in shallow wells at Spaulding Site, north of former Tonawanda Landfill (see Appendix 6.1.4). The midpoint of the sandpack for all wells is about 14 feet below ground surface in silty clay (probably till). Data shows spatial and temporal variability in shallow groundwater level. (Data source: Glen May, NYSDEC, 2005)

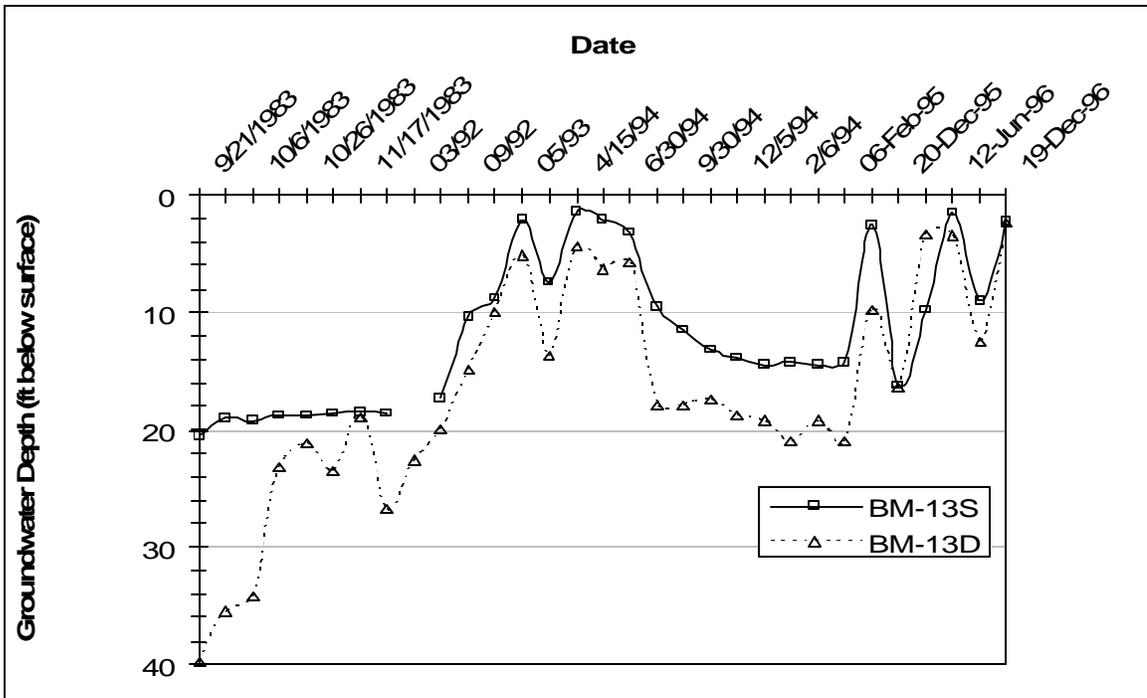
Figure 16. Tonawanda landfill wells BM-13 shallow (S) and deep (D). Sandpack midpoints are approximately 15 and 40 feet below ground surface. Note discontinuous dates. (Data source: Glen May, NYSDEC, 2005).

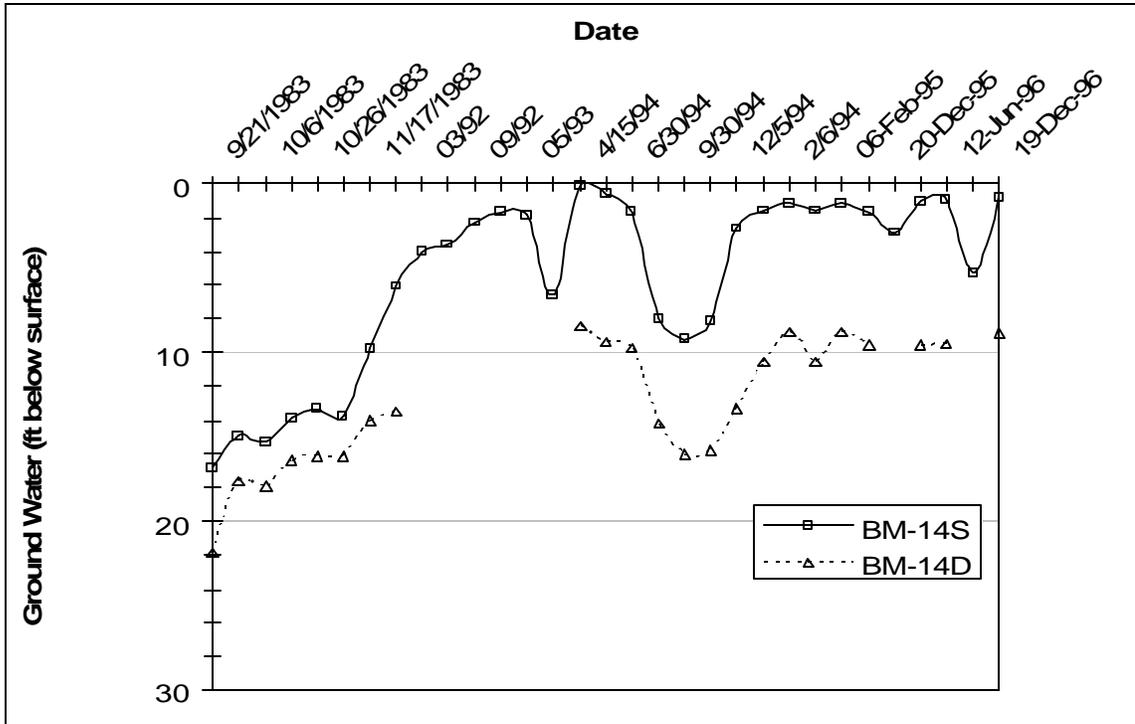
Figure 17. Tonawanda landfill wells BM-14 shallow (S) and deep (D). Sandpack midpoints are approximately 15 and 40 feet below ground surface. Note discontinuous dates. (Data source: Glen May, NYSDEC, 2005).

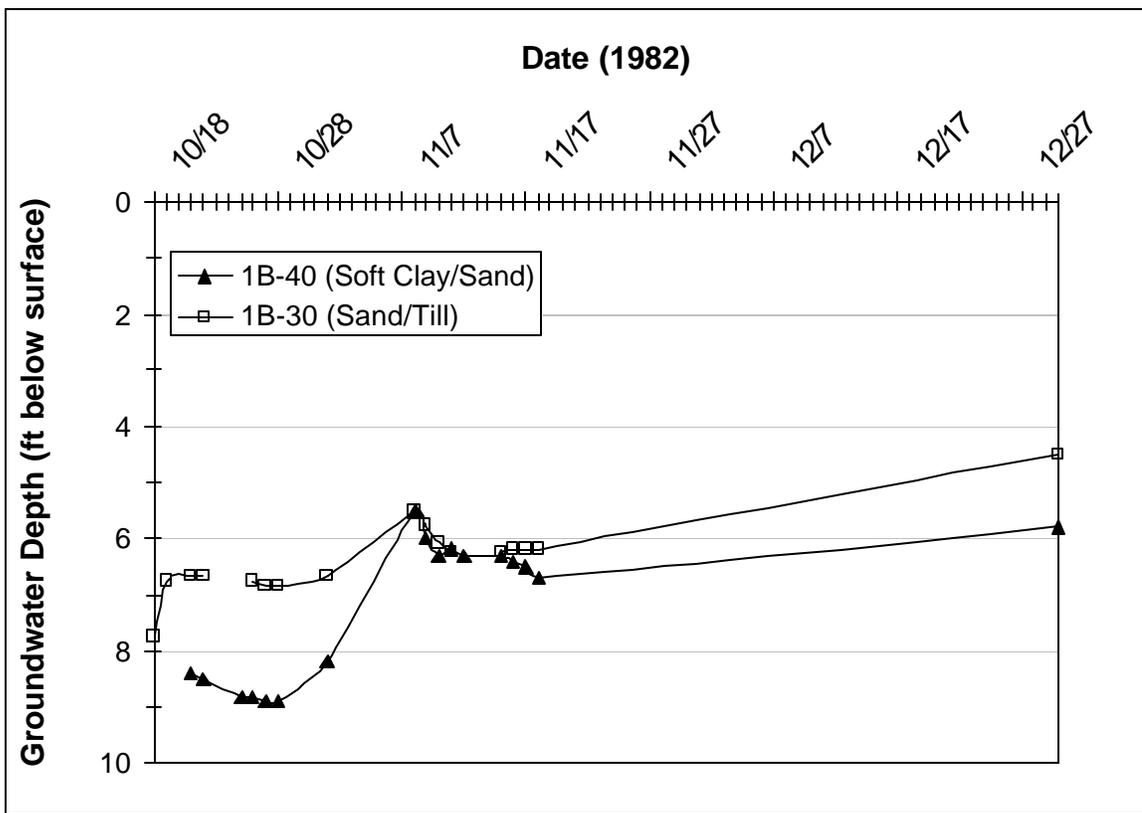
Figure 19. Groundwater elevations at two observation wells along Youngs Road, north of Sheridan Drive (1982). 1B-40 is screened in soft clay stratum transitioning to sand (12 to 20'), and 1B-30 is screened in sand/till (12-20'); both have a total depth of 20 ft. (Data source: Earth Dimensions, 1982).

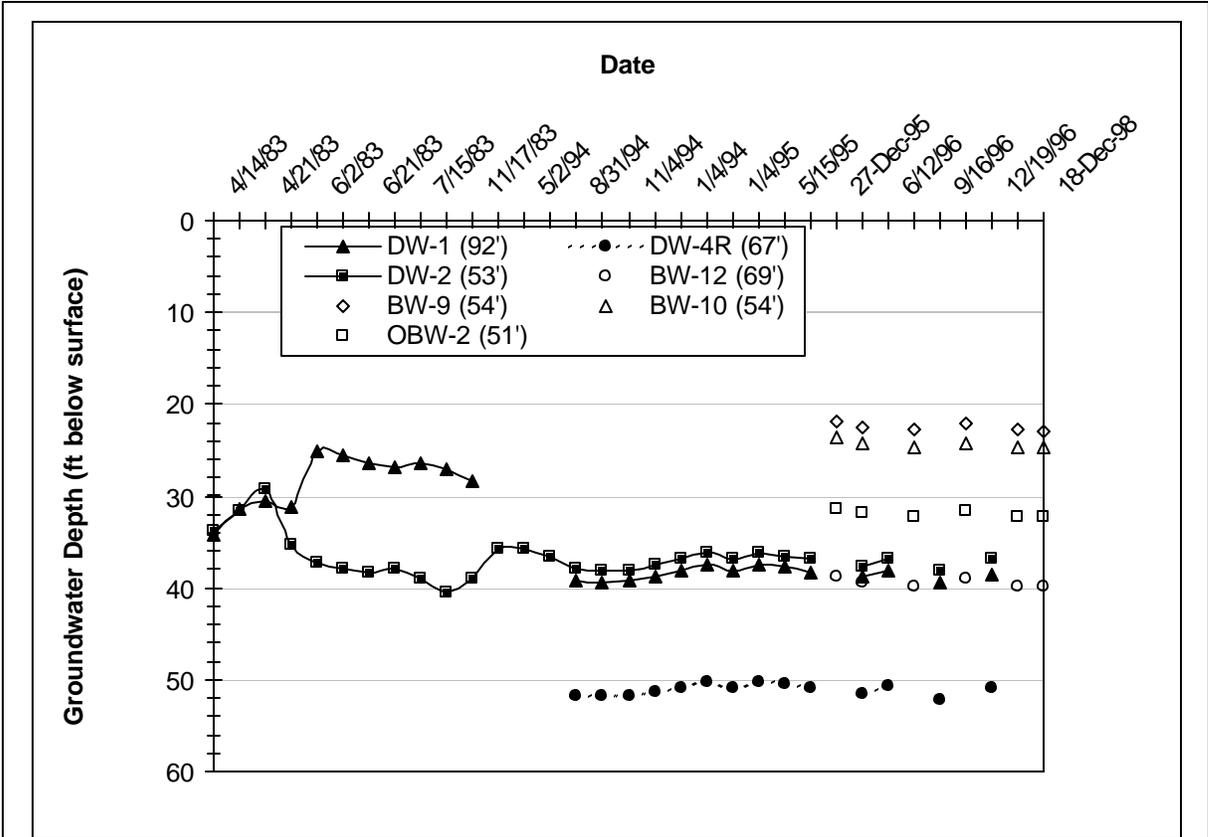
Figure 20. Hydrograph of till (open) and shale (solid) monitoring wells at the Tonawanda landfill. NY. Legend indicates midpoint depth of screened interval (see Appendix 6.4). Note hiatus in dates. (Data source: Glen May, NYSDEC, 2004)

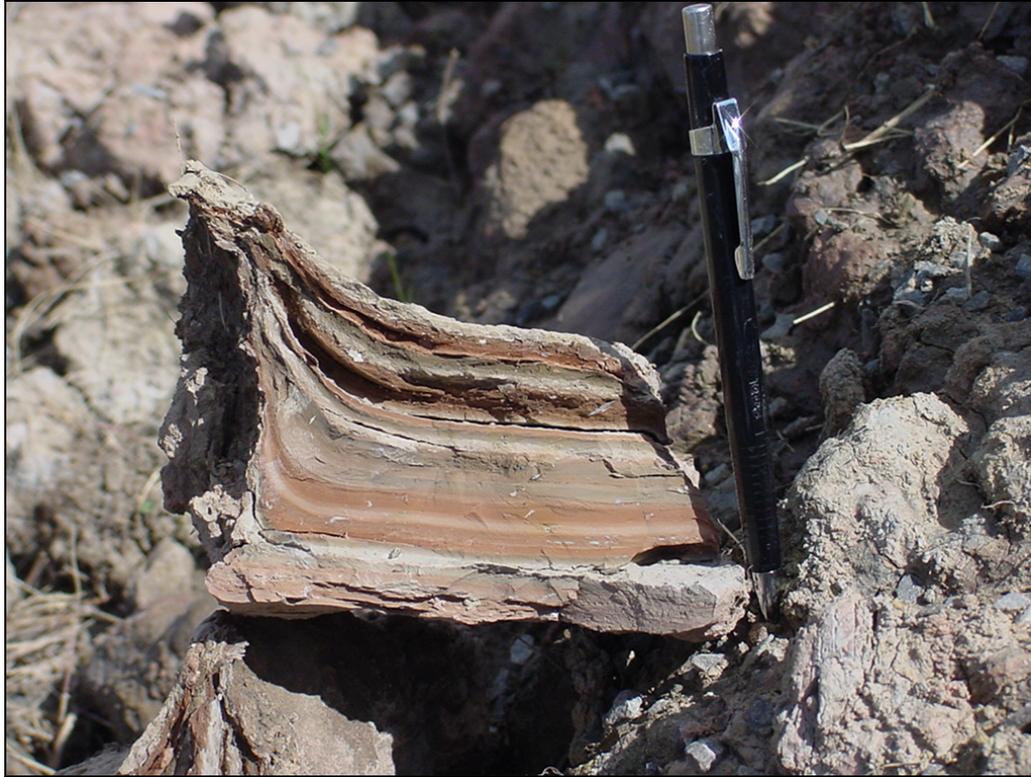
Photo 1. Varved clay from excavation near Millersport and Transit Roads. Sample characteristic of lacustrine material in Lake Dana-Lundy (D'Agostino, 1958). Laminated bands thought to indicate annual cycles of deposition from summer (pink) to winter (gray).

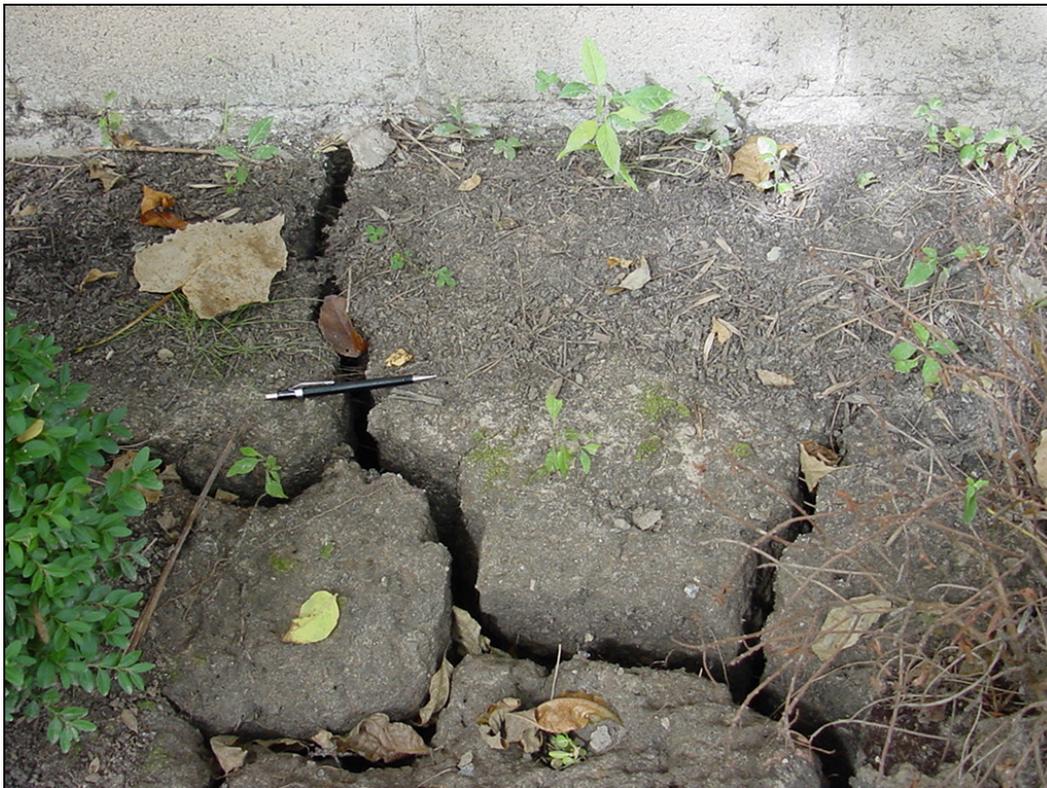
Photo 1. Desiccation cracks in backfill near basement wall in central Amherst, NY, in July 2004.

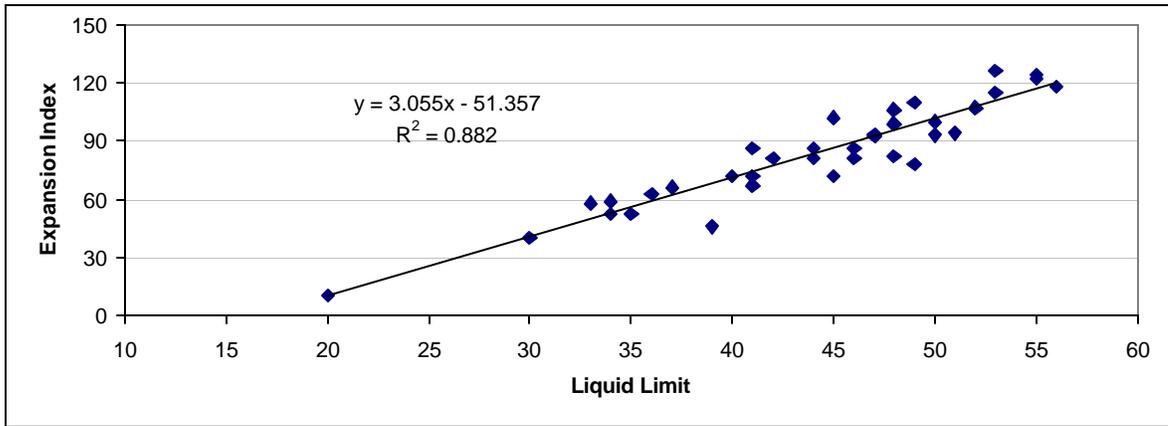
Figure 30. Regression analysis of expansion index (EI) and liquid limit (LL) for backfill and foundation soil samples in Amherst, NY.

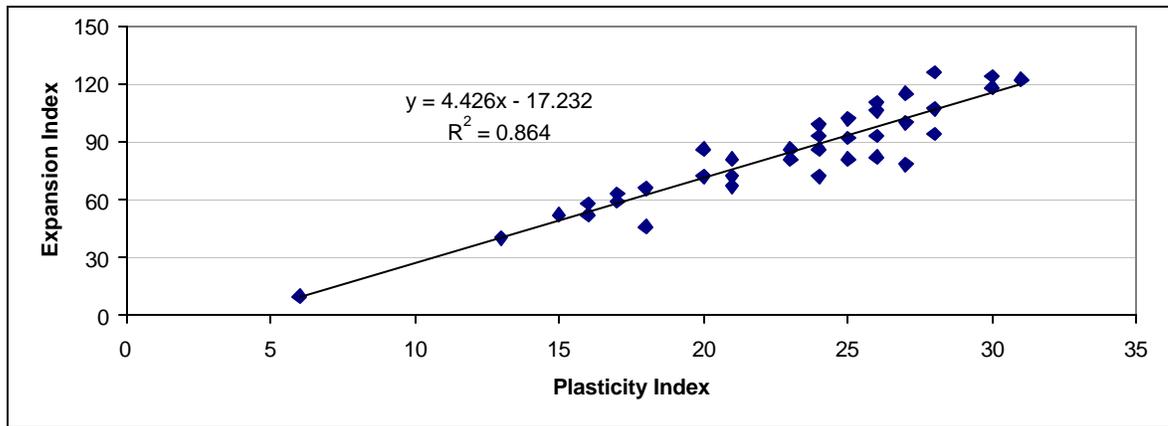
Figure 31. Regression analysis of expansion index (EI) and plasticity index (PI) for backfill and foundation soil samples in Amherst, NY.

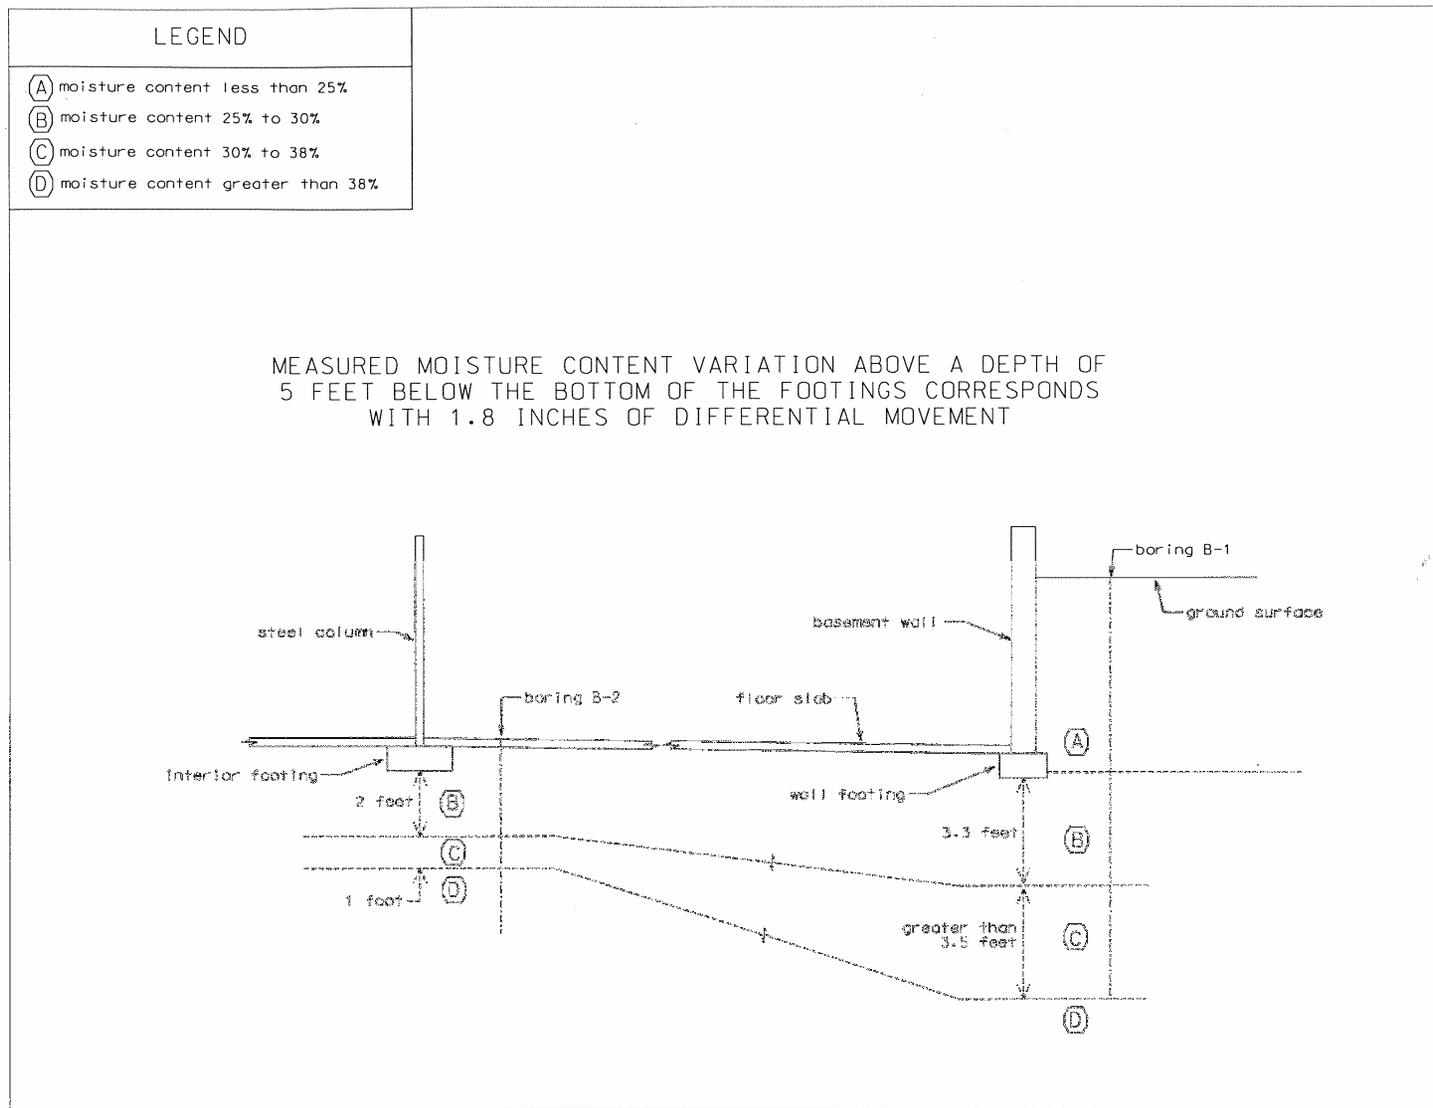
Figure 33. Foundation soil moisture content variation estimated from two borings at Site 4 in Amherst, NY (July, 2004).

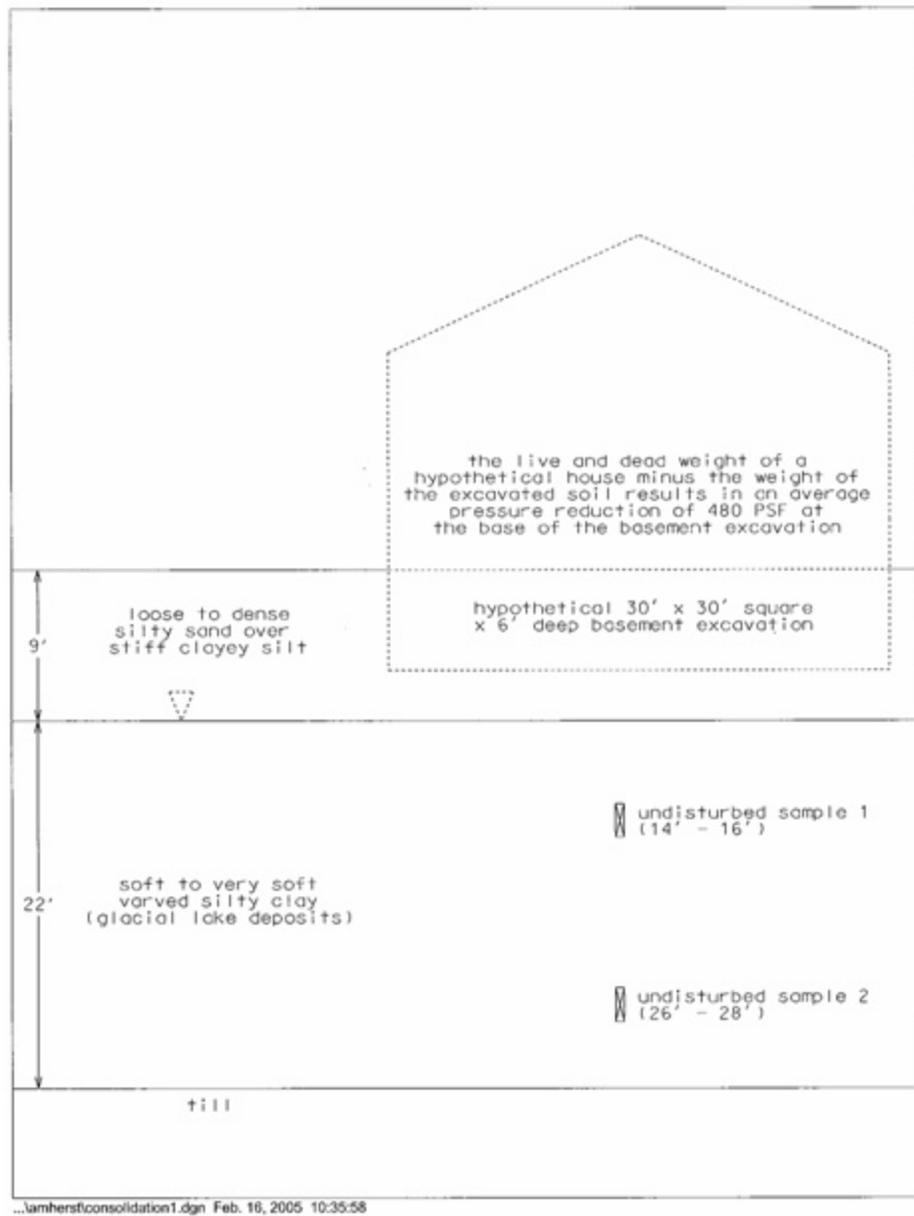
Figure 34. Schematic of hypothetical square house located within a 30' x 30' x 6' deep basement excavation (Section 3.4.3.2).

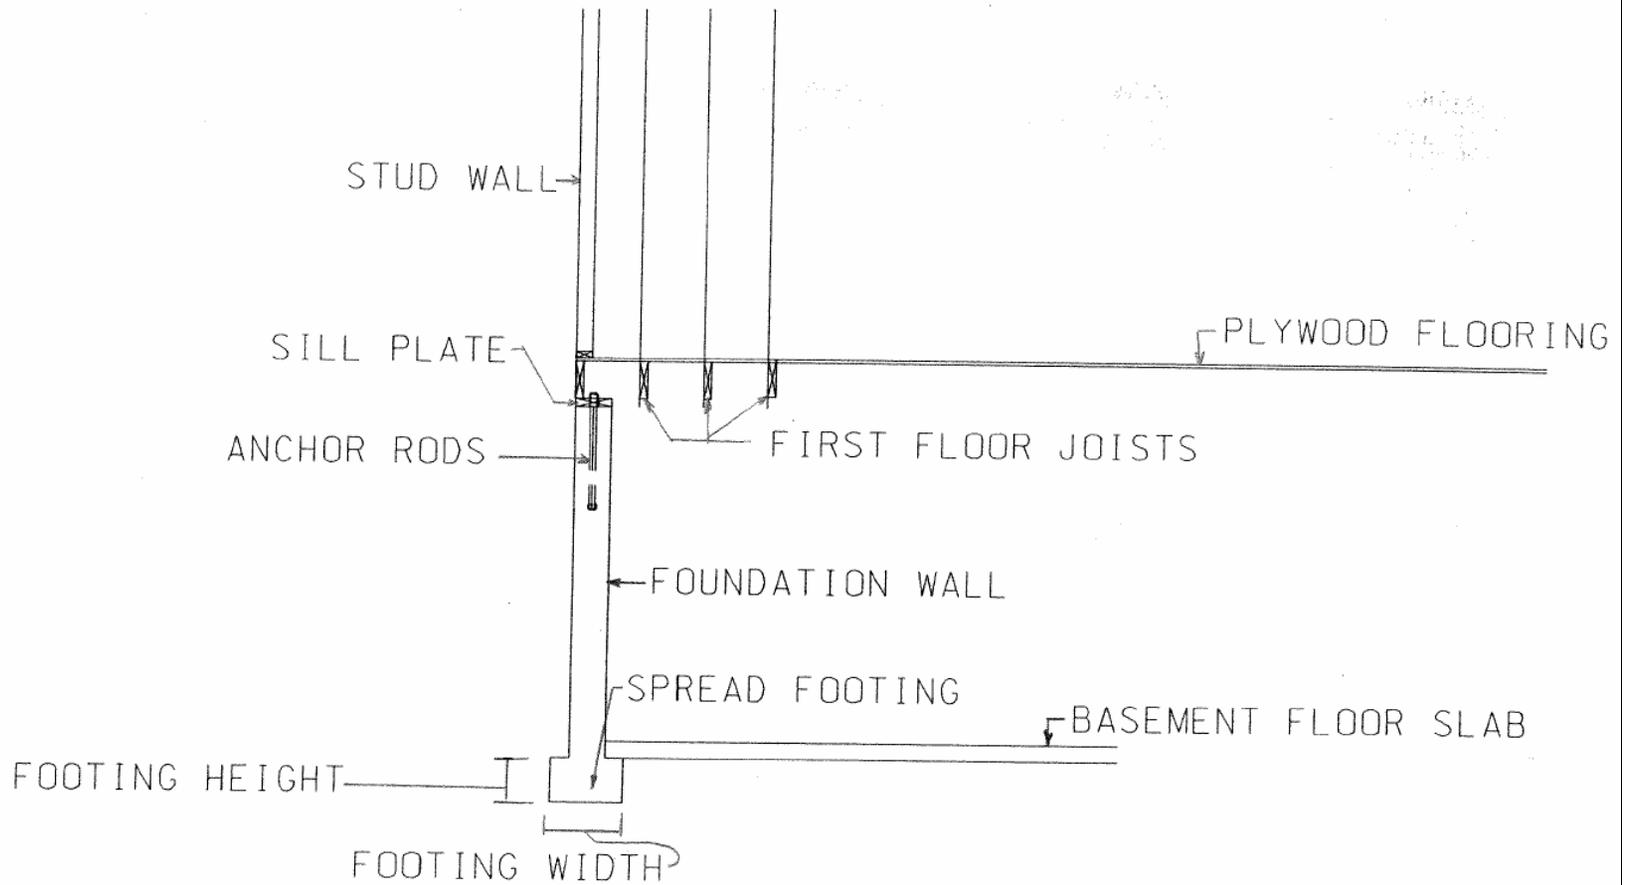
Figure 35. Typical structural components of foundation.
