TOWN OF AMHERST
SOILS AND RESIDENTIAL FOUNDATION STUDY

October 2005

U.S. Army Corps of Engineers

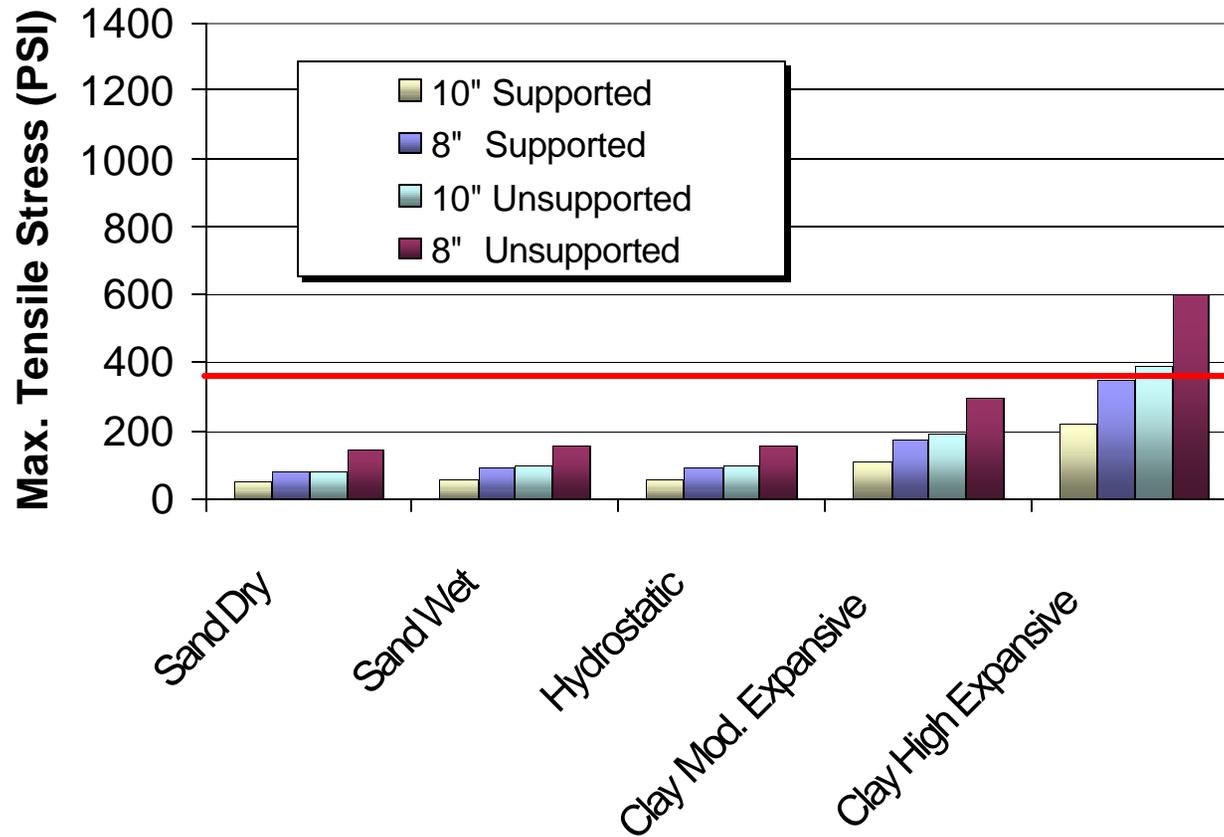
GTSTRUDL Model -- Lateral Load on 20 Ft Basement Wall

Figure 36. Modeling results of 20 ft basement wall with different backfill conditions, thickness, and support conditions. Red line indicates approximate maximum tensile strength of standard concrete (~389 psi). See Appendix 6.5 for model parameters.

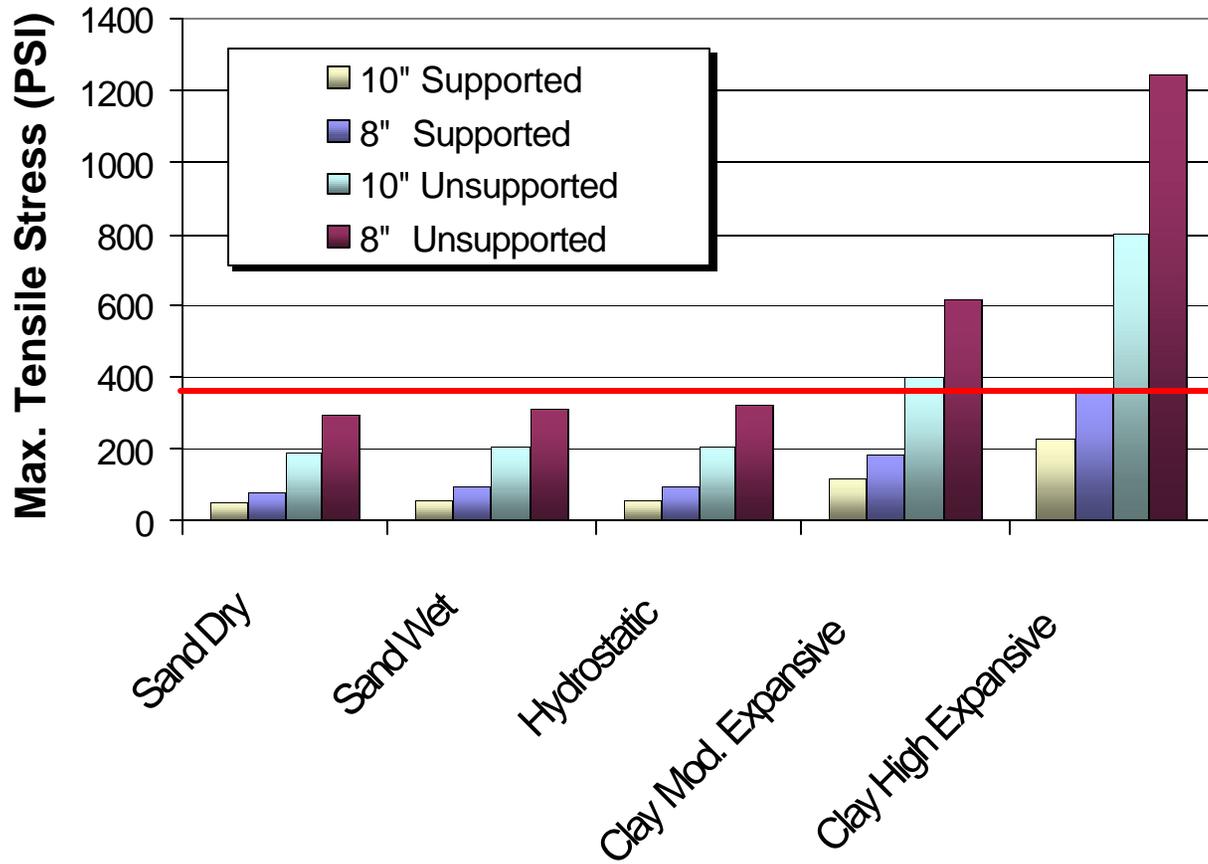
GTSTRUDL Model -- Lateral Load on 40 Ft Basement Wall

Figure 37. Modeling results of 40 ft basement wall with different backfill conditions, thickness, and support conditions. Red line indicates approximate maximum tensile strength of standard concrete (~389 psi). See Appendix 6.5 for model parameters. Results suggest unsupported walls may yield in the moderately expansive case similar to Amherst.

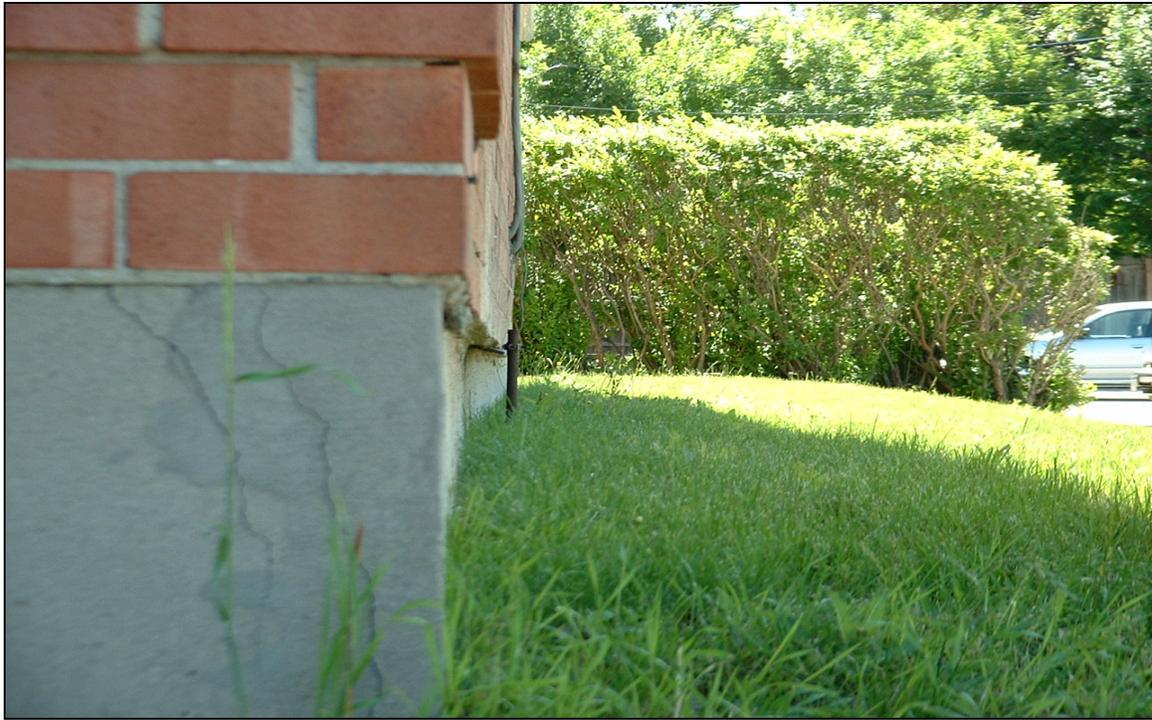
Photo 5. Lateral pressure affecting basement wall in central Amherst, NY. Wall has deflected inward nearly 3 inches from grounding rod.

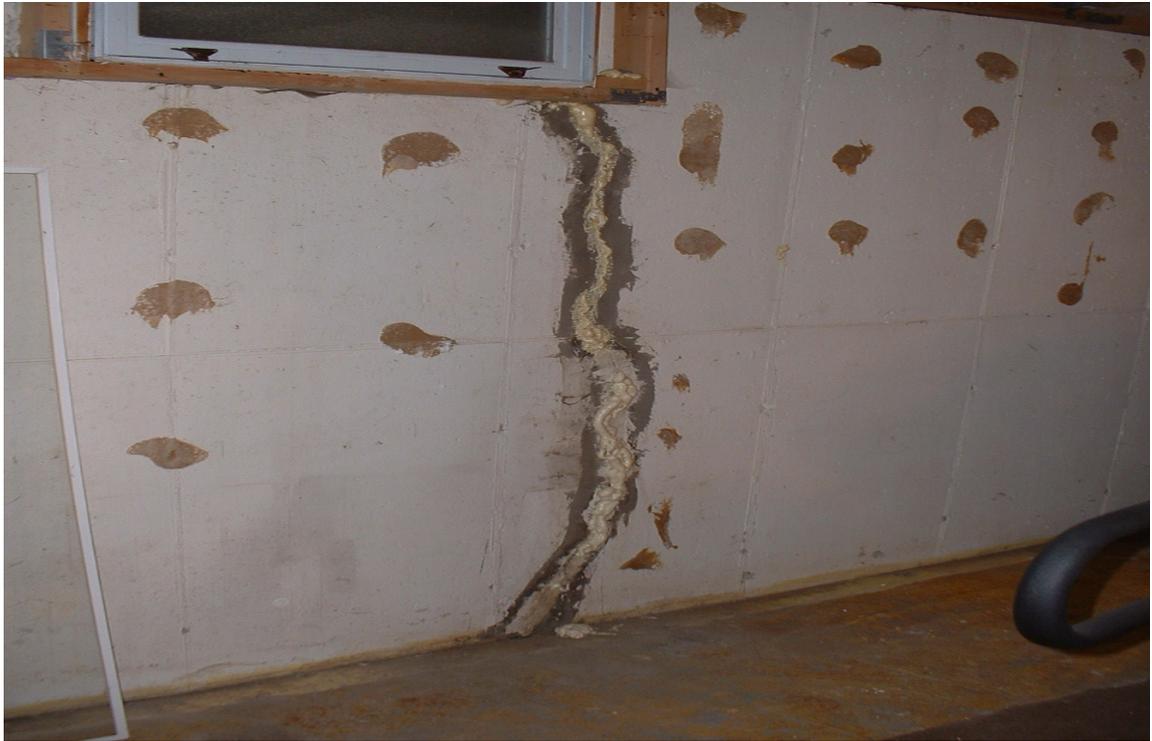
Photo 6. Lateral pressure causing vertical fracture in mid-span of basement wall in north-central Amherst, NY.

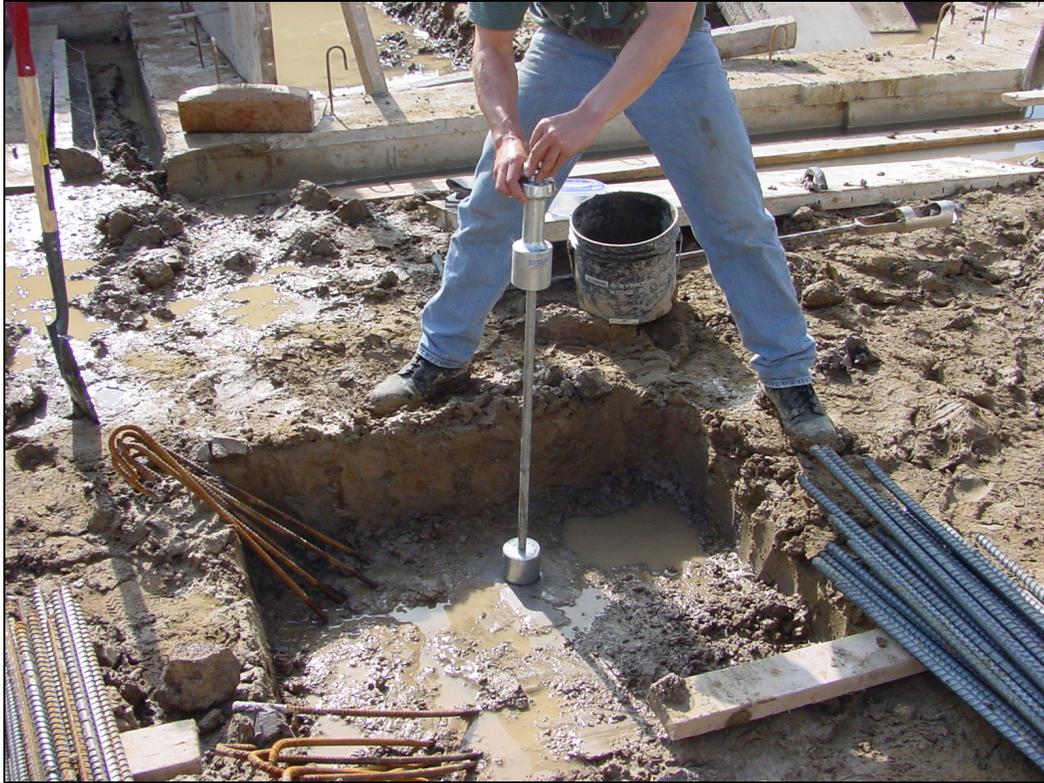
Photo 7. Undisturbed sampling of stiff stratum in north Amherst, NY.

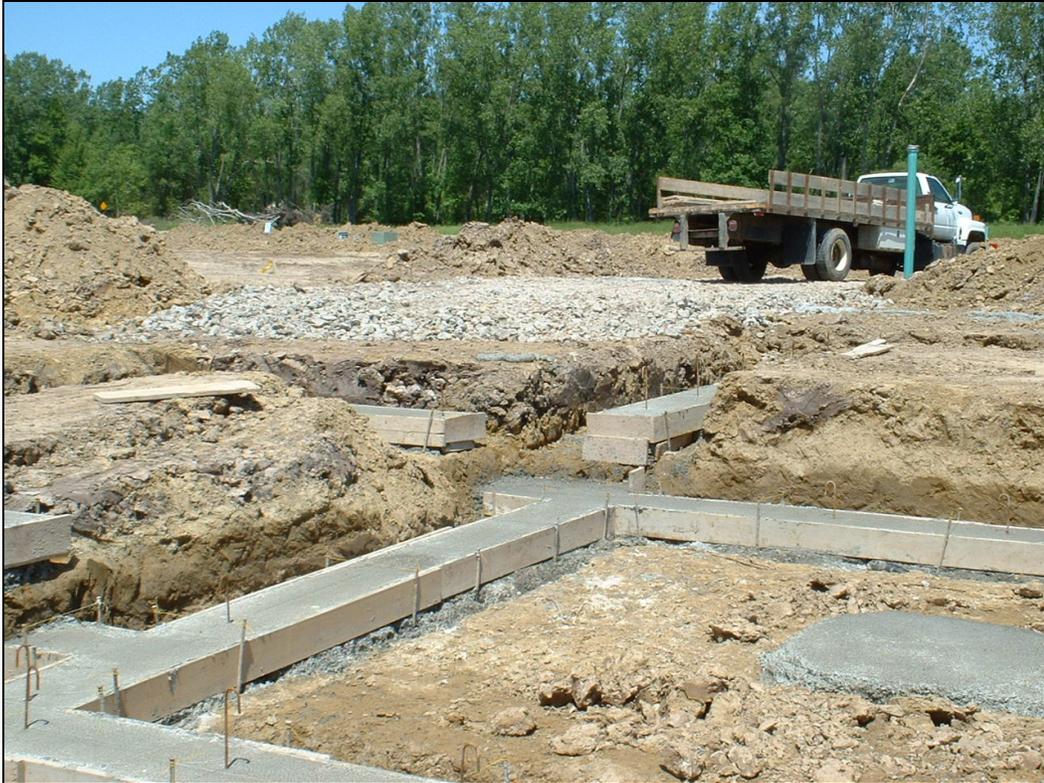
Photo 8. Heterogeneity in shallow soil conditions in north Amherst, NY. Darker soils are clay and lighter brown are fine sand. Note baking of footing soils (c.f., Photo 12).

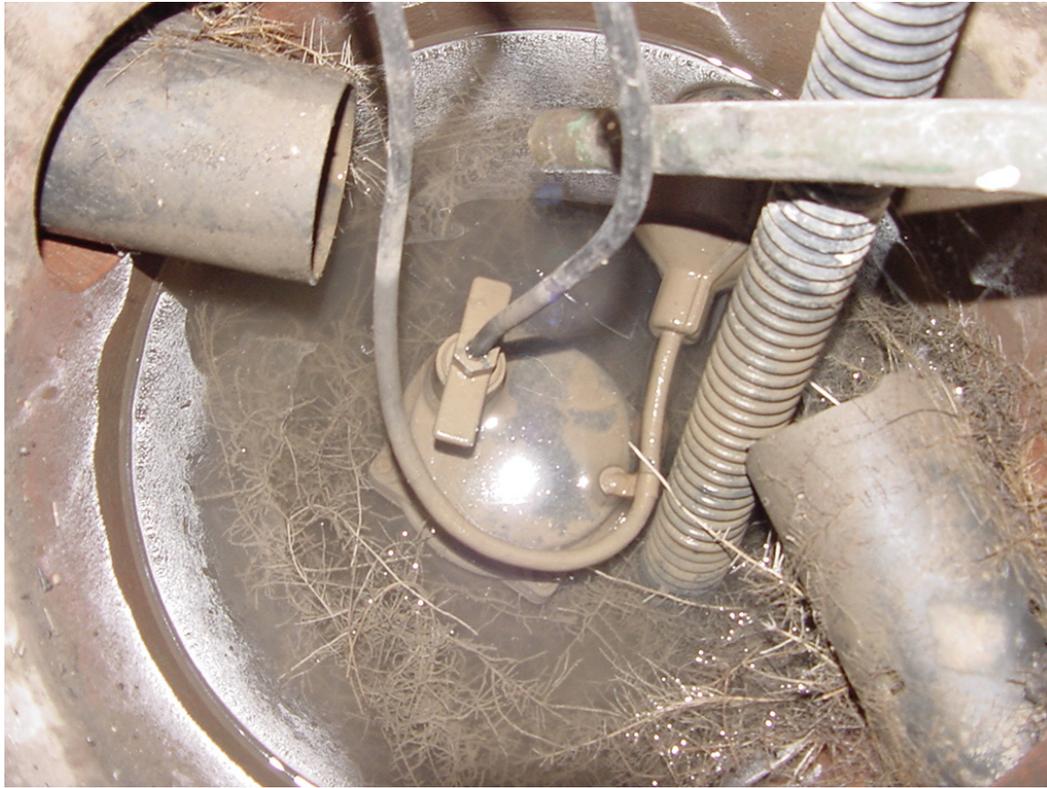
Photo 9. Root hairs penetrating into sump pit in central Amherst, NY.

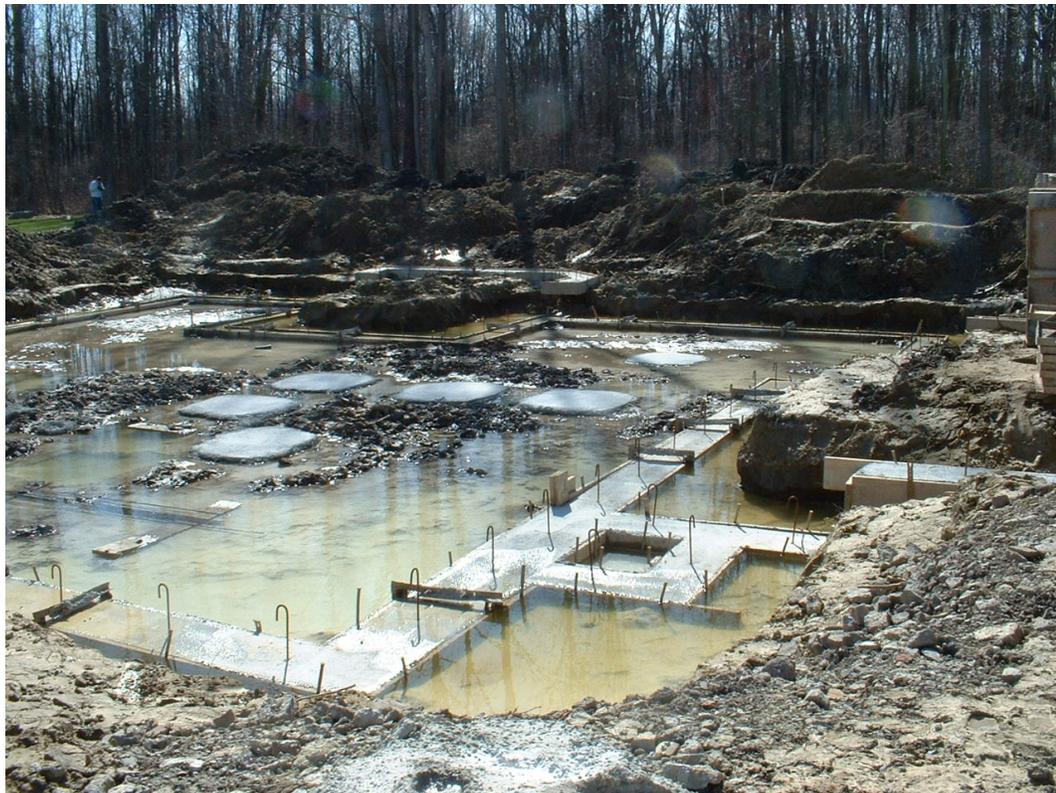
Photo 10. Construction of interior and perimeter footings on stiff stratum in north-central Amherst, NY.

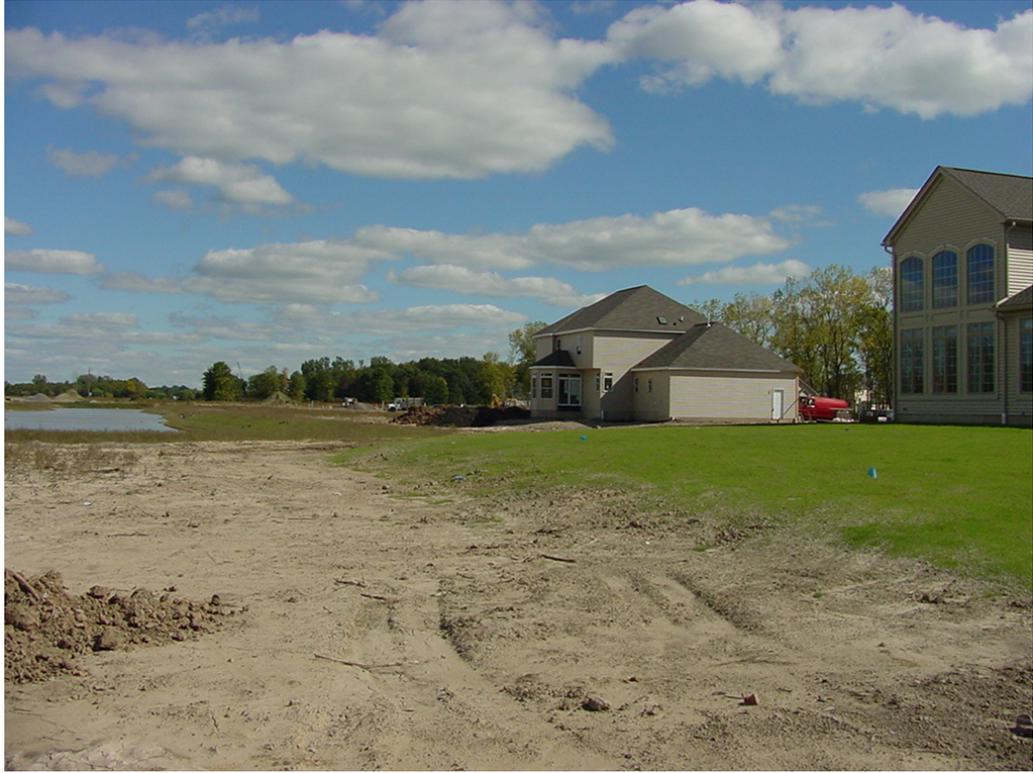
Photo 11. Perimeter loading of house with 3 to 4 feet of fill in northAmherst, NY.

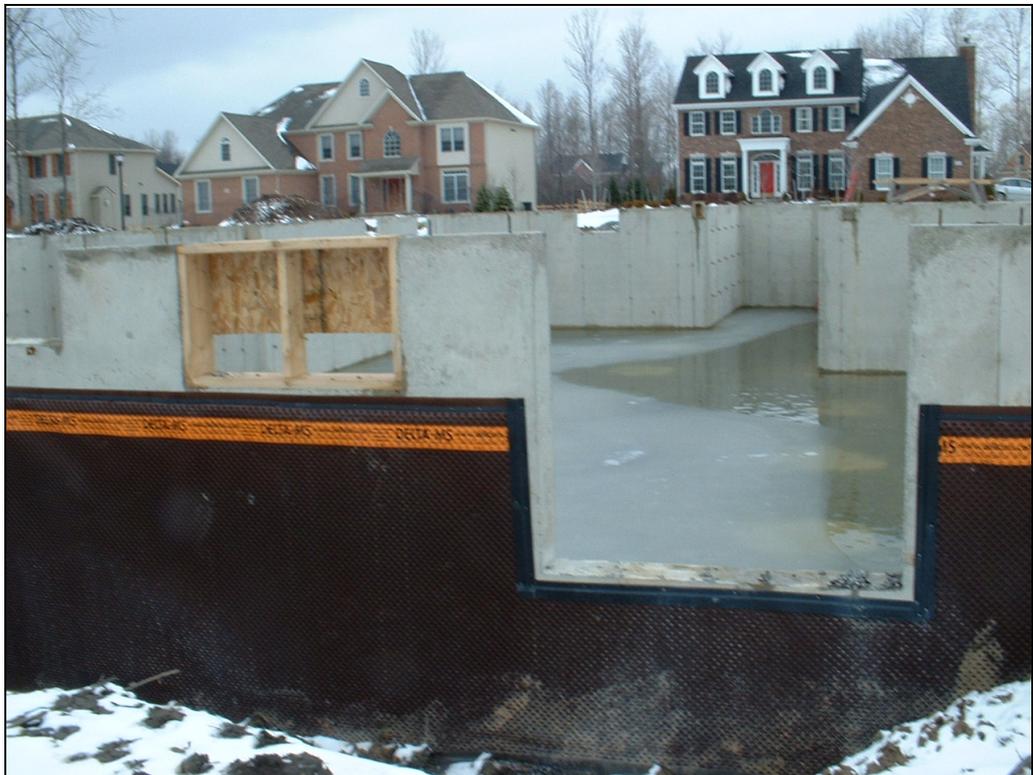
Photo 12. Winter foundation site in East Amherst showing potential for softening from frozen and saturated conditions (March, 2004).

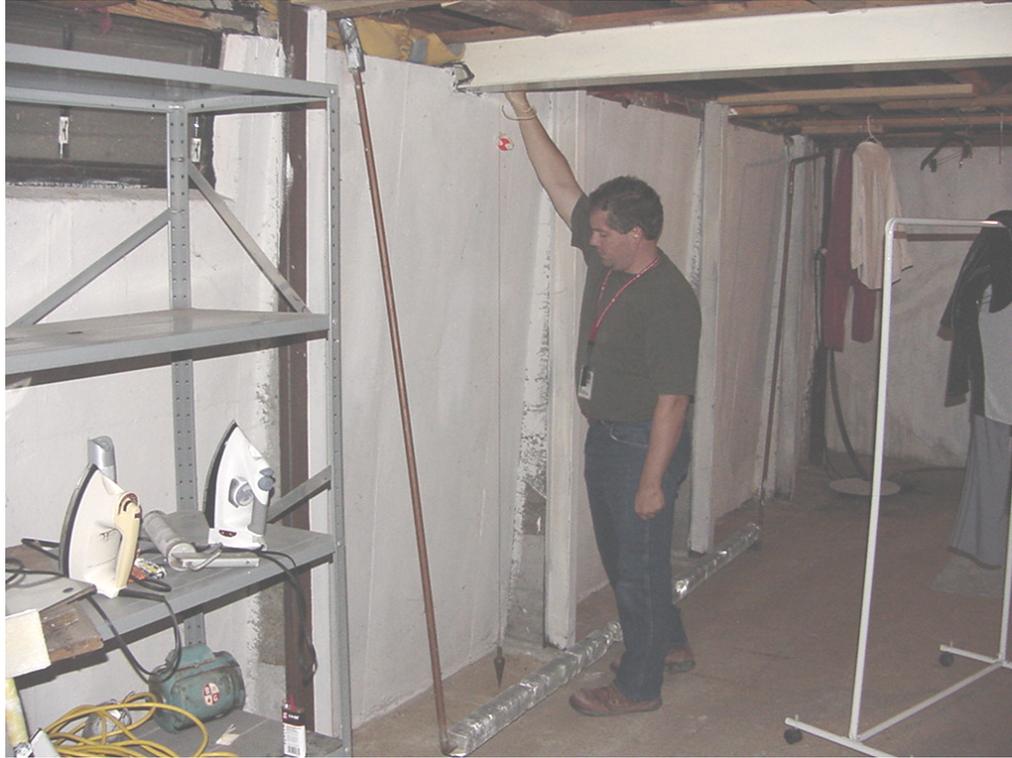
Photo 13. Inward deflection of basement wall (and pilasters) in central Amherst NY. Plum-bob indicates 9" of inward movement. Pipes are damaged and/or relocated.

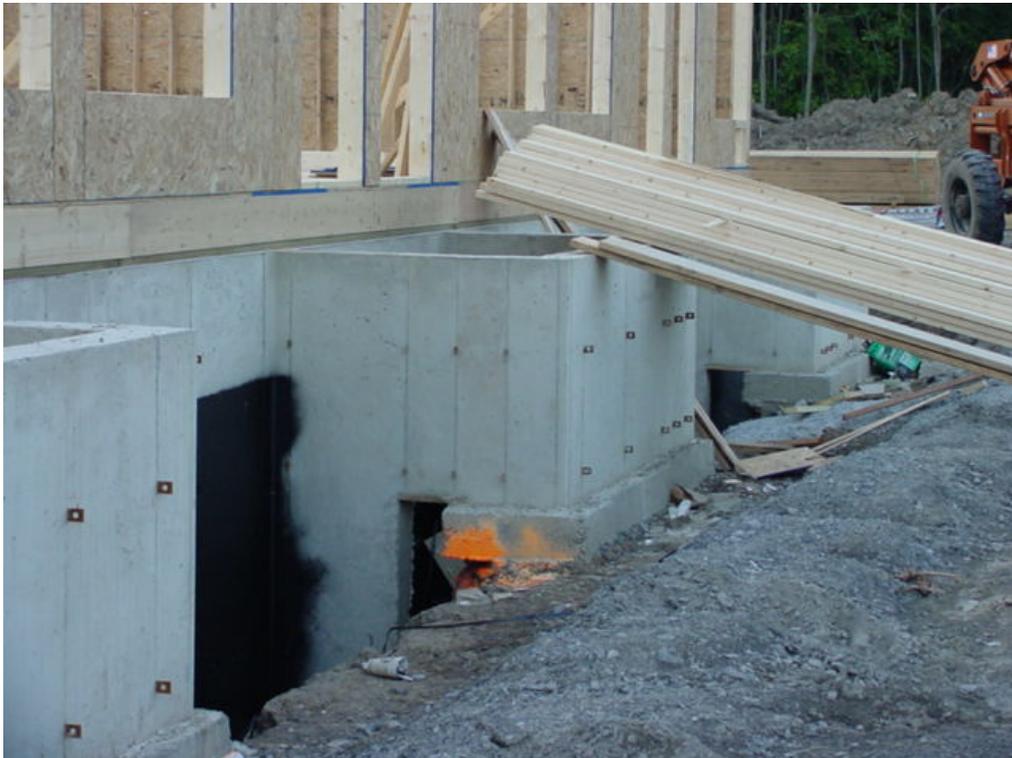
Photo 14. Erosion of strip footing during construction.

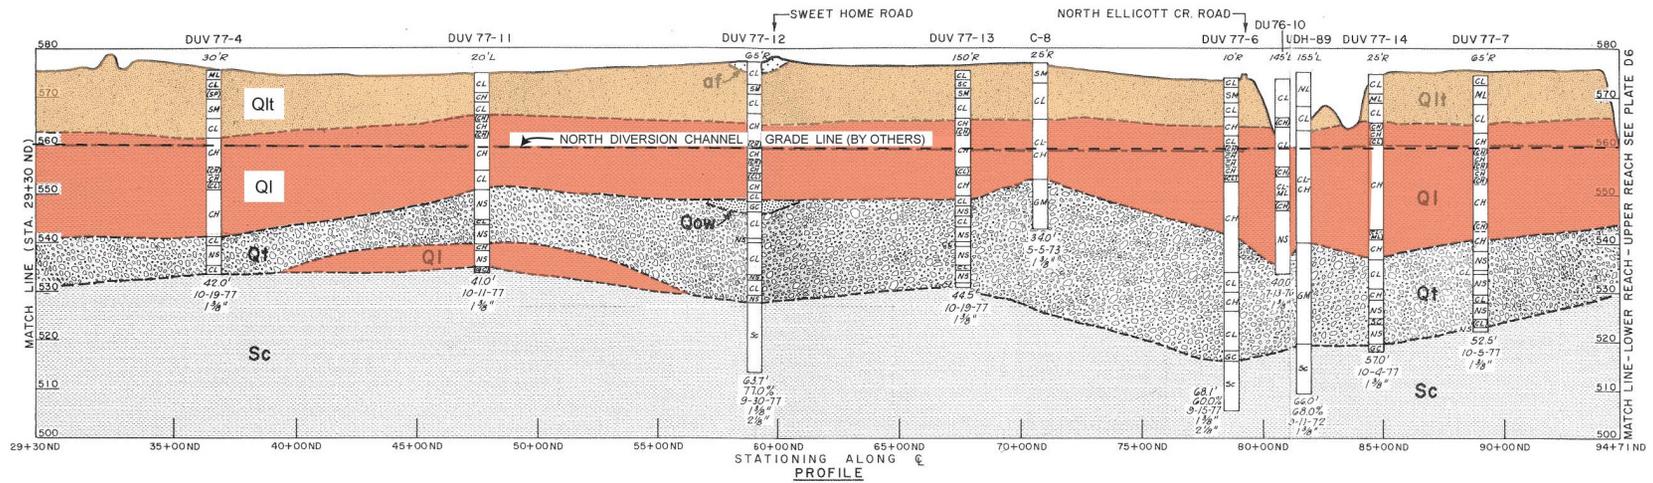
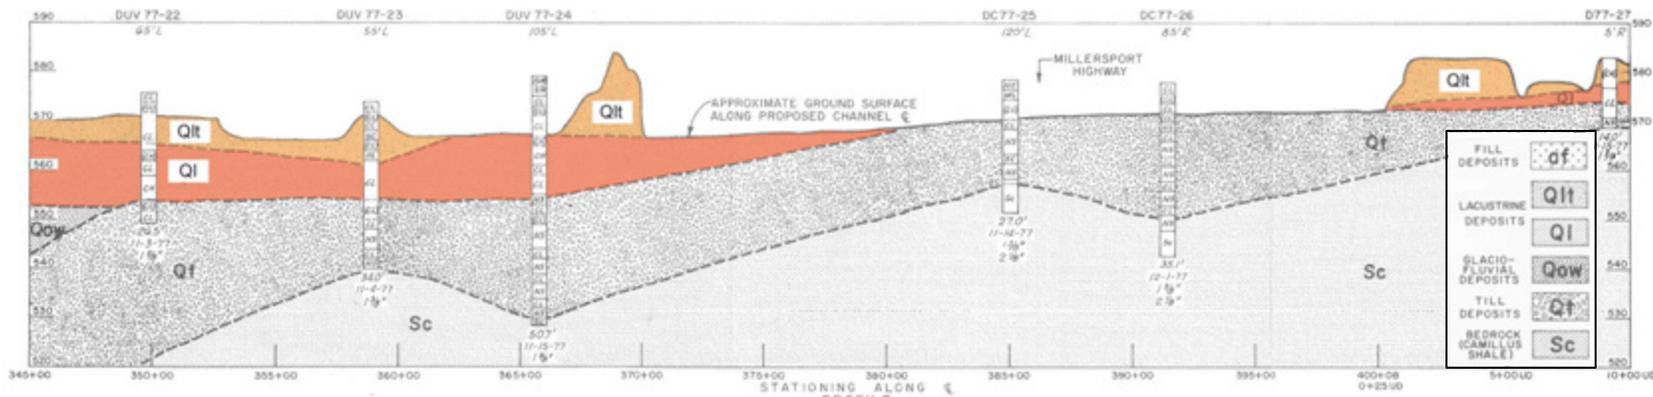
Appendix 6.1.2. Geologic cross sections along Ellicott Creek (after USACE, 1979)

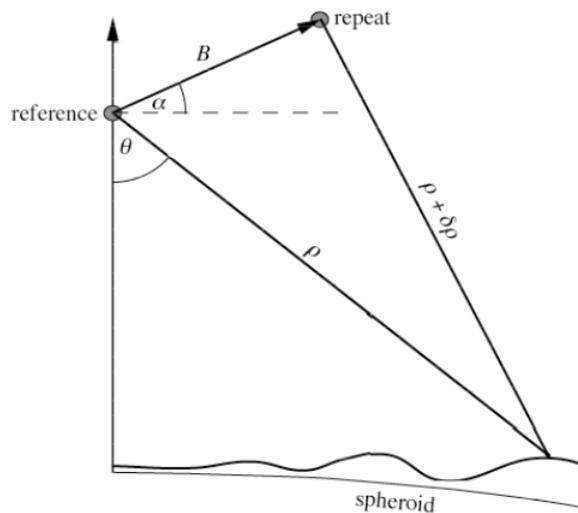
The following Fig. (Fig. 1) shows the basic configuration of a pair of images used in repeat pass interferometry. ρ is the range to a target from the satellite reference position, $\rho + \delta\rho$ is the range to that same target acquired in the second pass. B is the baseline, or physical distance between the location of the satellite in the first and second pass. θ is the look angle, and α is the angle between the baseline vector and the tangent plane. It is then possible to define $\delta\rho$ as a function of B, θ , α , ρ , and λ , the wavelength of the radar beam. $\delta\rho$ is proportional to the phase difference component of the radar return ϕ , measured at the two radar platforms: $\phi = (4\pi/\lambda)\delta\rho$. The common terminology for the reference scene is the master scene, and the repeat scene is the slave scene.

Figure 1: Geometry of Repeat Pass Interferometry [Sandwell and Price, 1998]

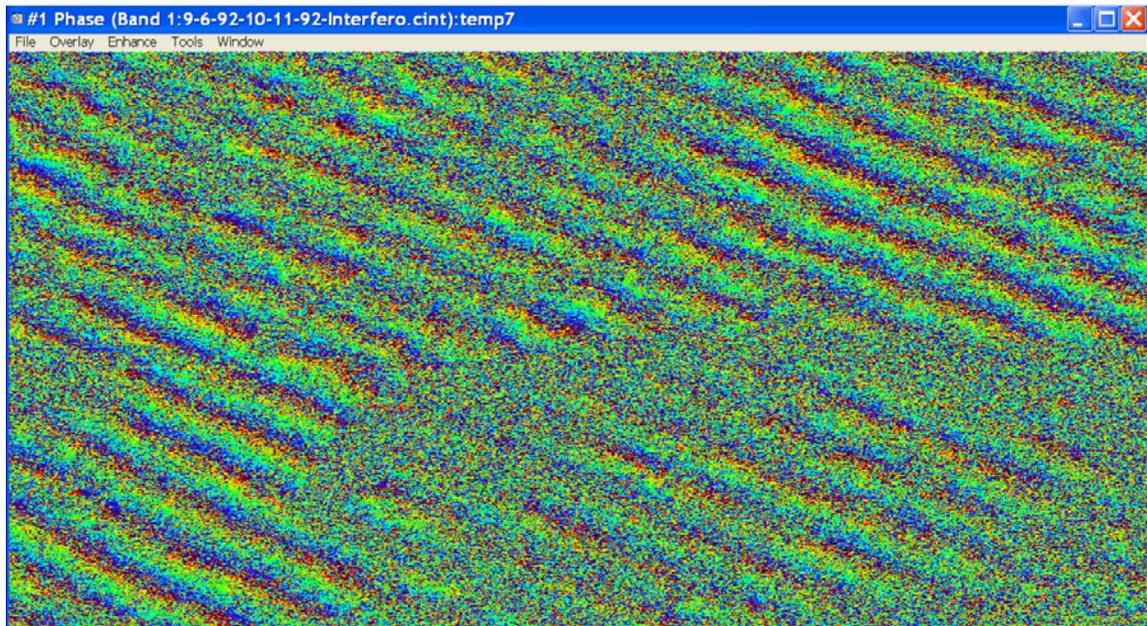
Figure 2: Sample interferogram generated from a pair of radr images acquired on 9-2-92 and 10-31-92.

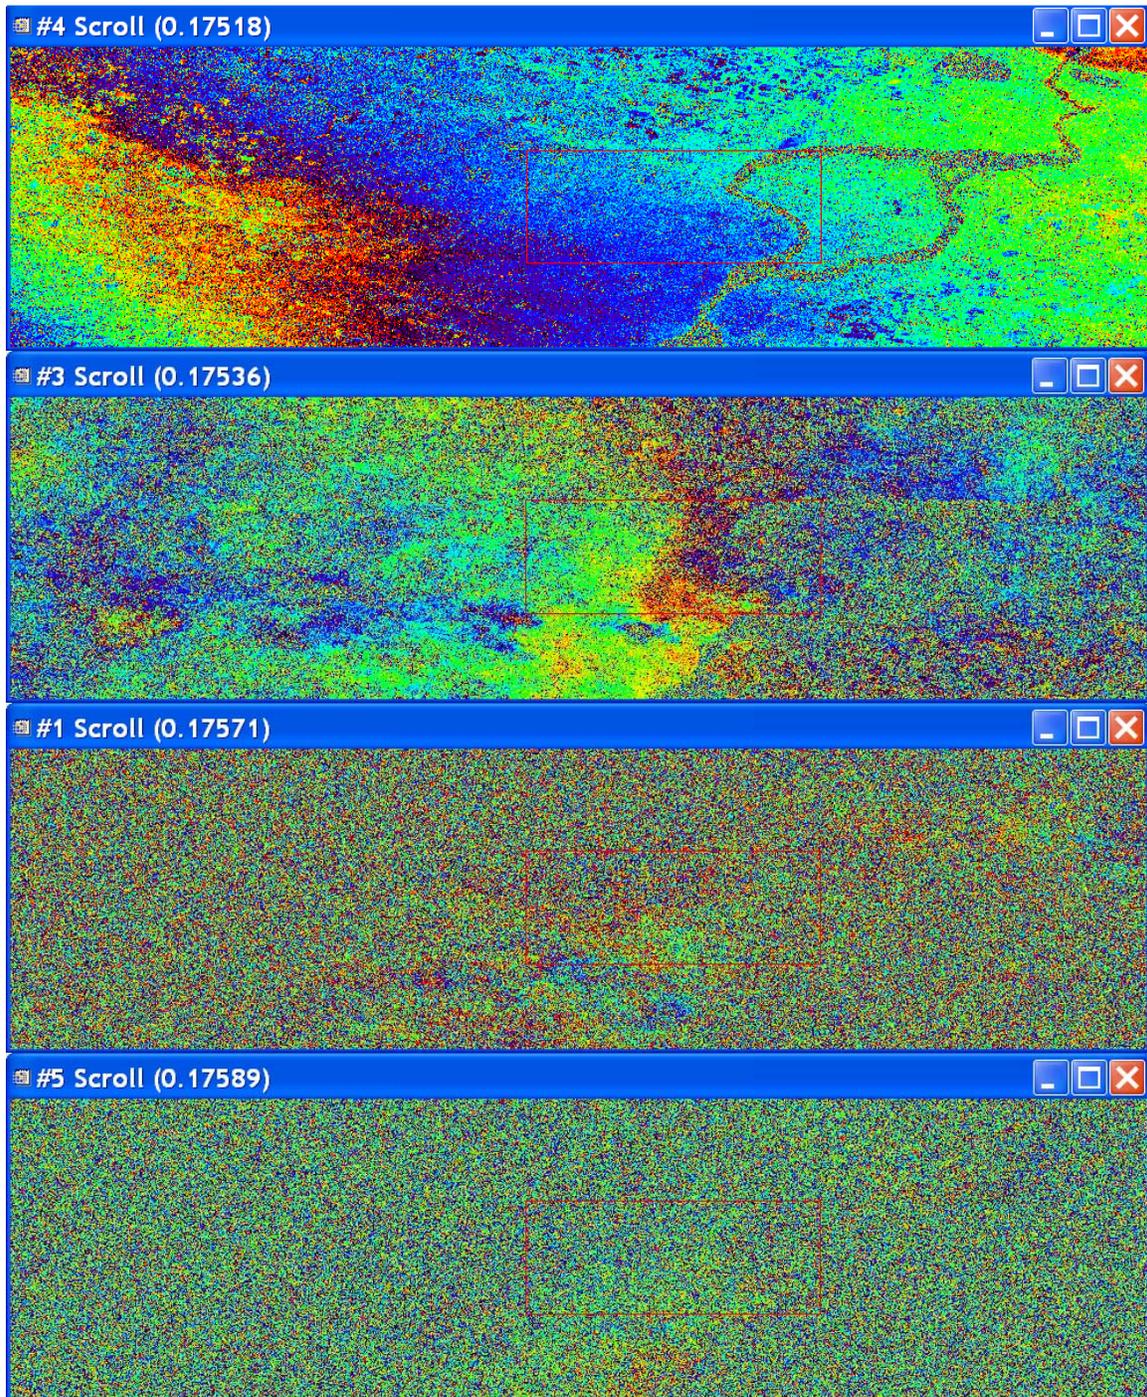
Figure: 3 Series of interferograms showing loss of coherence with increased temporal separation, even with good spatial baseline. (From Top, Master:11-28-95 Slave:11-29-95, $B_{\text{perp}}=43\text{m}$; M: 10-11-92, S:9-6-92, $B_{\text{perp}}=-17\text{m}$; M:10-11-92, S:10-24-95 $B_{\text{perp}}=273\text{m}$; M: 10-11-92, 3-12-03, $B_{\text{perp}}=54\text{m}$) . Images are in slant-range radar space, Grand Island is on the right, and Buffalo and Amherst are on the left. The Niagara river and the power reservoirs are visible on the right, as is the Niagara Escarpment, at the top right.

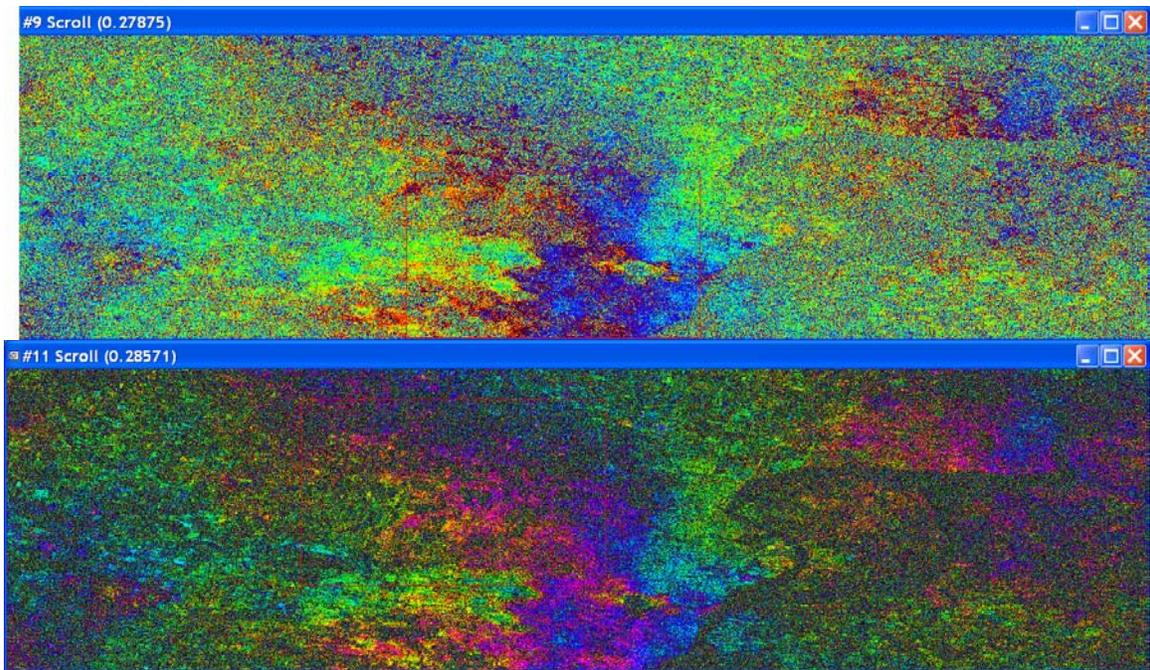
Figure 4: Results from the 4-Pass DINSAR, unfiltered (above), and filtered based on coherence (below)

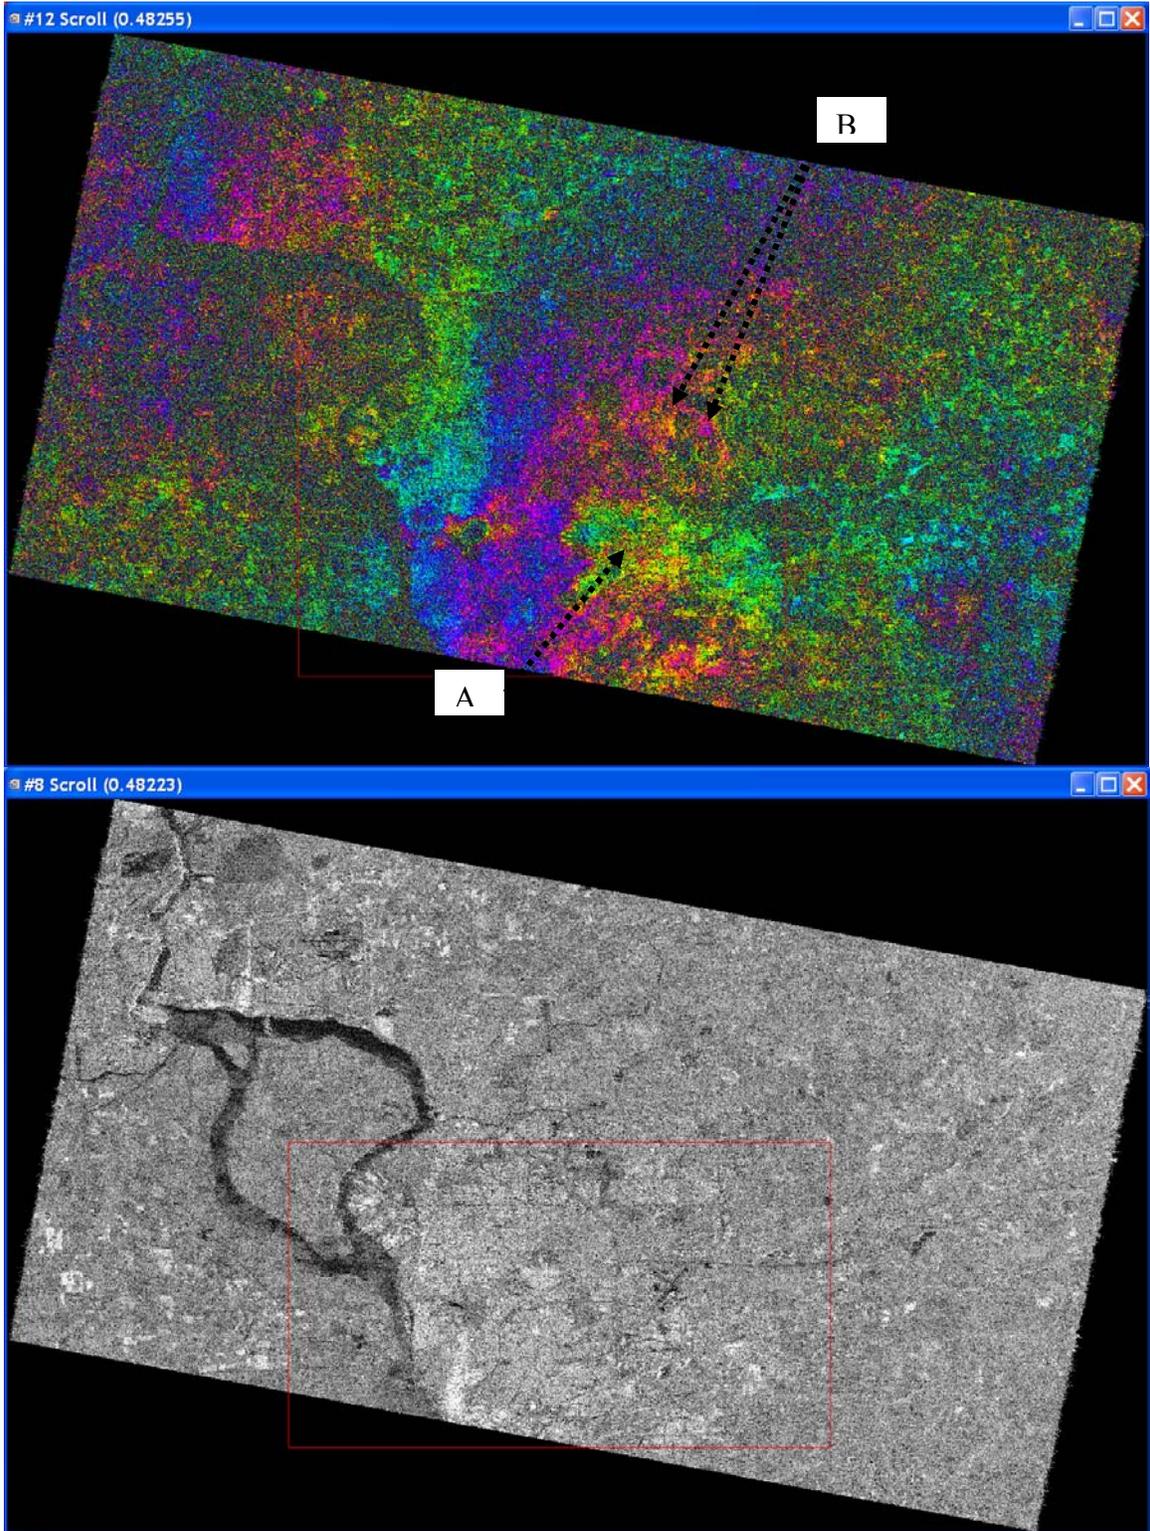
Figure 5: 4-Pass DINSAR result (phase), resampled to UTM (above) and reference image (below) showing areas of interest in DINSAR result.

This product was re-projected to UTM to allow better visualization of the areas of change. The re-projected product and is shown again in Fig. 5.

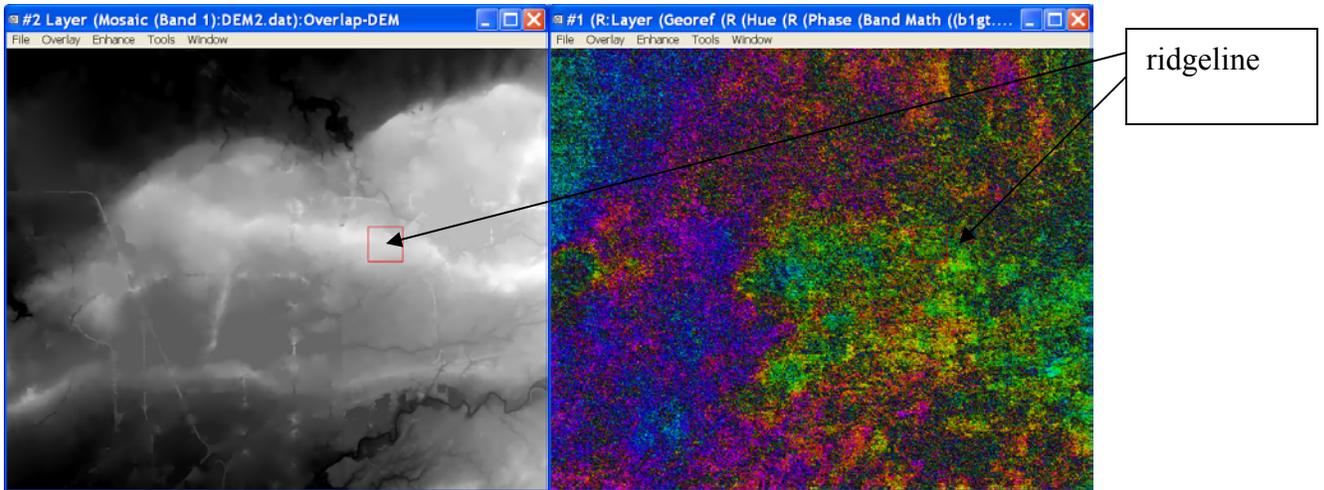
Figure 6: Comparison between DEM mode (left) and DINSAR (right) shows that ridgeline aligns in part with the interferometric feature.

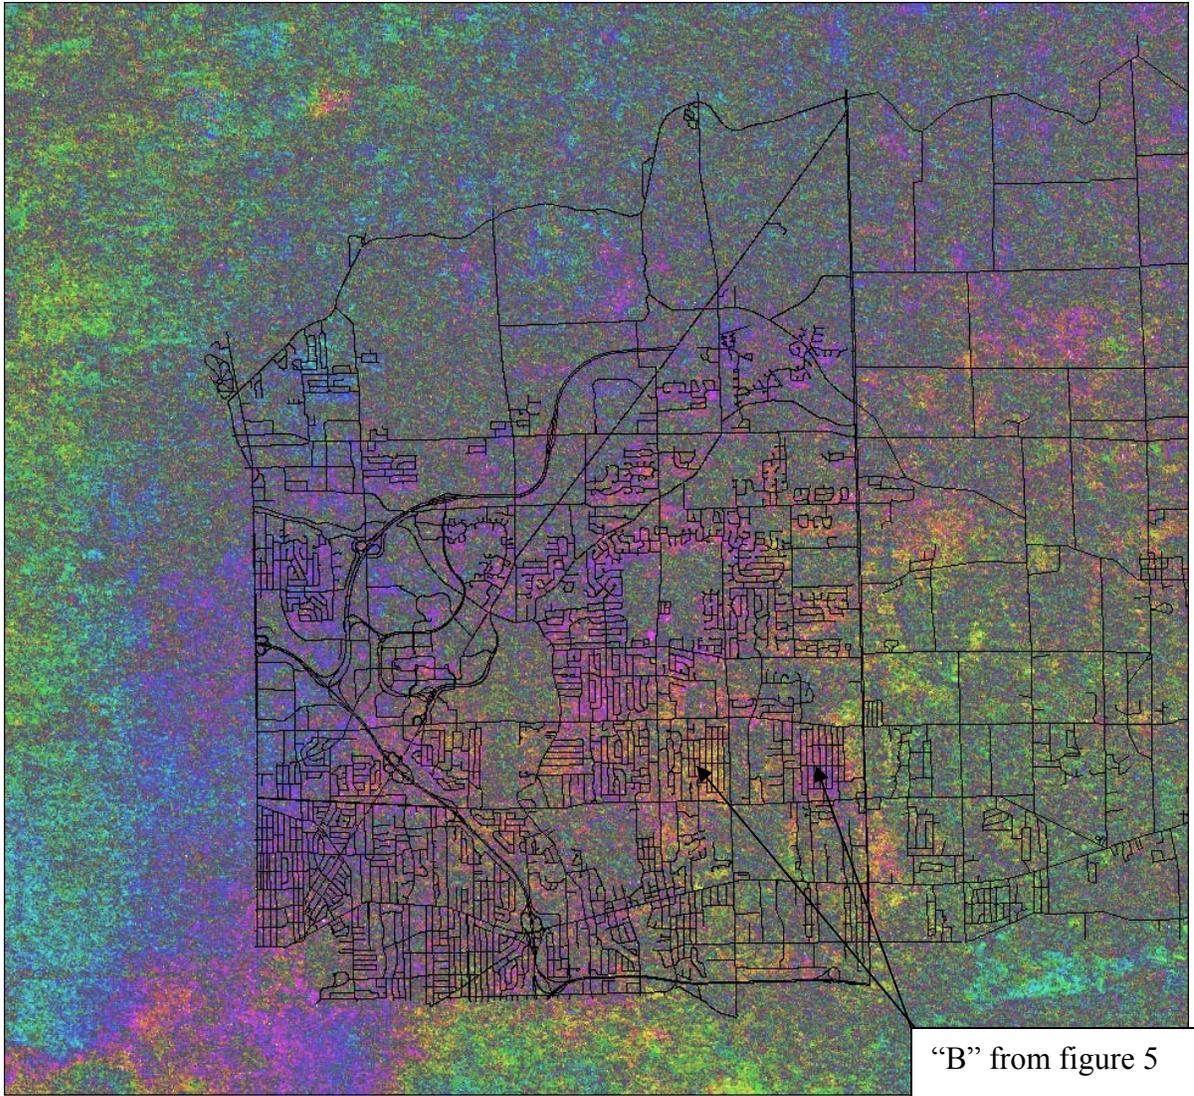
Fig. 7. Four-pass DINSAR deformation result over Amherst, NY, with street map overlain for reference

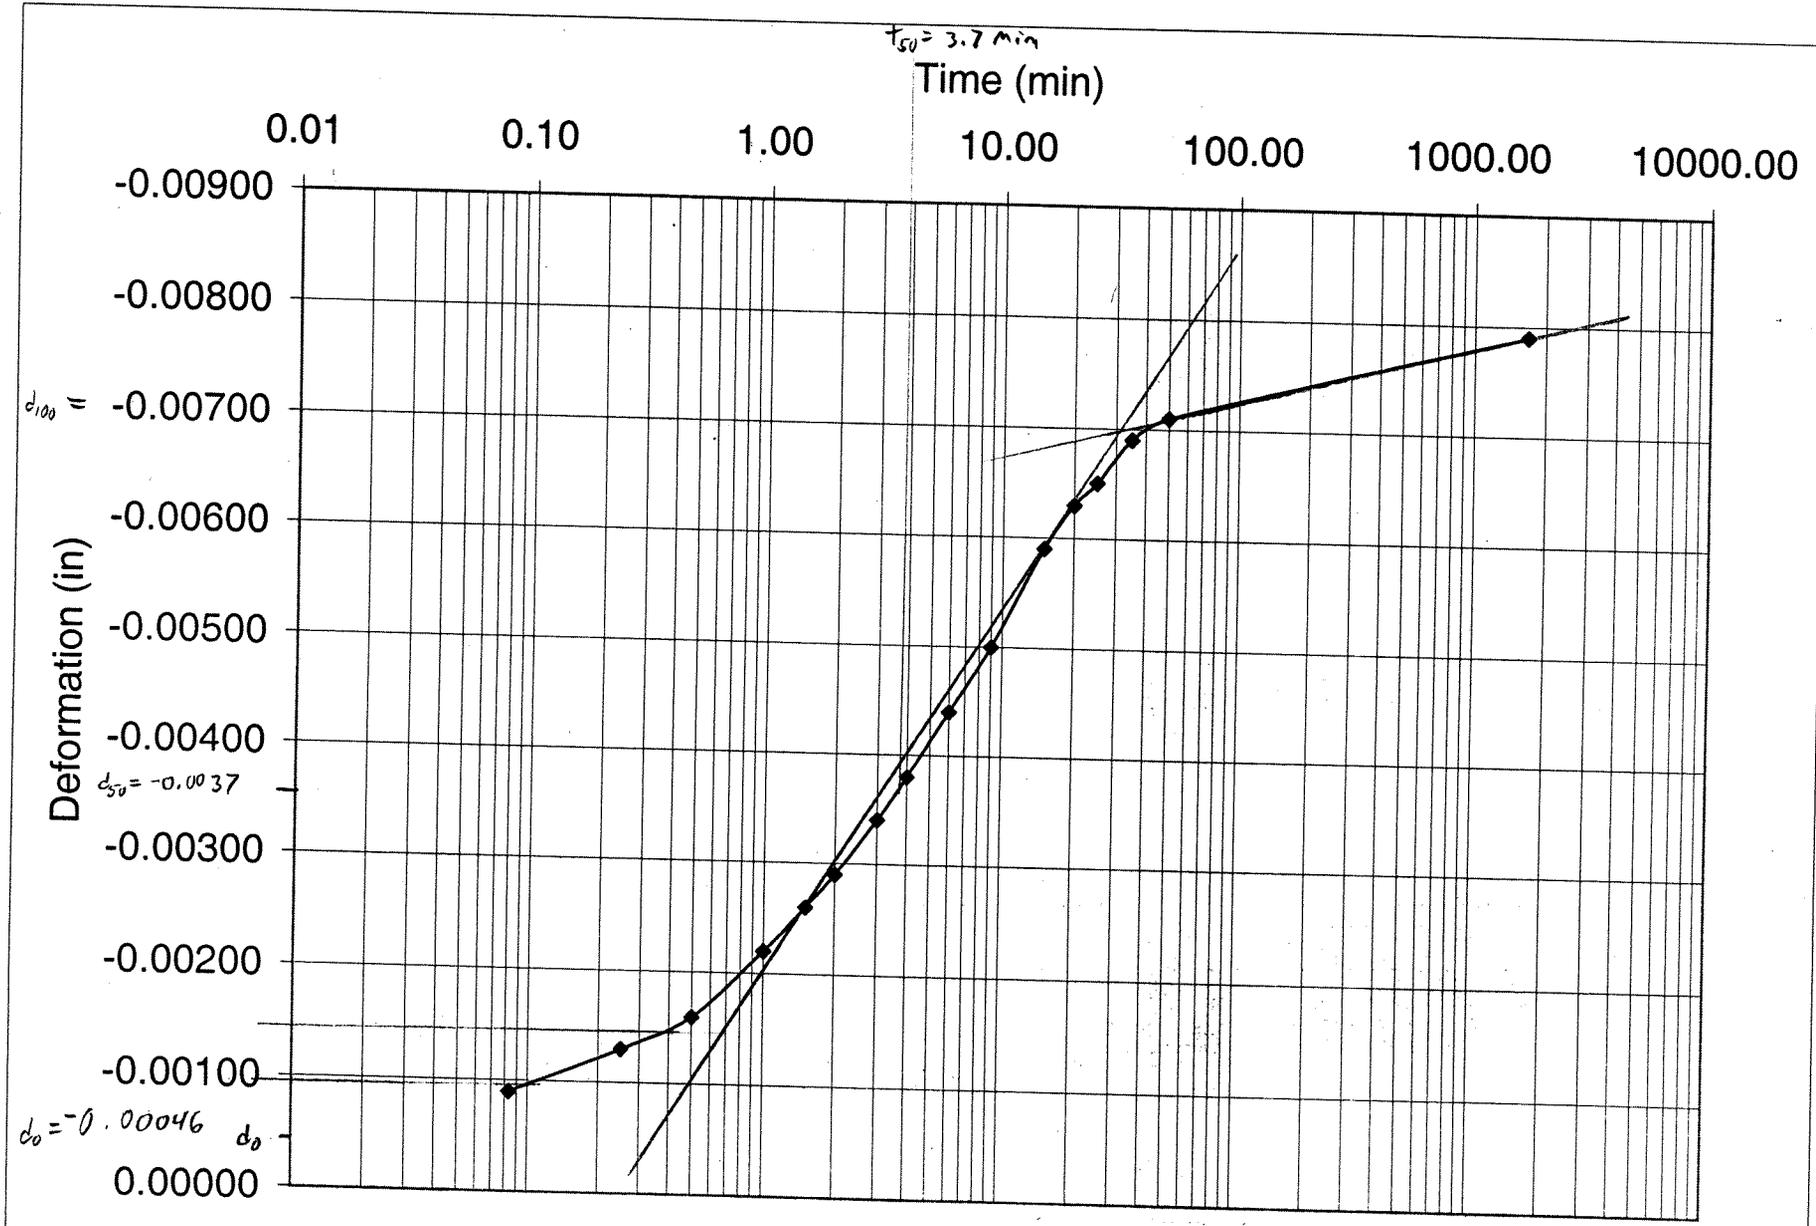
$$C_v = \frac{(0.197) (0.06559/2)^2 (60 \times 24) \frac{\text{min}}{\text{day}}}{3.7 \text{ min}} = 0.082 \frac{\text{ft}^2}{\text{day}}$$
