TOWN OF AMHERST
SOILS AND RESIDENTIAL FOUNDATION STUDY

October 2005

U.S. Army Corps of Engineers

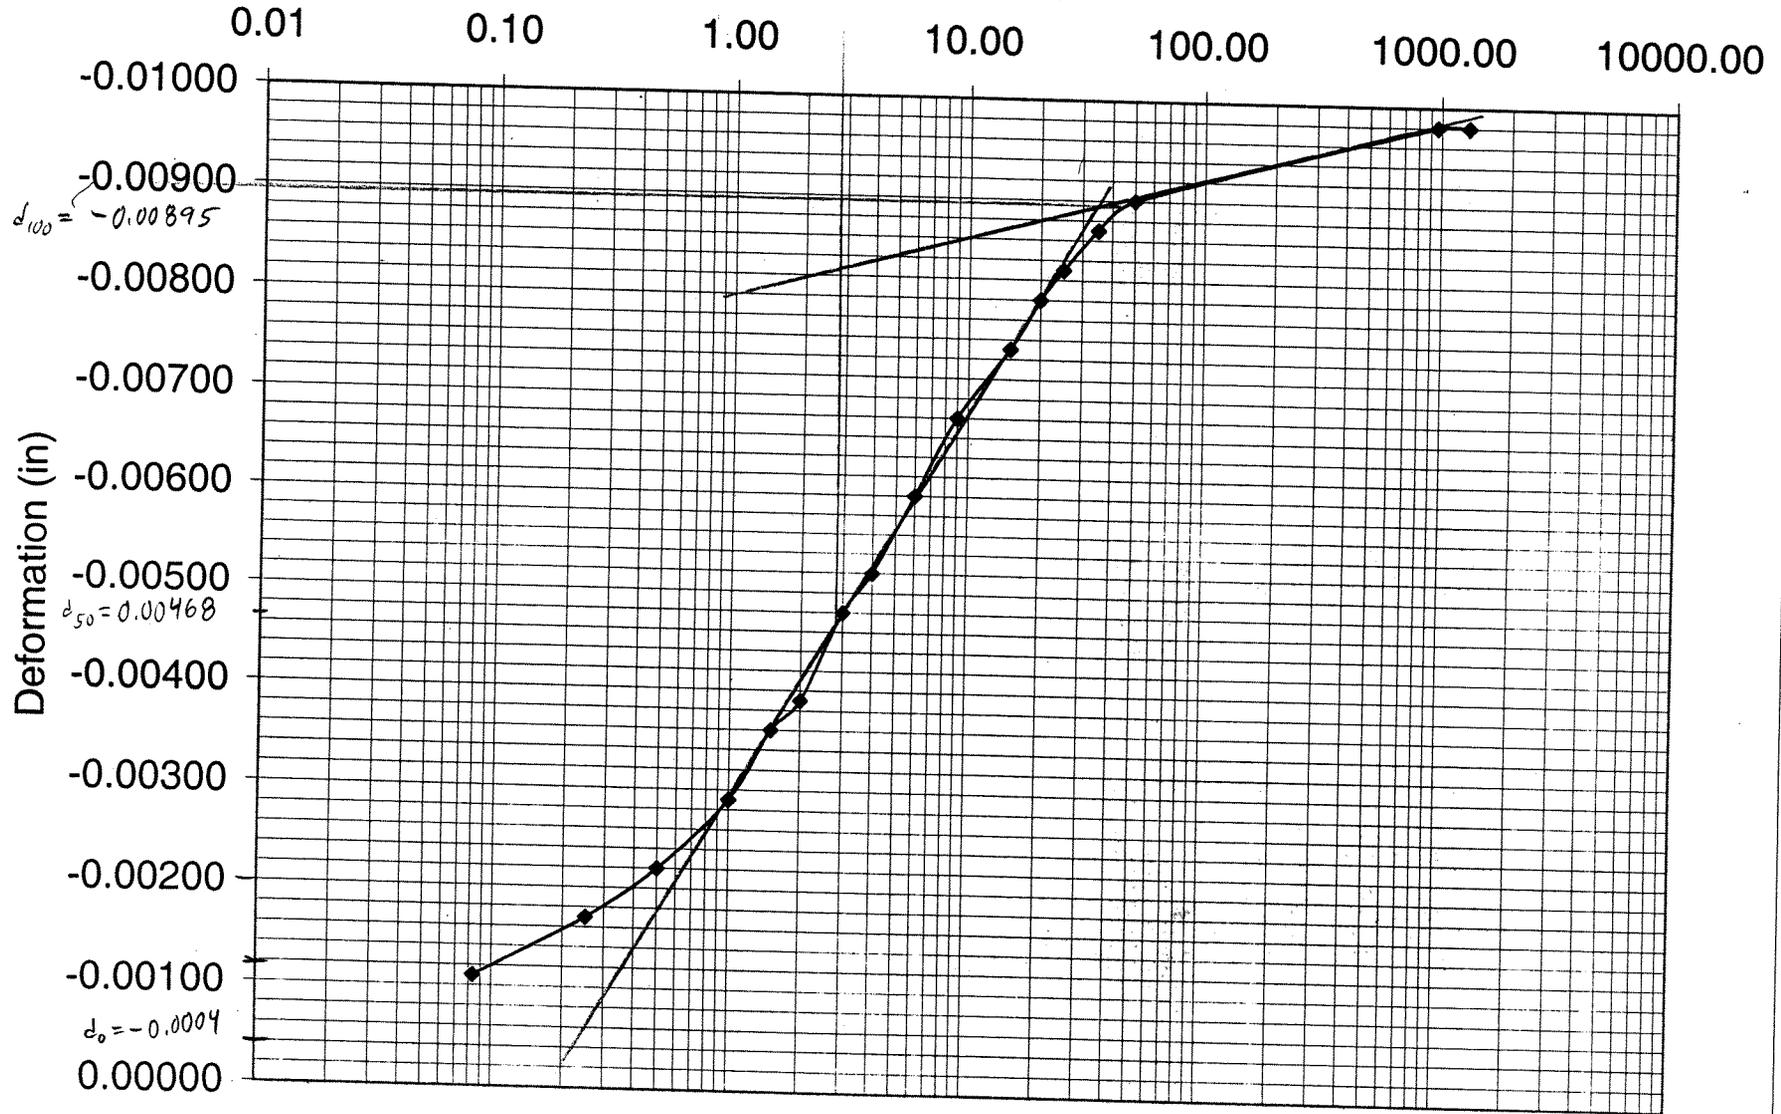
$$C_v = \frac{0.197 (0.06268/2)^2}{2.7 \text{ min}} \times (60 \times 24) \frac{\text{min}}{\text{day}} = 0.103 \frac{\text{ft}^2}{\text{day}}$$
