The New Home of Earth Dimensions, Inc.

> Jurisdictional Determination Request LaBella No. 2254561; SBL 55.03-1-10 330 Maple Road, Town of Amherst, Erie County, New York

WETLAND AND STREAM DELINEATION REPORT

716 Sports Fieldhouse Complex 330 Maple Road, Amherst, NY 14221 LaBella Project No. 2254561

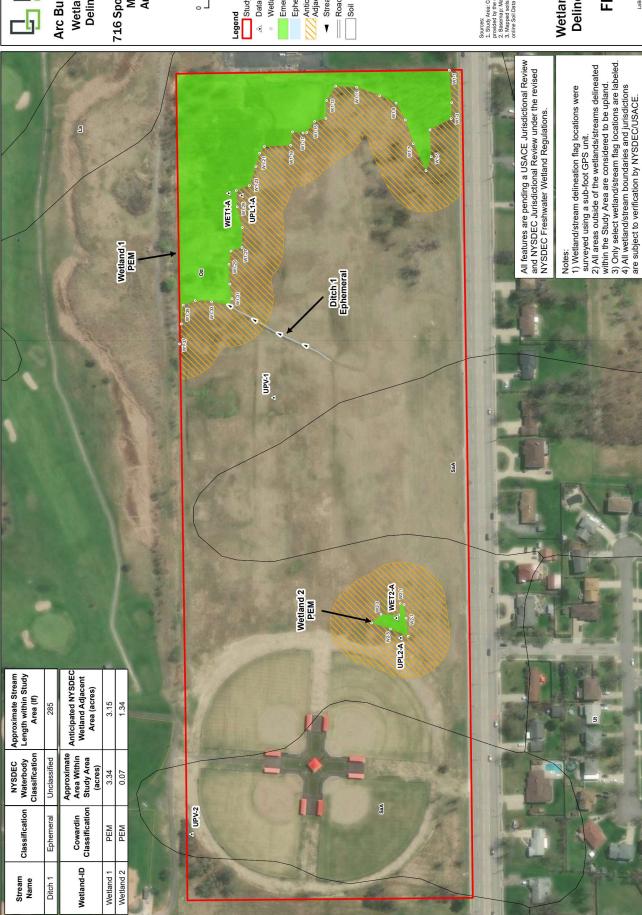
FIGURE 4 – WETLAND AND STREAM DELINEATION SURVEY

LaBella field staff delineated two palustrine emergent (PEM) wetlands within the Study Area (see Appendix A, Figure 4). Table 4 provides areas and classifications of the delineated wetlands.

LaBella field staff delineated one ephemeral stream within the Study Area (see Appendix A, Figure 4). Table 5 provides areas and classifications of the delineated streams.

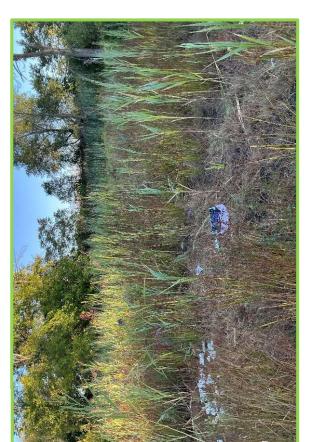
Wetland 1 (PEM)

5.2.1 Wetland 1

Wetland 1 is a 3.34-acre palustrine emergent (PEM) wetland located within a shallow concave depression bordering the entire northeast and eastern section of the Study Area. At the time of the site visit, Wetland 2 appeared to have a hydrologic regime driven by mostly by surface water inputs from precipitation. Hydrology indicators observed include saturation to a depth of two inches and water-stained leaves. Inundation was also visible on aerial imagery.

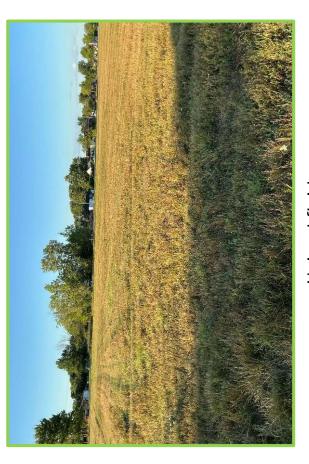
Upland field

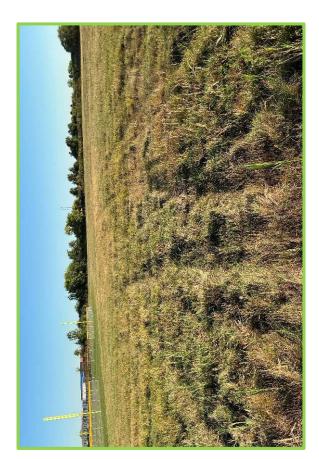
Wetland 2 (PEM)

5.2.2 Wetland 2

Wetland 2 is a palustrine emergent (PEM) wetland located within a shallow concave depression within a field in the southwestern portion of the Study Area adjacent to the baseball fields. The wetland is 0.07 acres in size within the Study Area. At the time of the site visit, Wetland 1 appeared to have a hydrologic regime driven by mostly by surface water inputs from precipitation. Hydrology indicators observed include saturation to a depth of four inches and water-stained leaves. Saturation was also visible on aerial imagery.

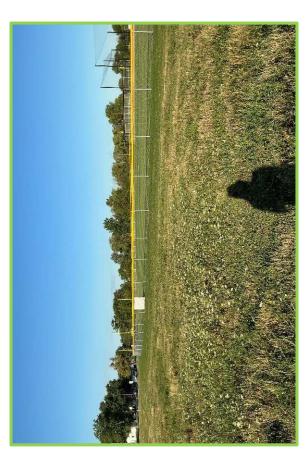
Upland field adjacent to baseball field

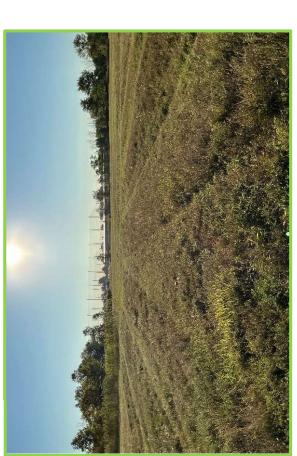
Upland field (UPLV-1)

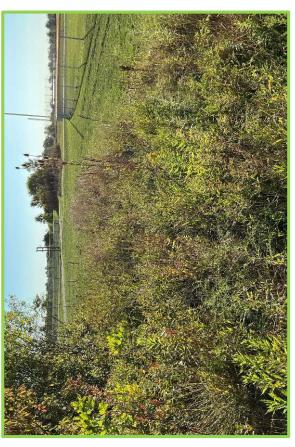
Upland shrubs (UPLV-2)

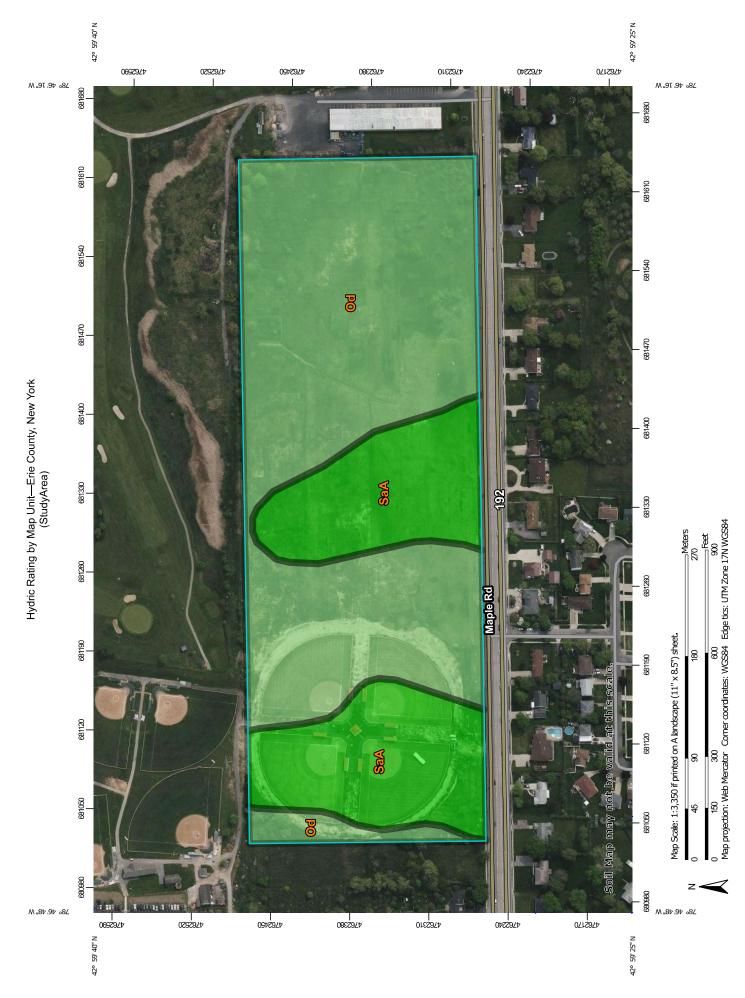
Hydric Soil Map

The Hydric Soil ratings outlined in Table 1 and the Web Soil Survey map provided in Appendix D indicate there is one soil map unit containing hydric components. The soil is considered somewhat poorly drained.
