# **Wetland Delineation Report**

**2190 WEHRLE DRIVE**

**Town of Amherst**

Project Code: **25-067**

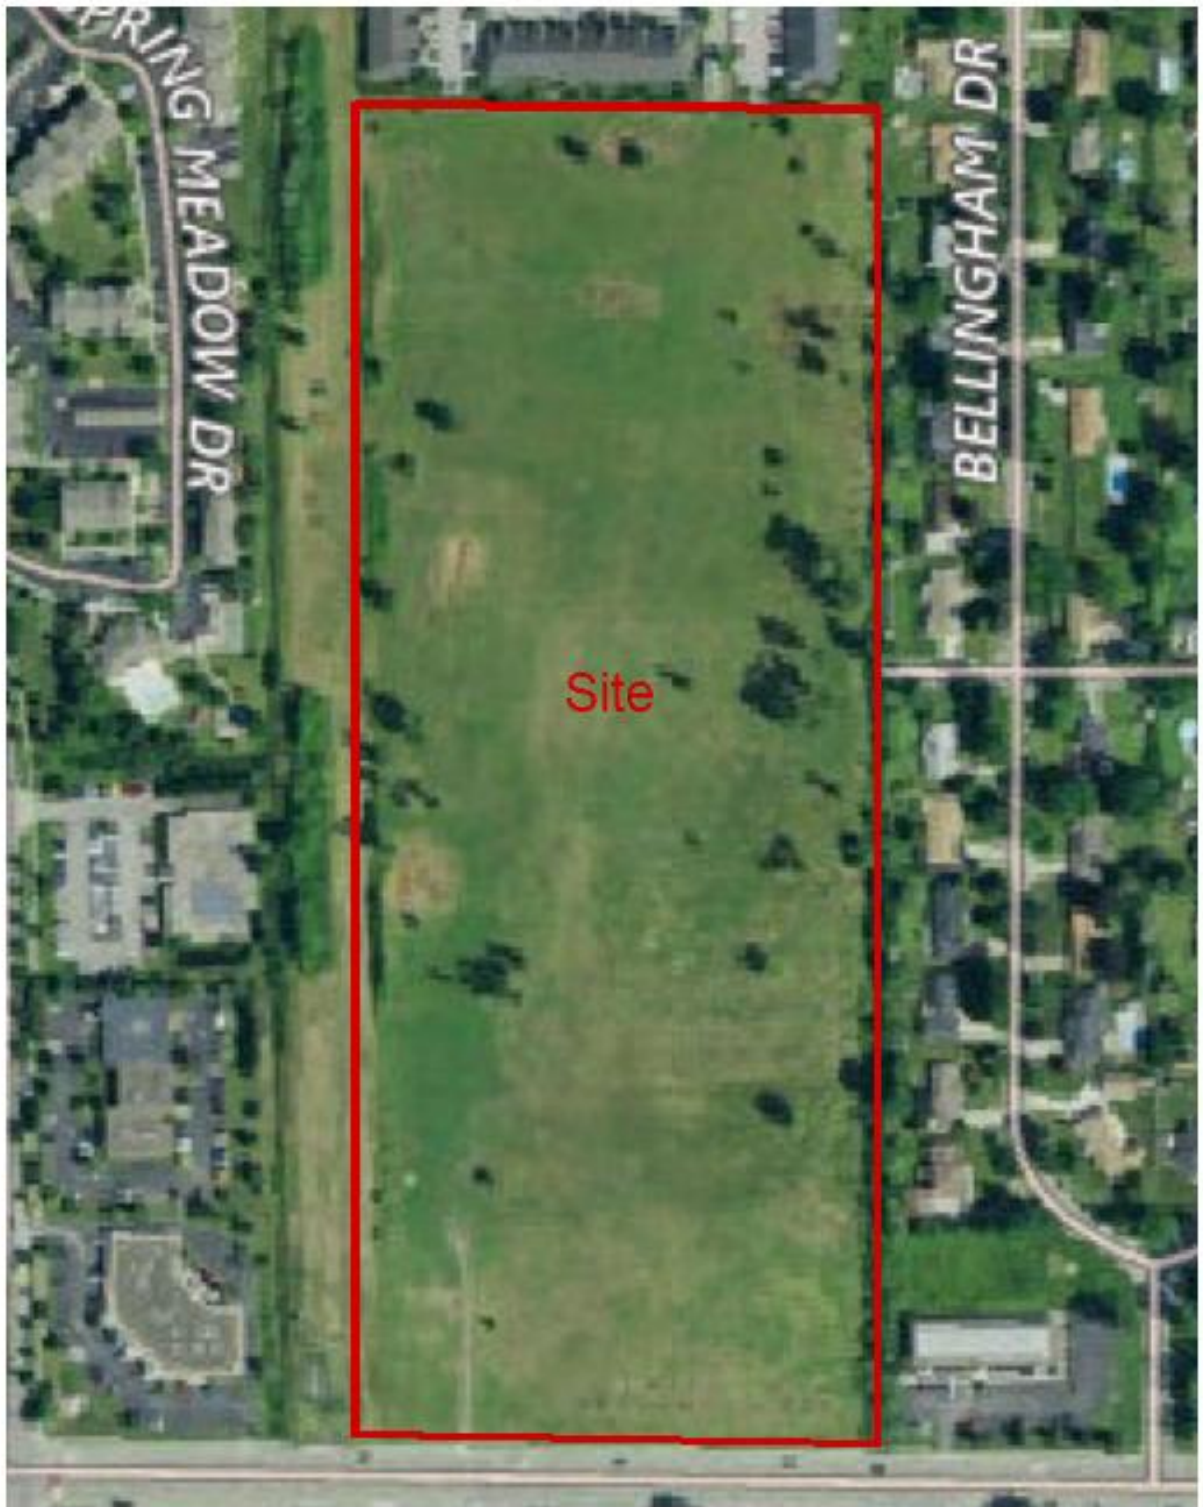
The USGS quadrangle map (Figure 1) depicts the investigation area on the Lancaster quadrangle map. The figure depicts the flat topography of the site.

Figure 1: USGS Topographical Map  
Source: [apps.nationalmap.gov/viewer](https://apps.nationalmap.gov/viewer)

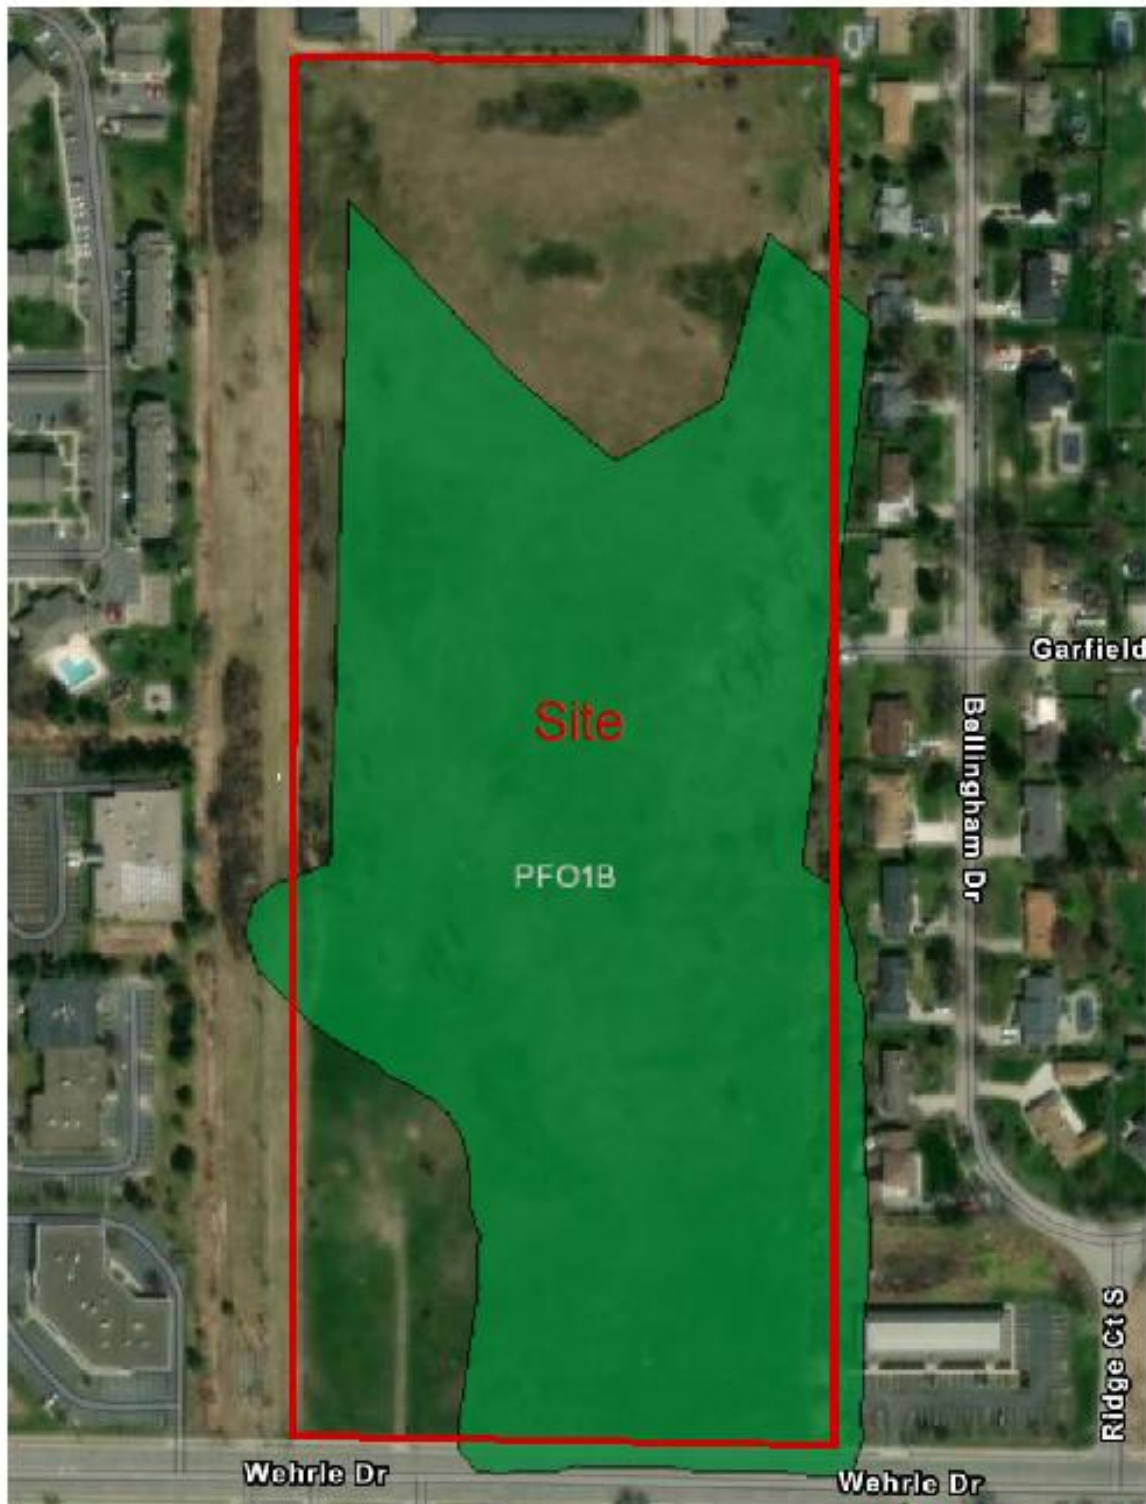
The National Wetlands Inventory (NWI) map (Figure 2) obtained from the USFWS Wetland Mapper [fwsprimary.wim.usgs.gov/wetlands/apps/wetlandsmapper](https://fwsprimary.wim.usgs.gov/wetlands/apps/wetlandsmapper) displays a large forested wetland across most of the site. This layer is based on old information as the site was cleared many years ago and currently is dominated by a maintained lawn area.

Figure 2: National Wetlands Inventory Map  
 Source: <https://www.fws.gov/nwis/wetlands/mapper>

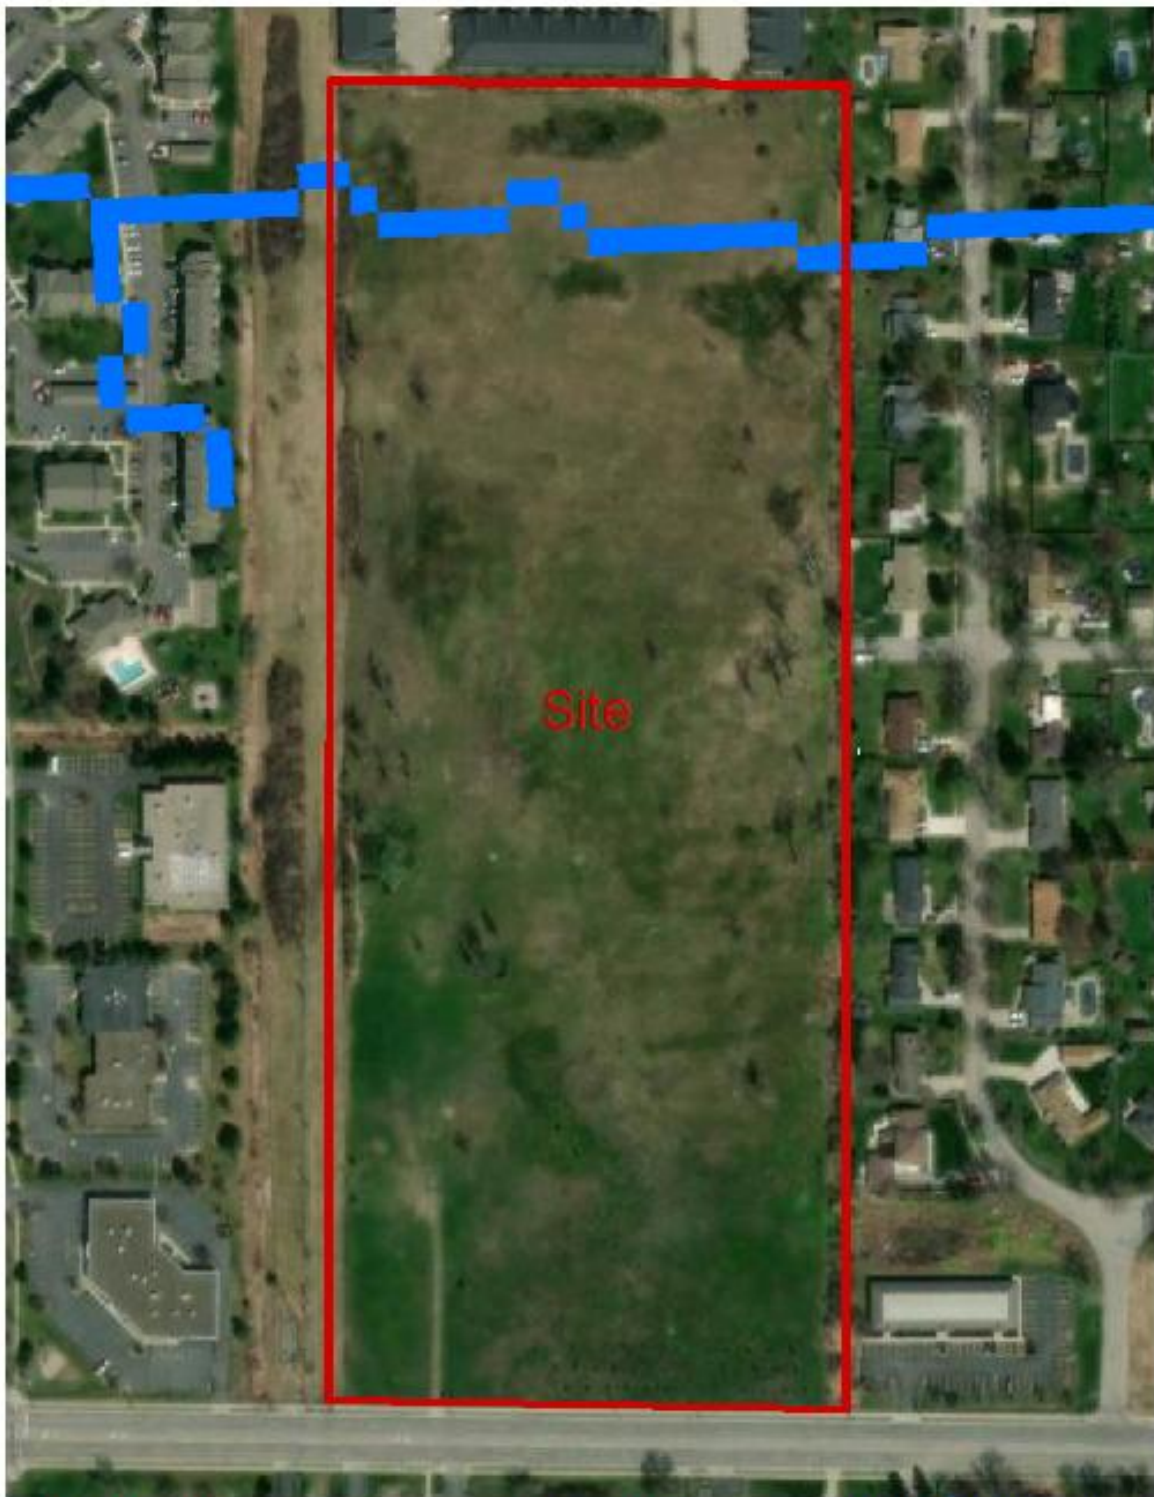
The USGS StreamStats map (Figure 7) indicates one (1) waterway flowing through the site. Although a fragmented ditch is located along the north and west sides of the property, the depicted stream was not found to be present during the investigation. It is likely that if there was a drainage feature here previously, it has since been directed into the storm sewer system. The fragmented ditch segments identified in the field do not appear to drain to a stream and the remnant segments are identified as wetlands in this report.

Figure 7: USGS Stream Stats  
Source: [streamstats.usgs.gov/ss/](http://streamstats.usgs.gov/ss/)

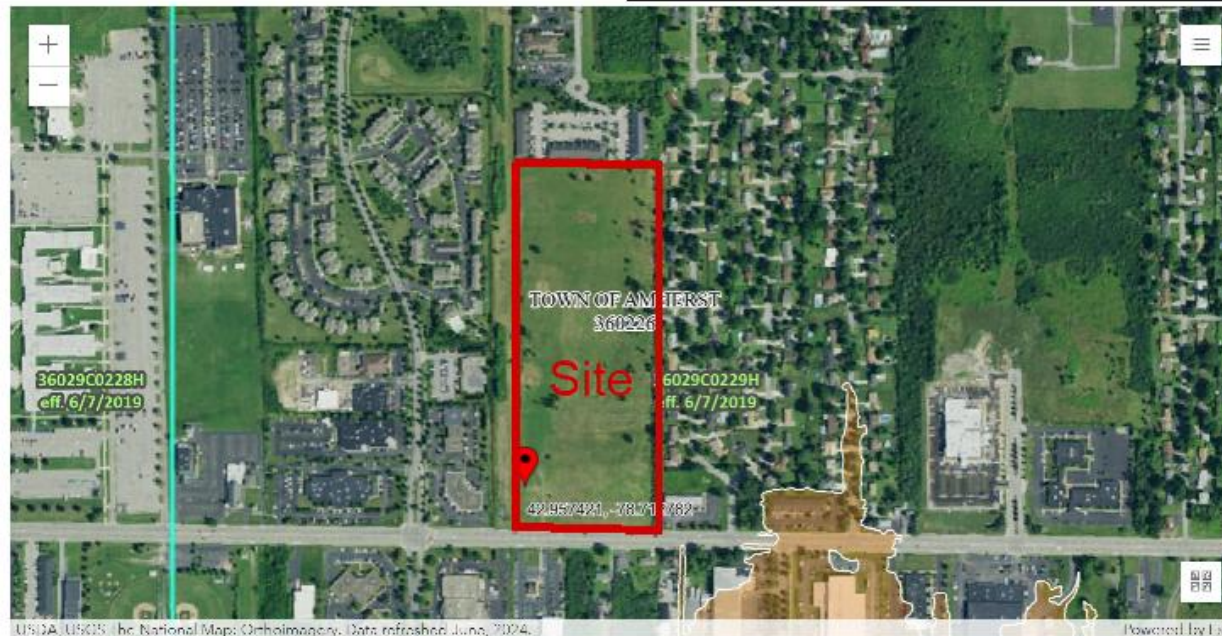
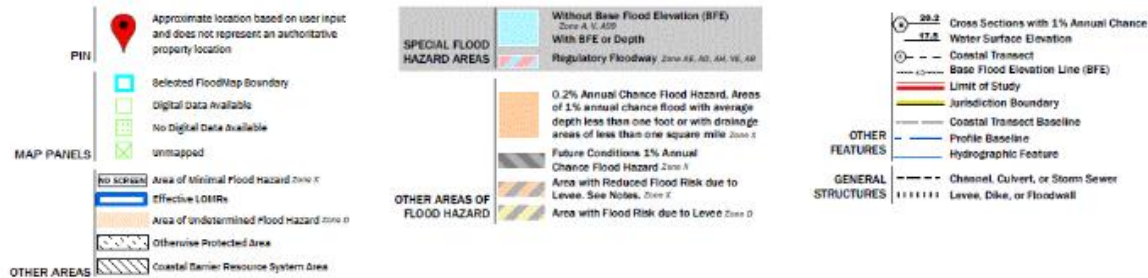
The Federal Emergency Management Agency (FEMA) flood map (Figure 8) obtained from the National Flood Hazard Layer on-line map indicates that there is no active floodplain present on this site.

**Figure 8: FEMA Floodplain Map**  
Source: [msc.fema.gov/portal/search](https://msc.fema.gov/portal/search)

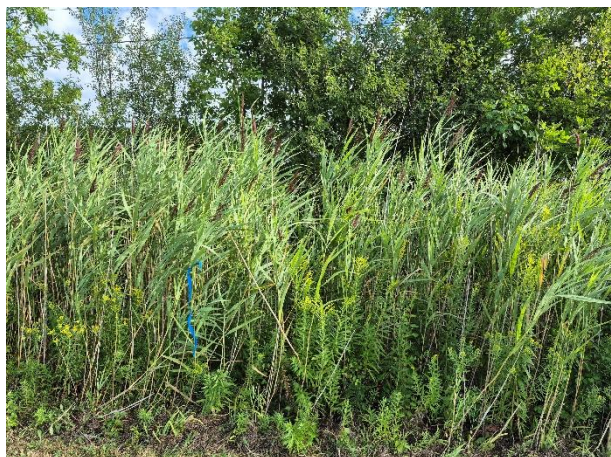
Wetland W1 is a 0.049± acre shallow emergent marsh community dominated by common reed (*Phragmites australis*).

**Photo 1: Facing north toward D1 and Wetland 1. August 26, 2025.**
