# **Wetland Delineation Report**

**3765 SHERIDAN DRIVE**

**Town of Amherst**

Project Code: **25-088**

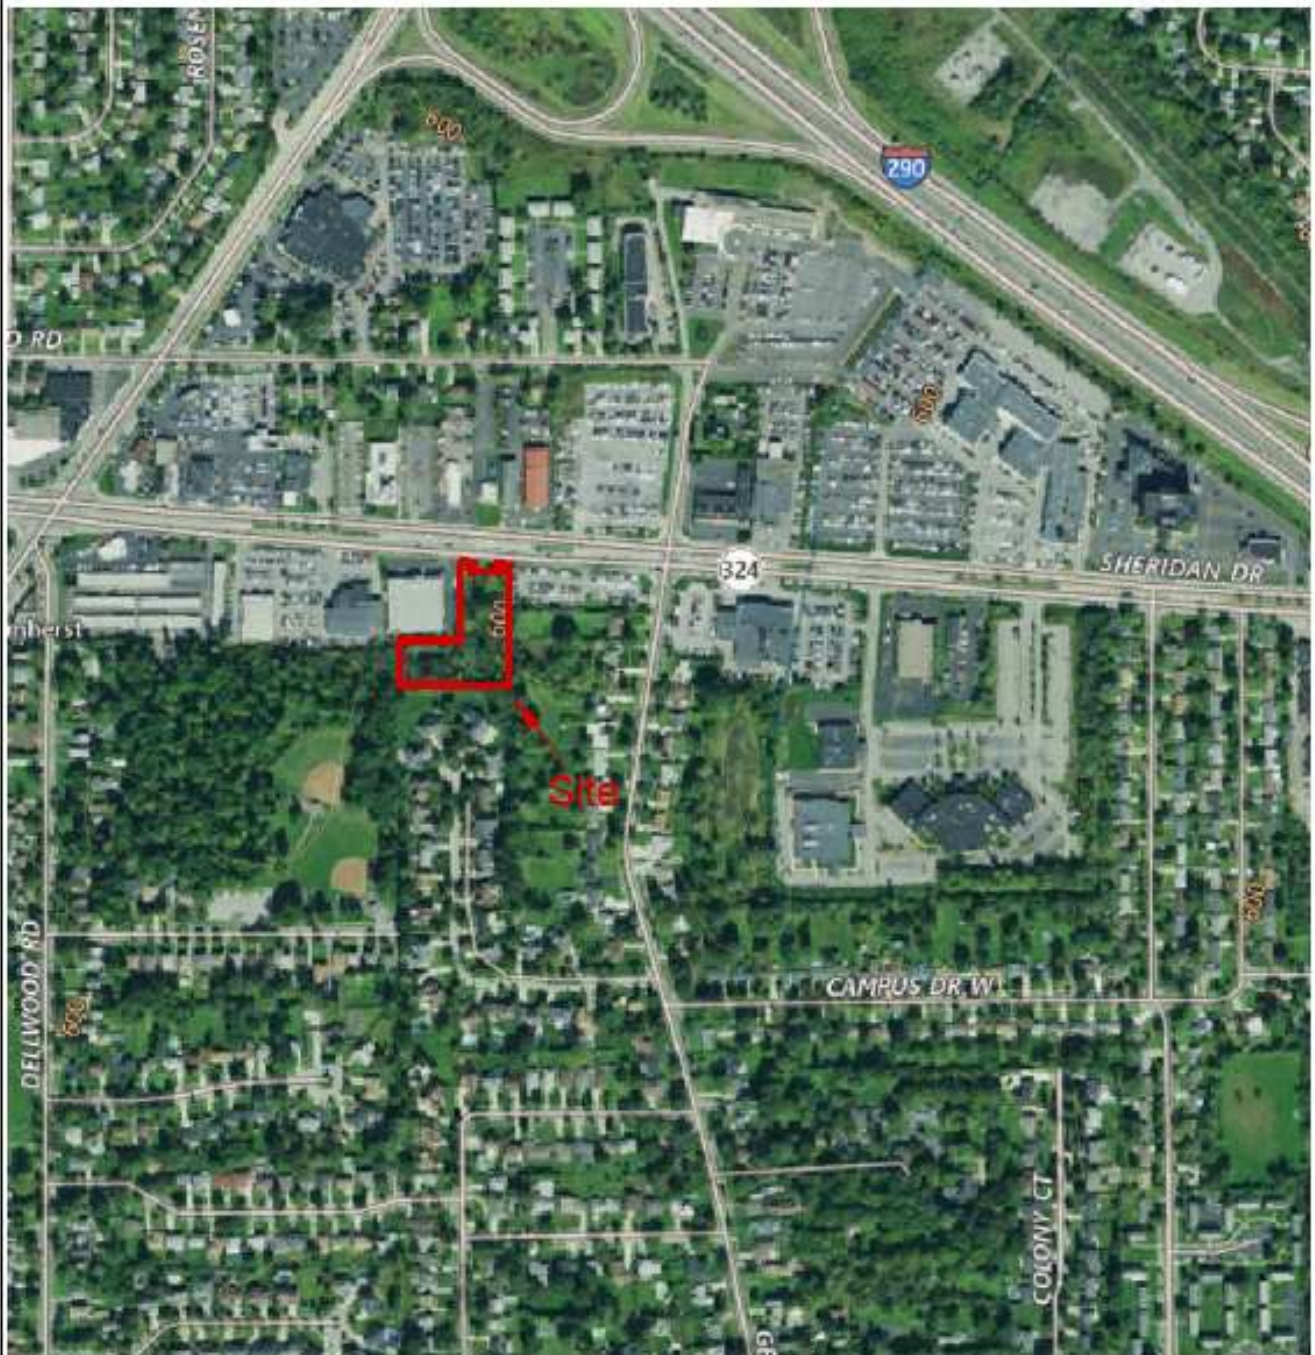
Figure 1: USGS Topographical Map  
Source: [apps.nationalmap.gov/viewer](https://apps.nationalmap.gov/viewer)

The USGS quadrangle map (Figure 1) depicts the investigation area on the Buffalo Northeast Quadrangle map. The figure depicts the gently sloping topography of the site.

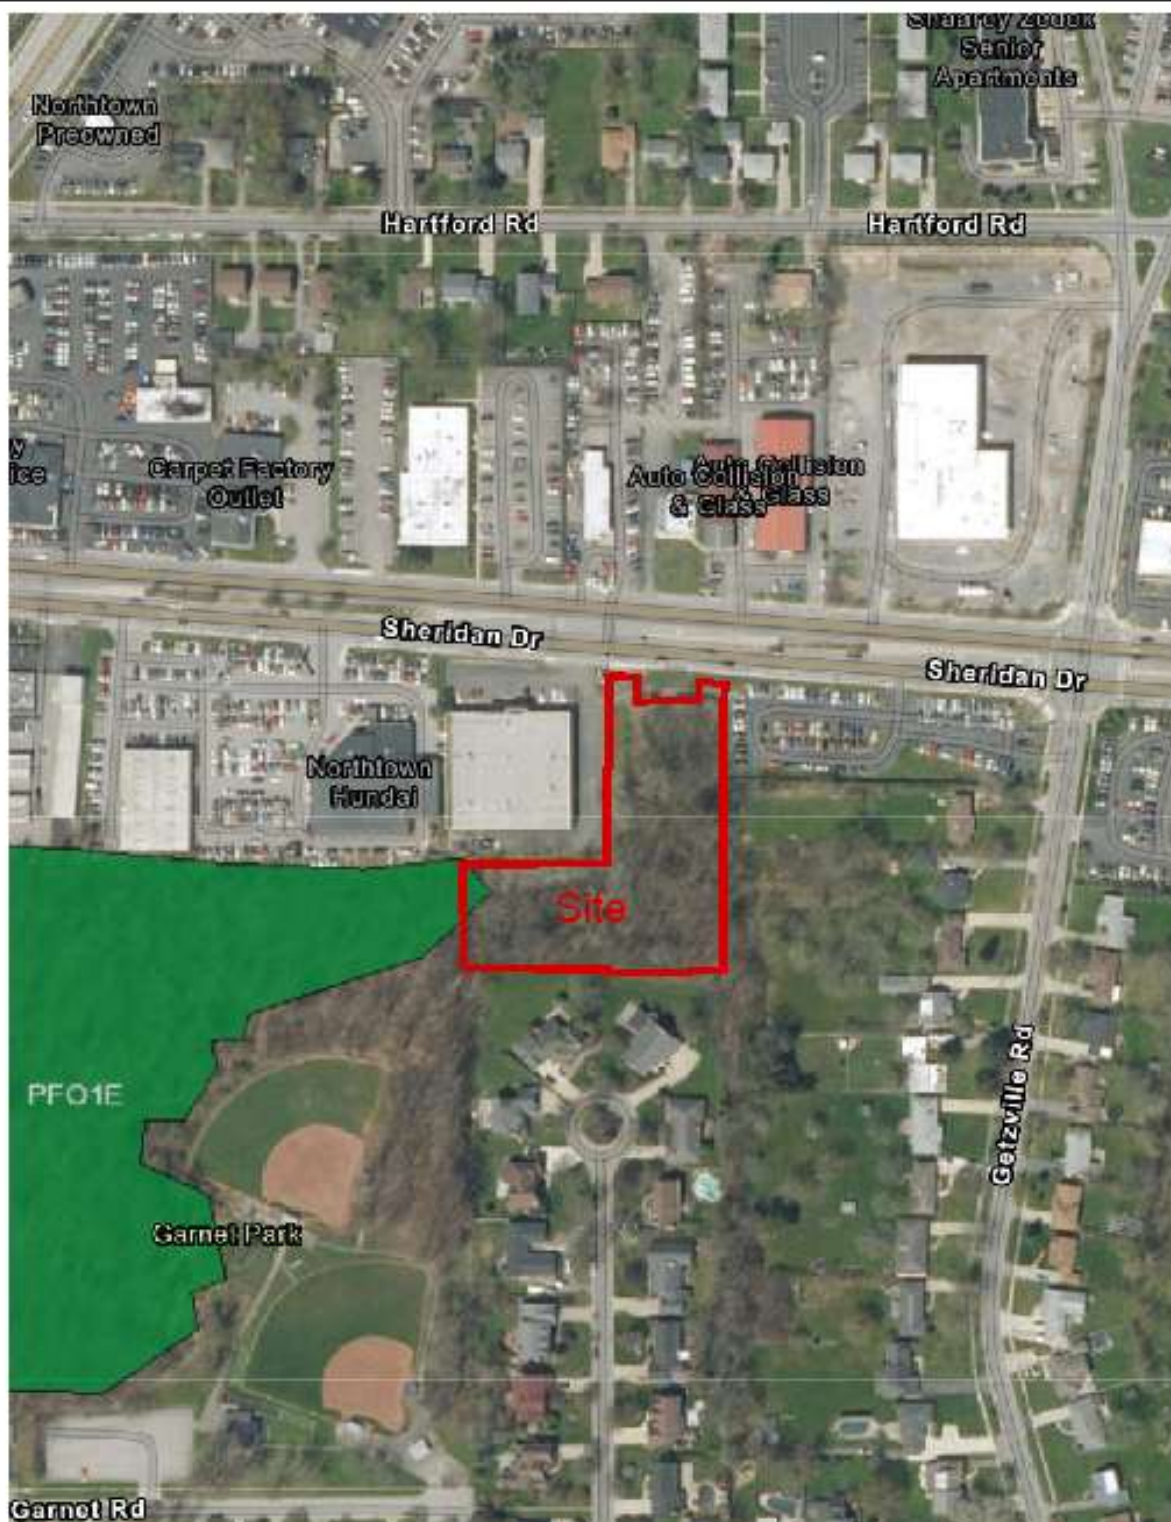
Figure 2: National Wetlands Inventory Map  
Source: <https://www.fws.gov/nwis/wetlands/>

The National Wetlands Inventory (NWI) map (Figure 2) obtained from the USFWS Wetland Mapper [fwsprimary.wim.usgs.gov/wetlands/apps/wetlandsmapper](https://fwsprimary.wim.usgs.gov/wetlands/apps/wetlandsmapper) displays a small area in the western portion of the investigation area as a forested wetland.

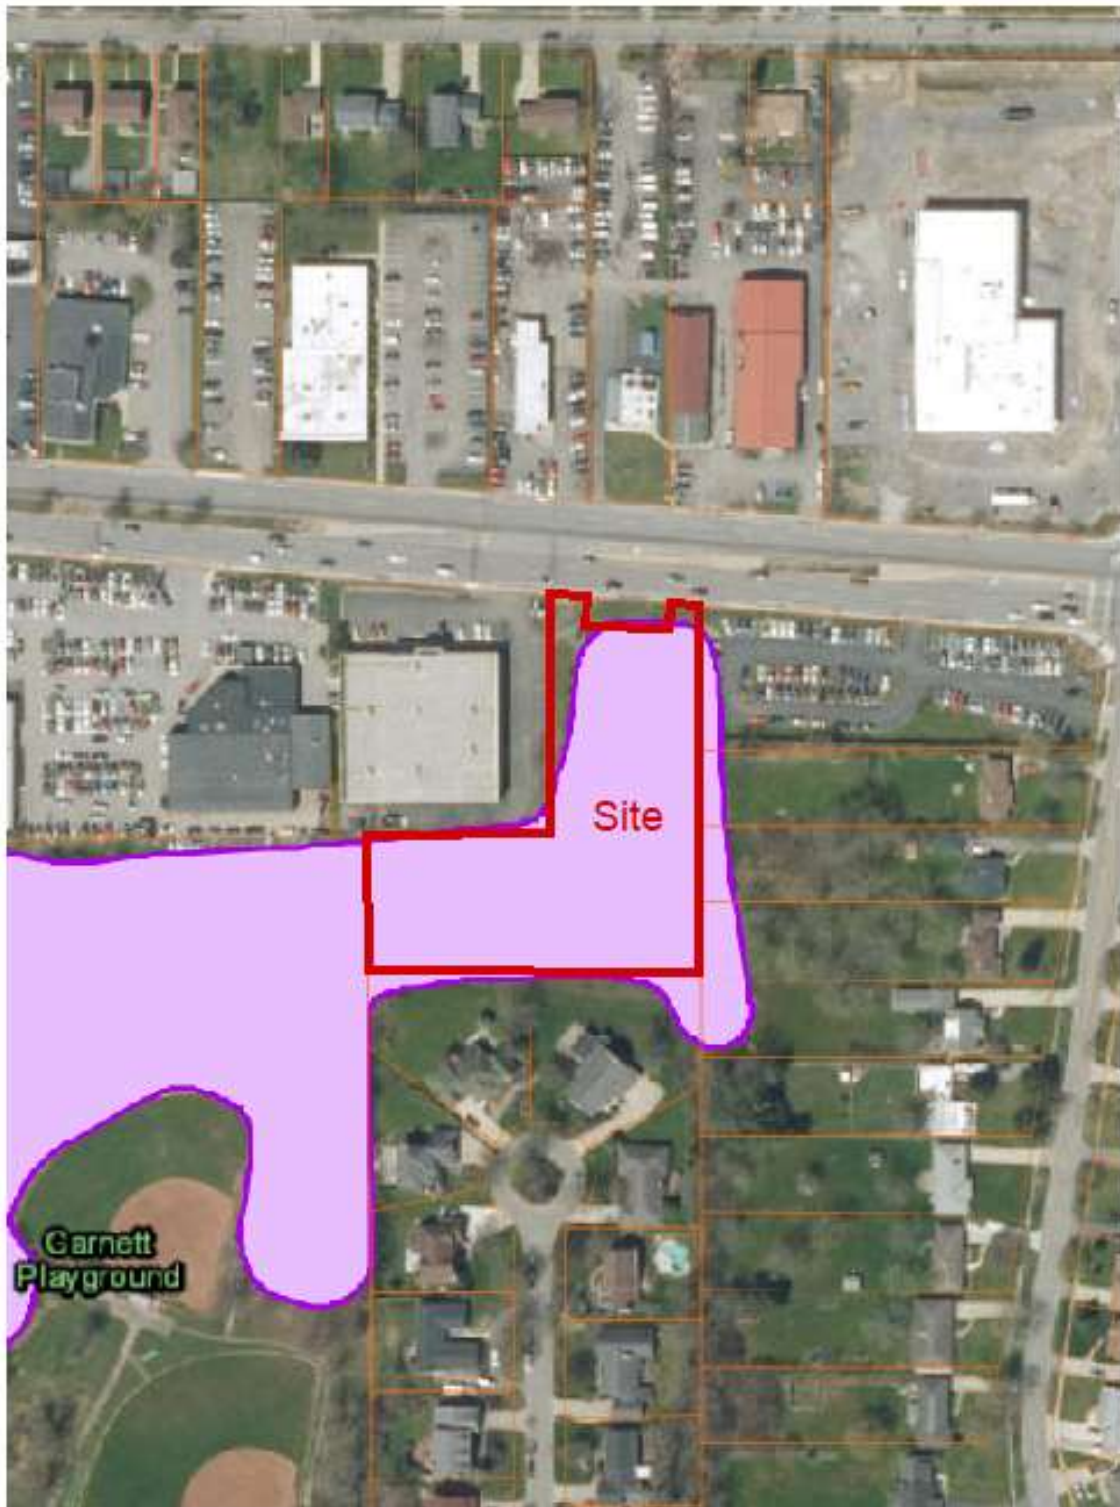
Figure 4: NYSDDEC Environmental Resource Mapper  
 Source: <https://gis-services.dec.ny.gov/gis/tem/>

The NYSDEC Freshwater Wetlands map (Figure 4) obtained from the online NYSDEC Environmental Resource Mapper displays nearly the entire investigation area as an “informational” wetland area.

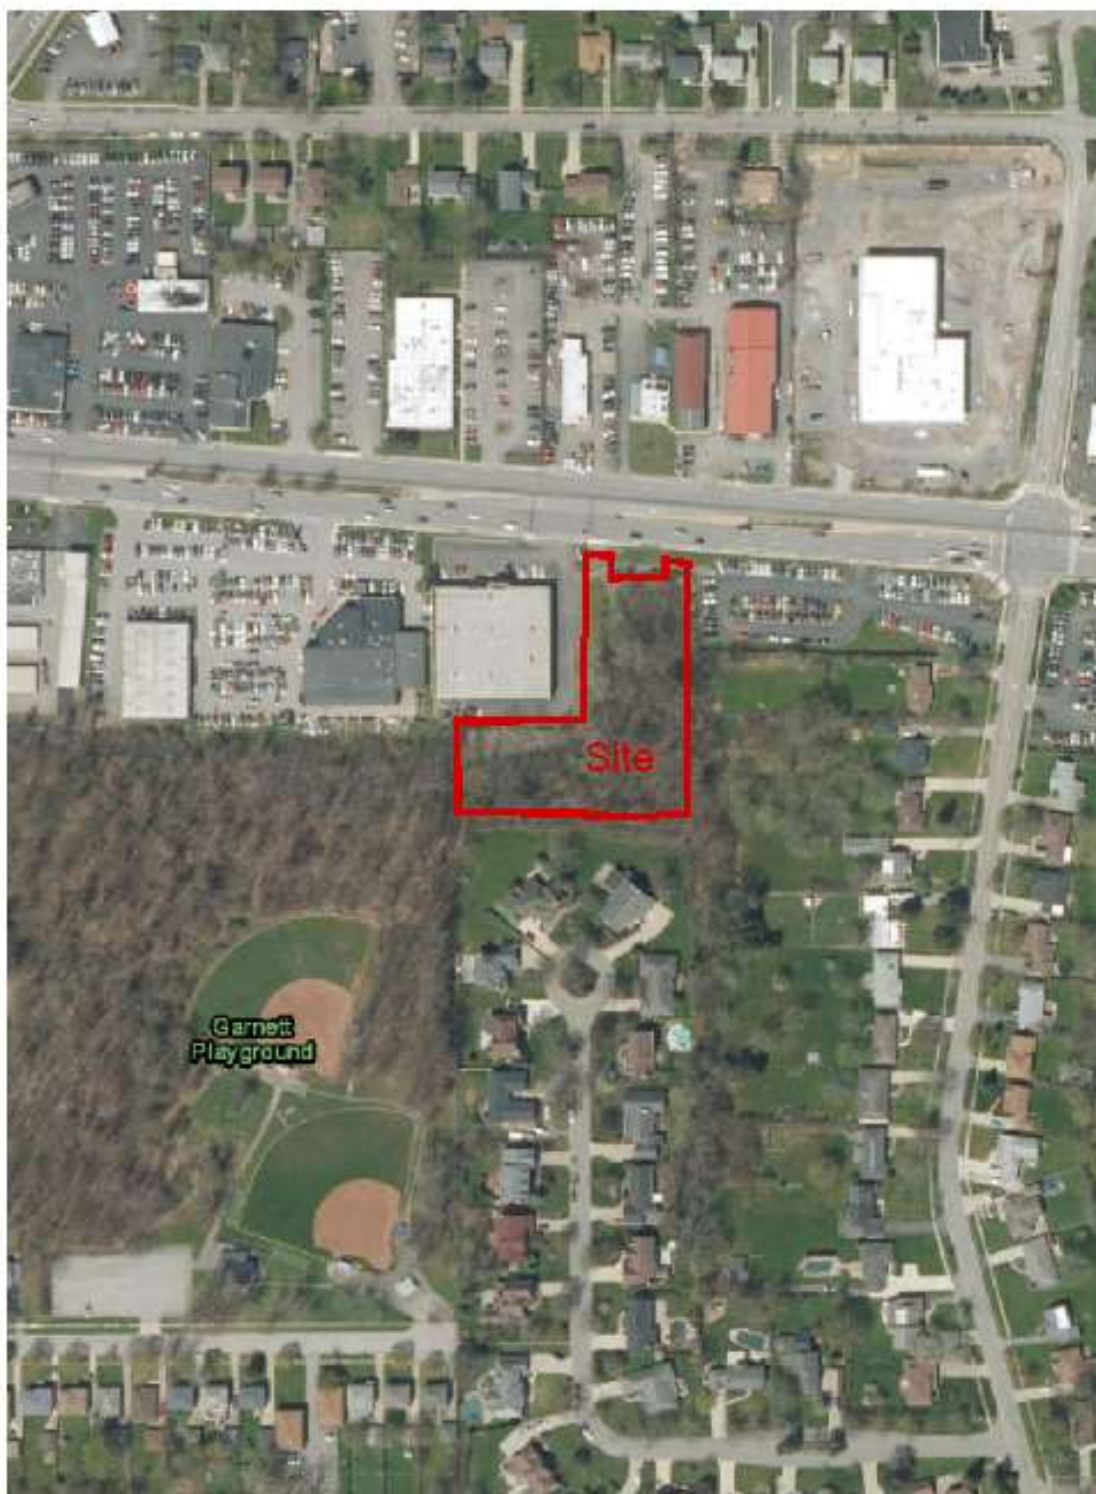
Figure 7: USGS Stream Stats  
Source: [streamstats.usgs.gov/ss/](https://streamstats.usgs.gov/ss/)

The USGS StreamStats map (Figure 7) does not indicate any streams or drainage features that flow through the investigation area.

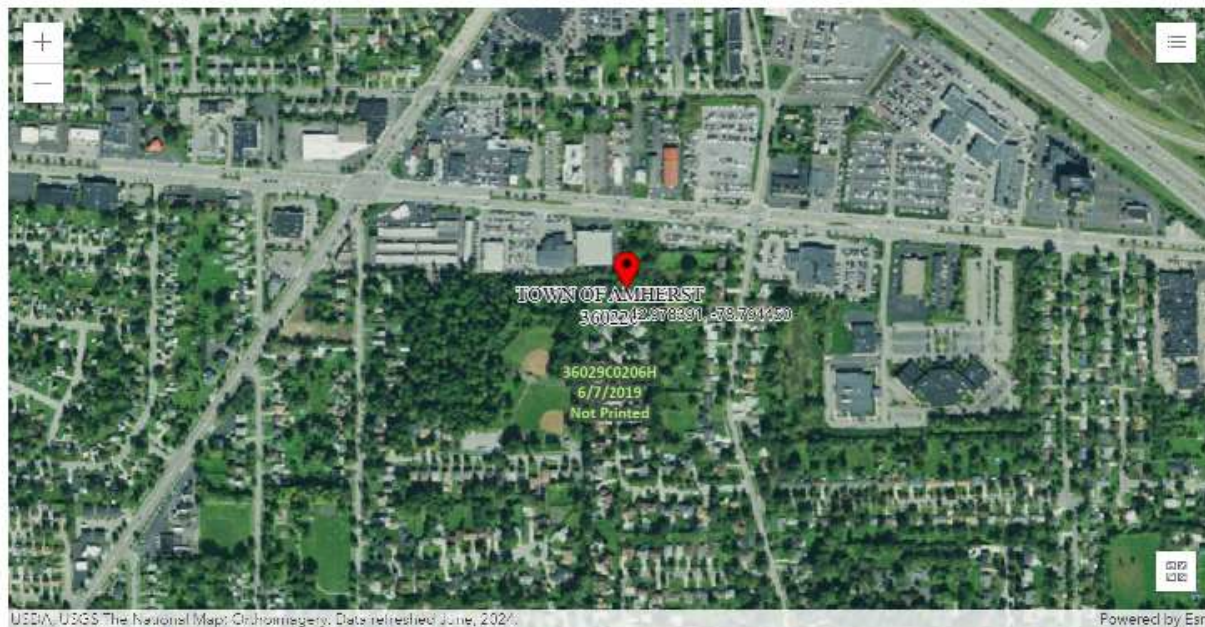
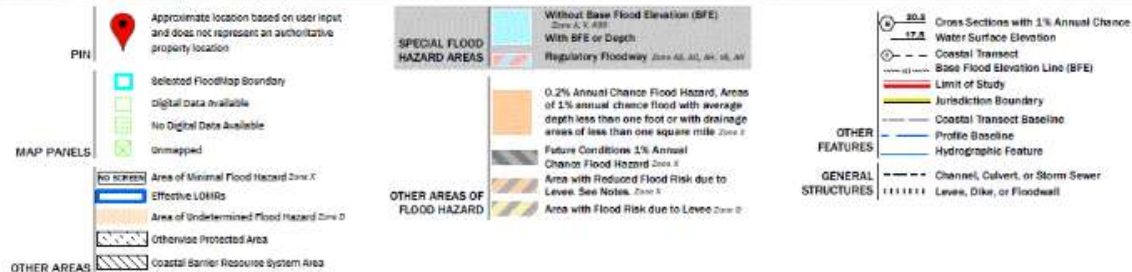
Figure 8: FEMA Floodplain Map  
Source: [msc.fema.gov/portal/search](https://msc.fema.gov/portal/search)

The Federal Emergency Management Agency (FEMA) flood map (Figure 8) obtained from the National Flood Hazard Layer on-line map indicates no FEMA-designated floodplains or floodways within the investigation area.

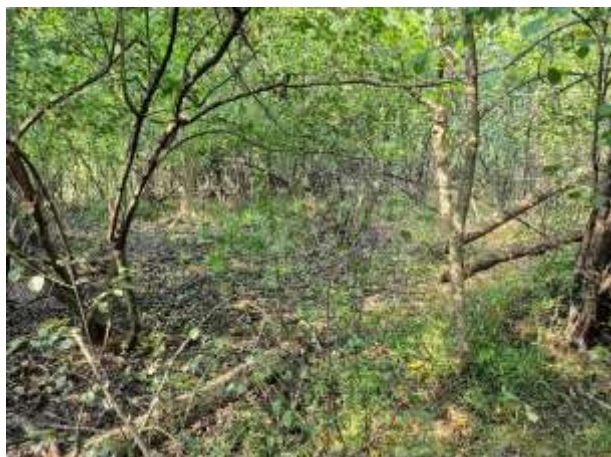
**Photo 1**: Facing west from D1. September 22, 2025.

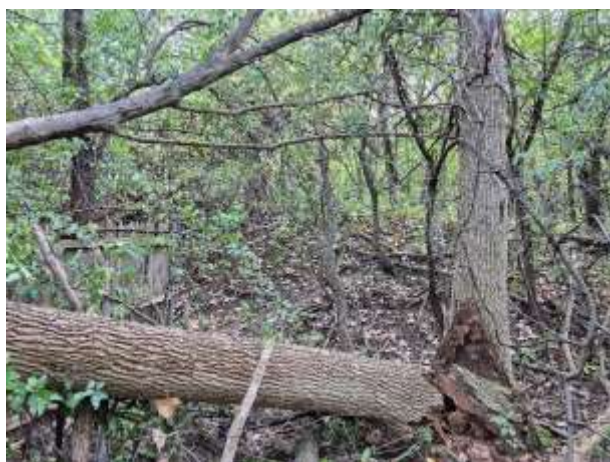
**Photo 2**: Facing east from D2. September 22, 2025.

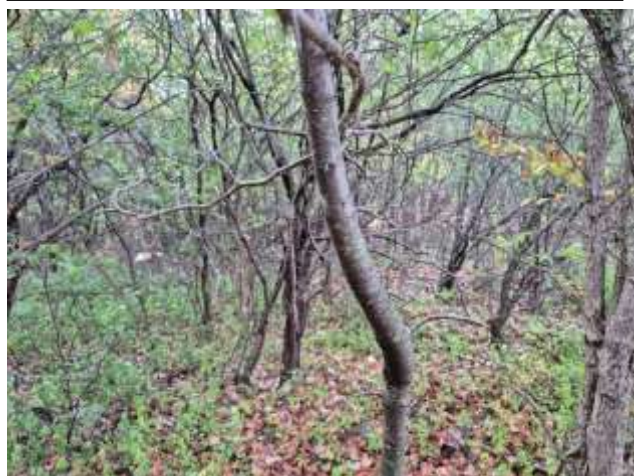
**Photo 3**: Facing south from D3. September 22, 2025.
