SECTION 2 – SCOPE AND EXTENT

2.1 OVERVIEW

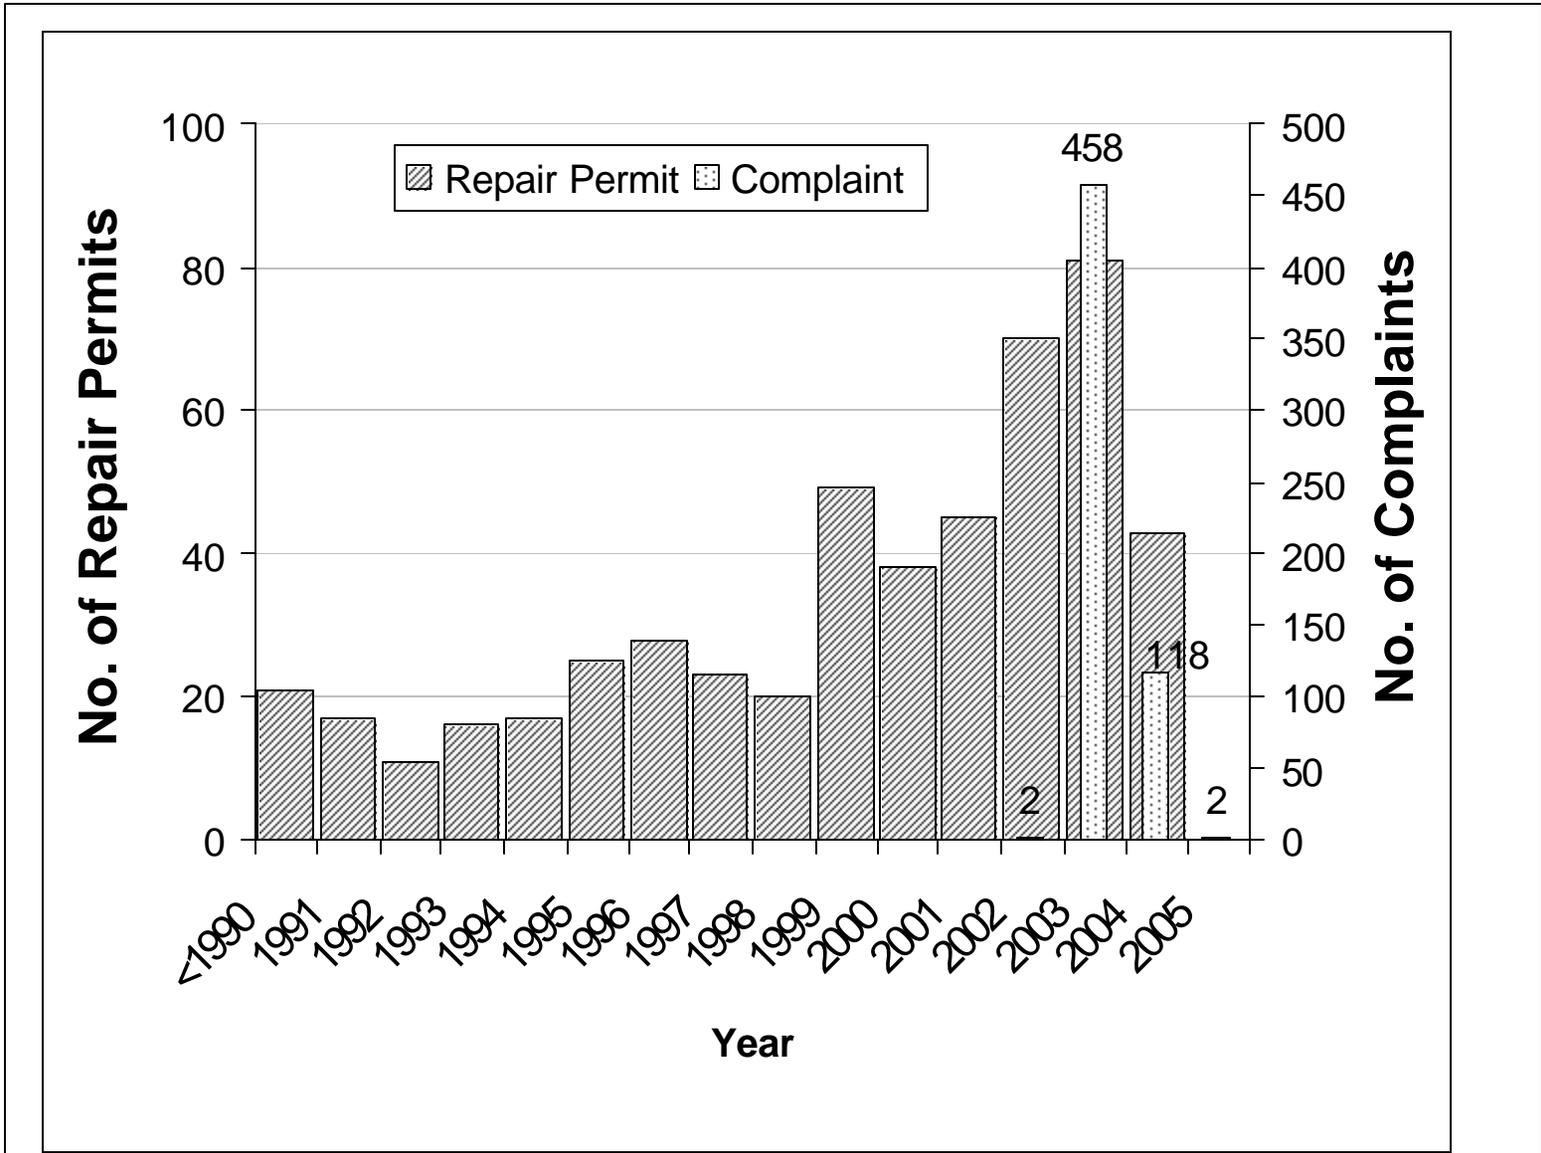
Figure 22 shows the number of foundation repair permits and complaints recorded by the Amherst Building Department through January 2004. The number of repair permits increased sharply in the early 1990’s, sometimes catalyzed by dry conditions and increased media coverage. The Building Department established an inspection and tracking system for foundation-related complaints in 2003. Figure 23 shows the spatial distribution of these sites (maps available from Building Department). The majority of permits and inquiries are located north of Sheridan Drive, with the exception of houses in southwestern Amherst.

Figure 22. Frequency of foundation-related repair permits and complaints in Amherst, NY, through January 2005.

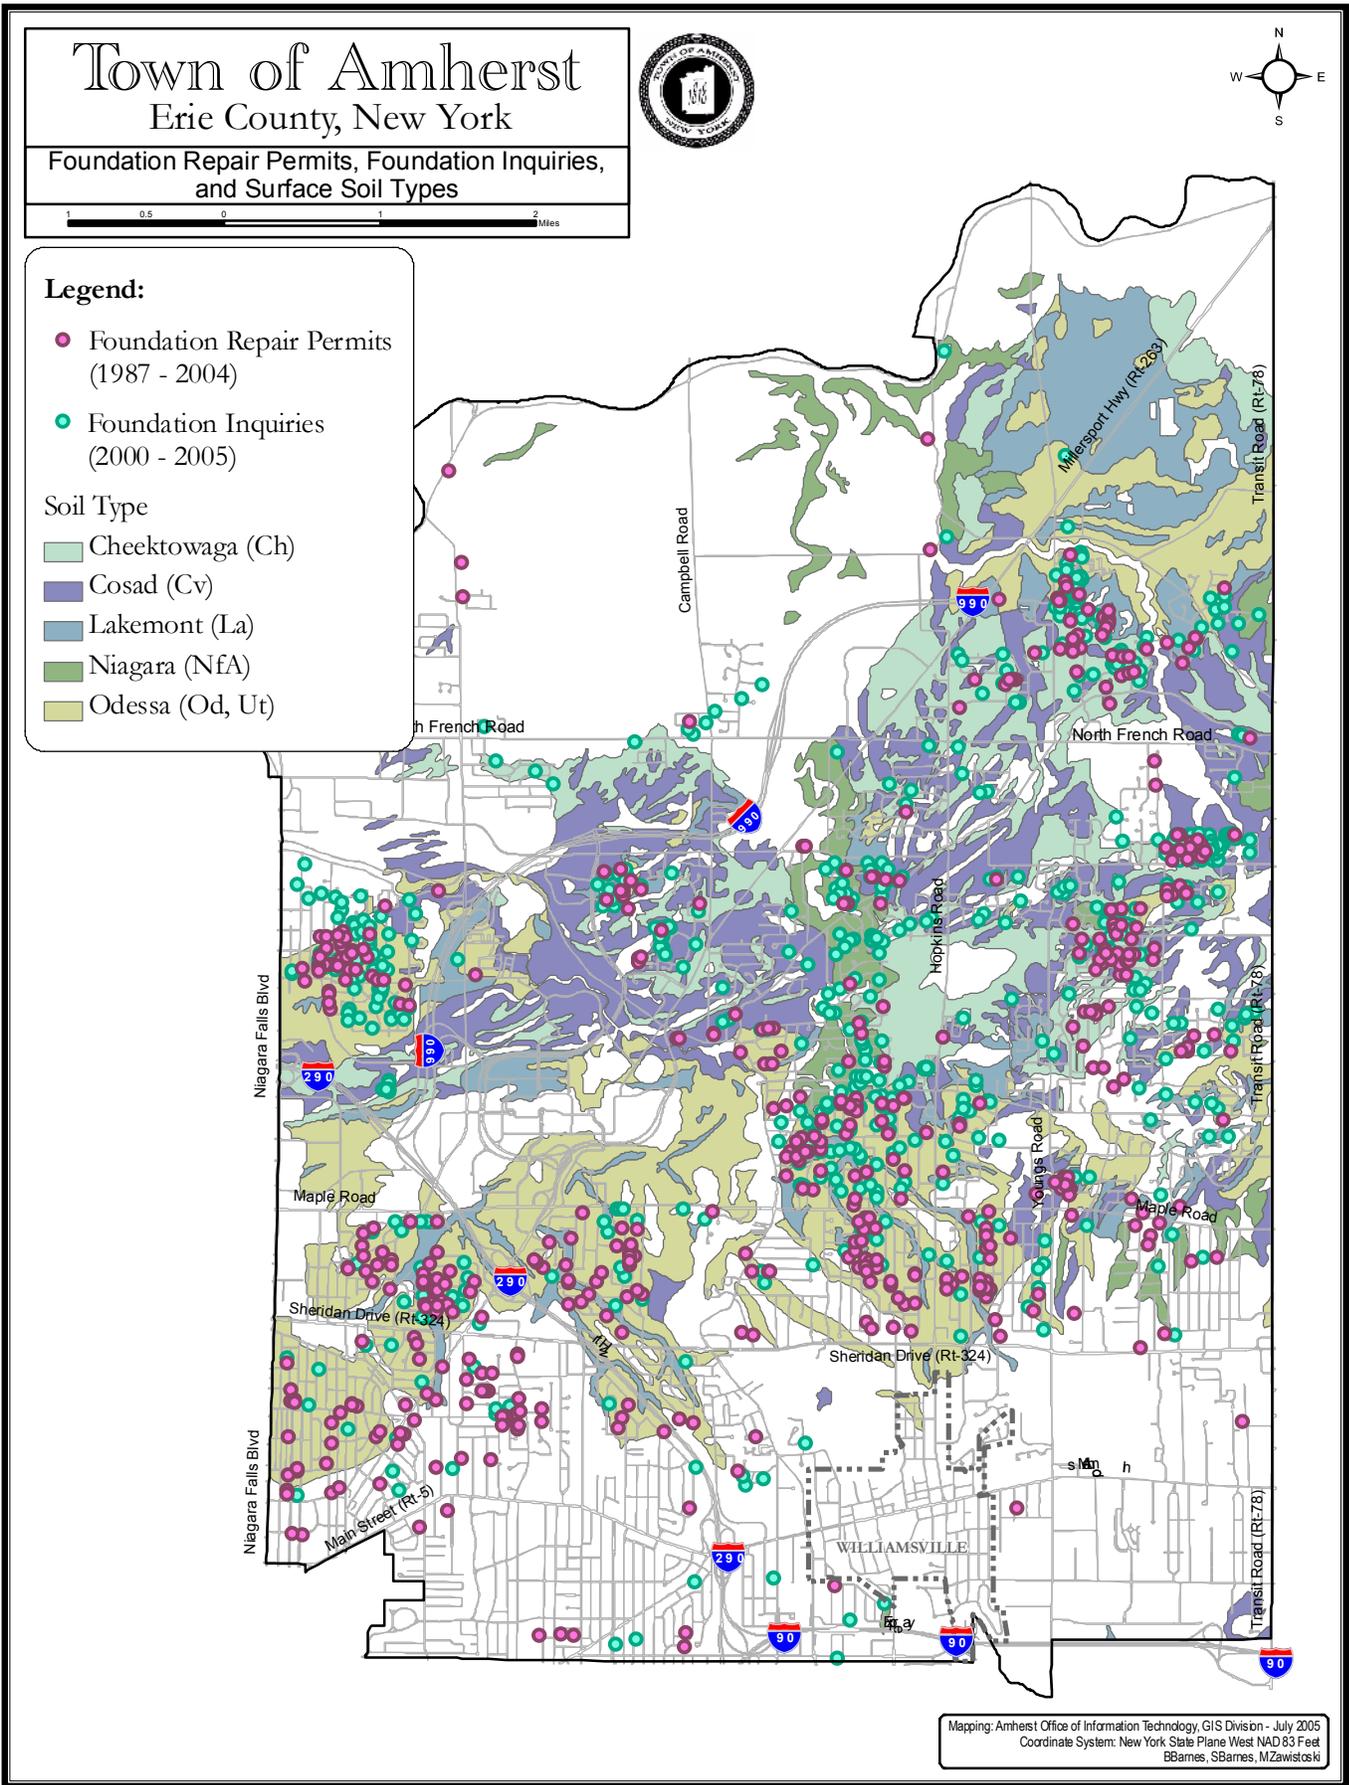
Figure 24 shows the relationship of foundation repair permits and complaints to the five soils types described in Section 1.5.6.2. Table 7 shows these five soils types account for 42% of the town area, 48% of the total number of foundations, and account for 75% of the foundation repair permits and 82% of the complaints.

Figure 24: Relationship of foundation-related repair permits and inquiries to five lacustrine surface soils in Amherst, NY.

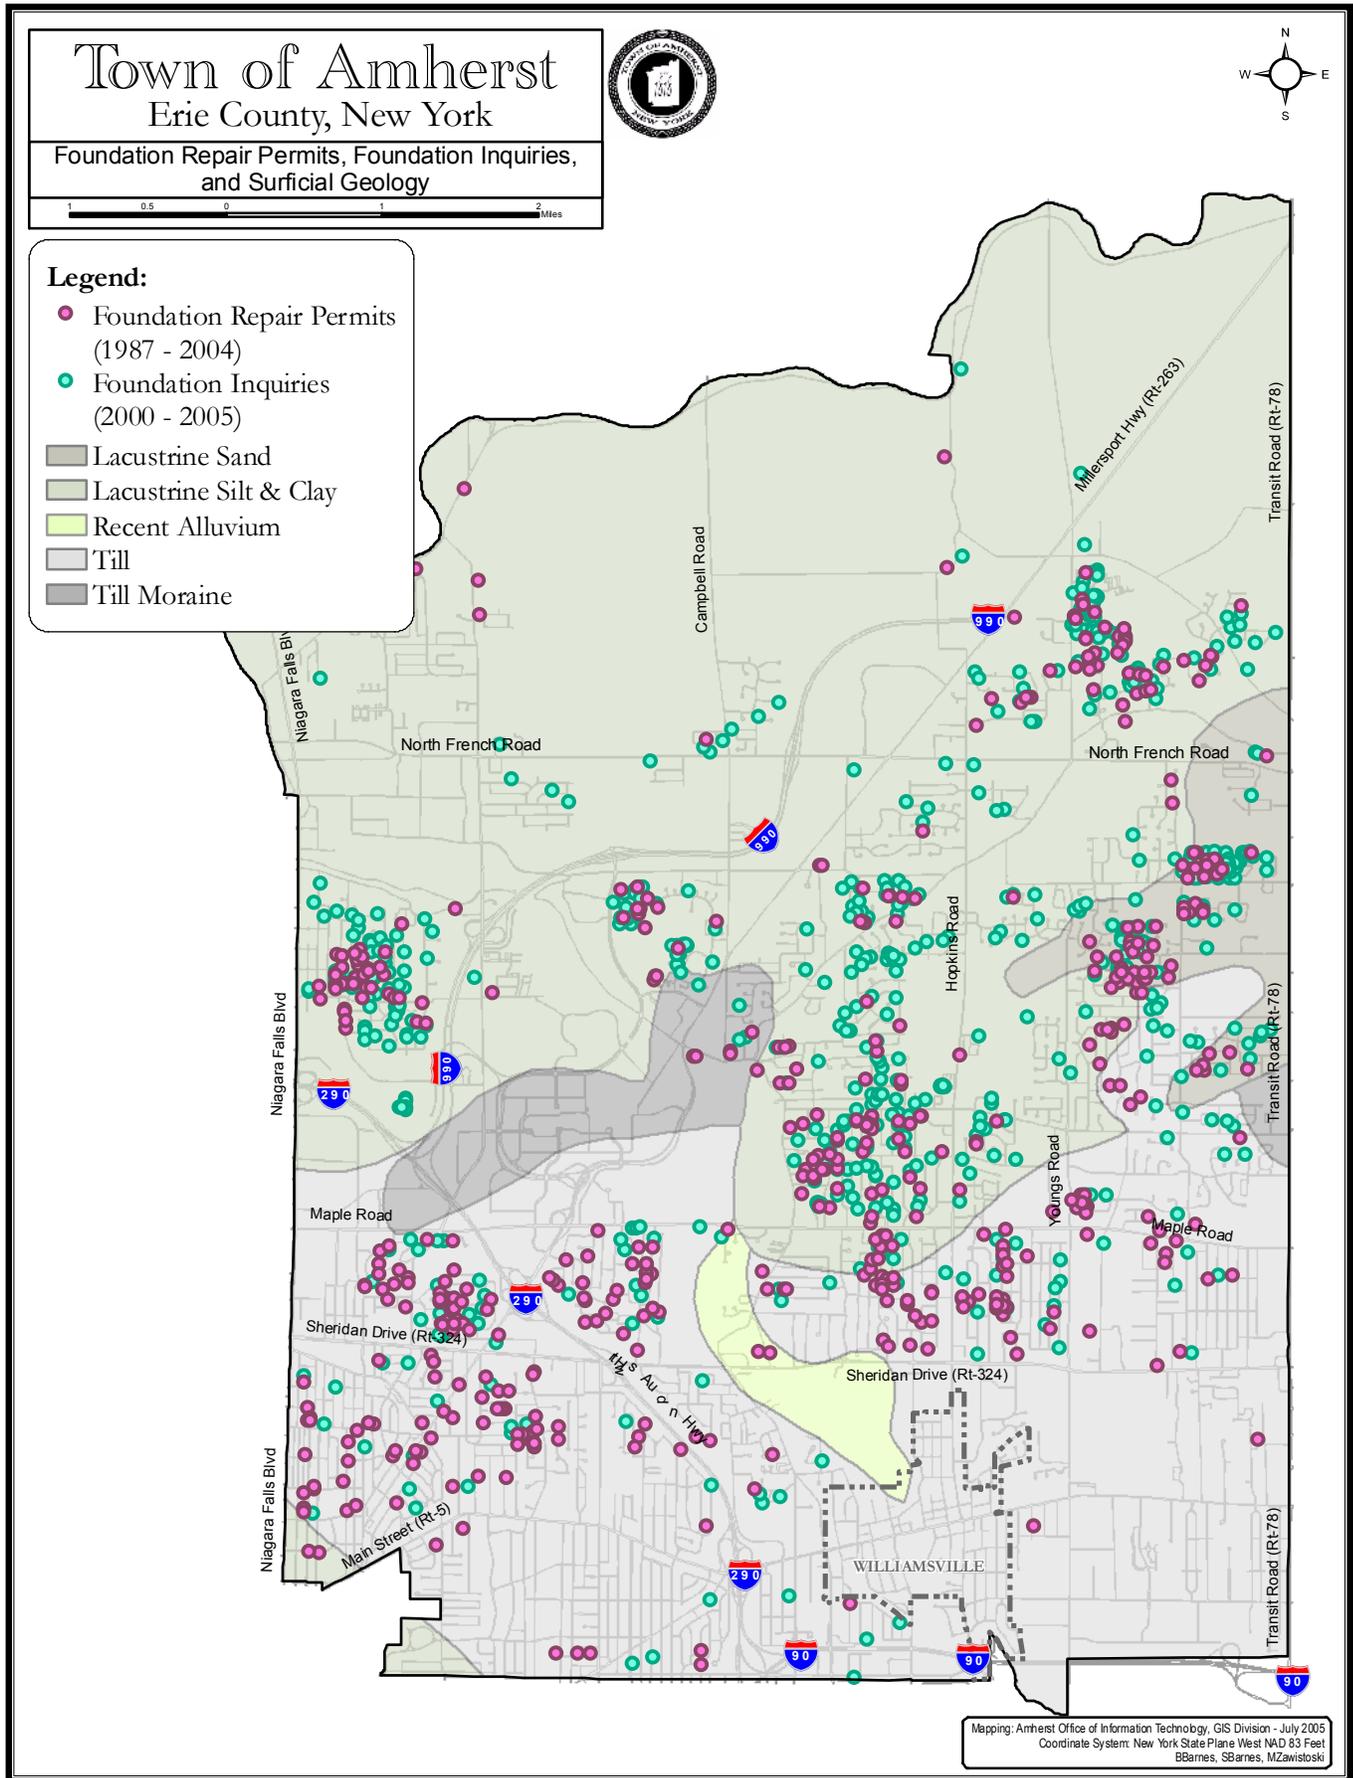
Figure 25 shows the relationship of surficial geology units and foundation repair permits and foundation inquiries. The geologic units do not appear to be a good predictor of foundation-related problems.

Figure 25: Relationship of foundation-related repair permits and inquiries to surficial and bedrock geology.

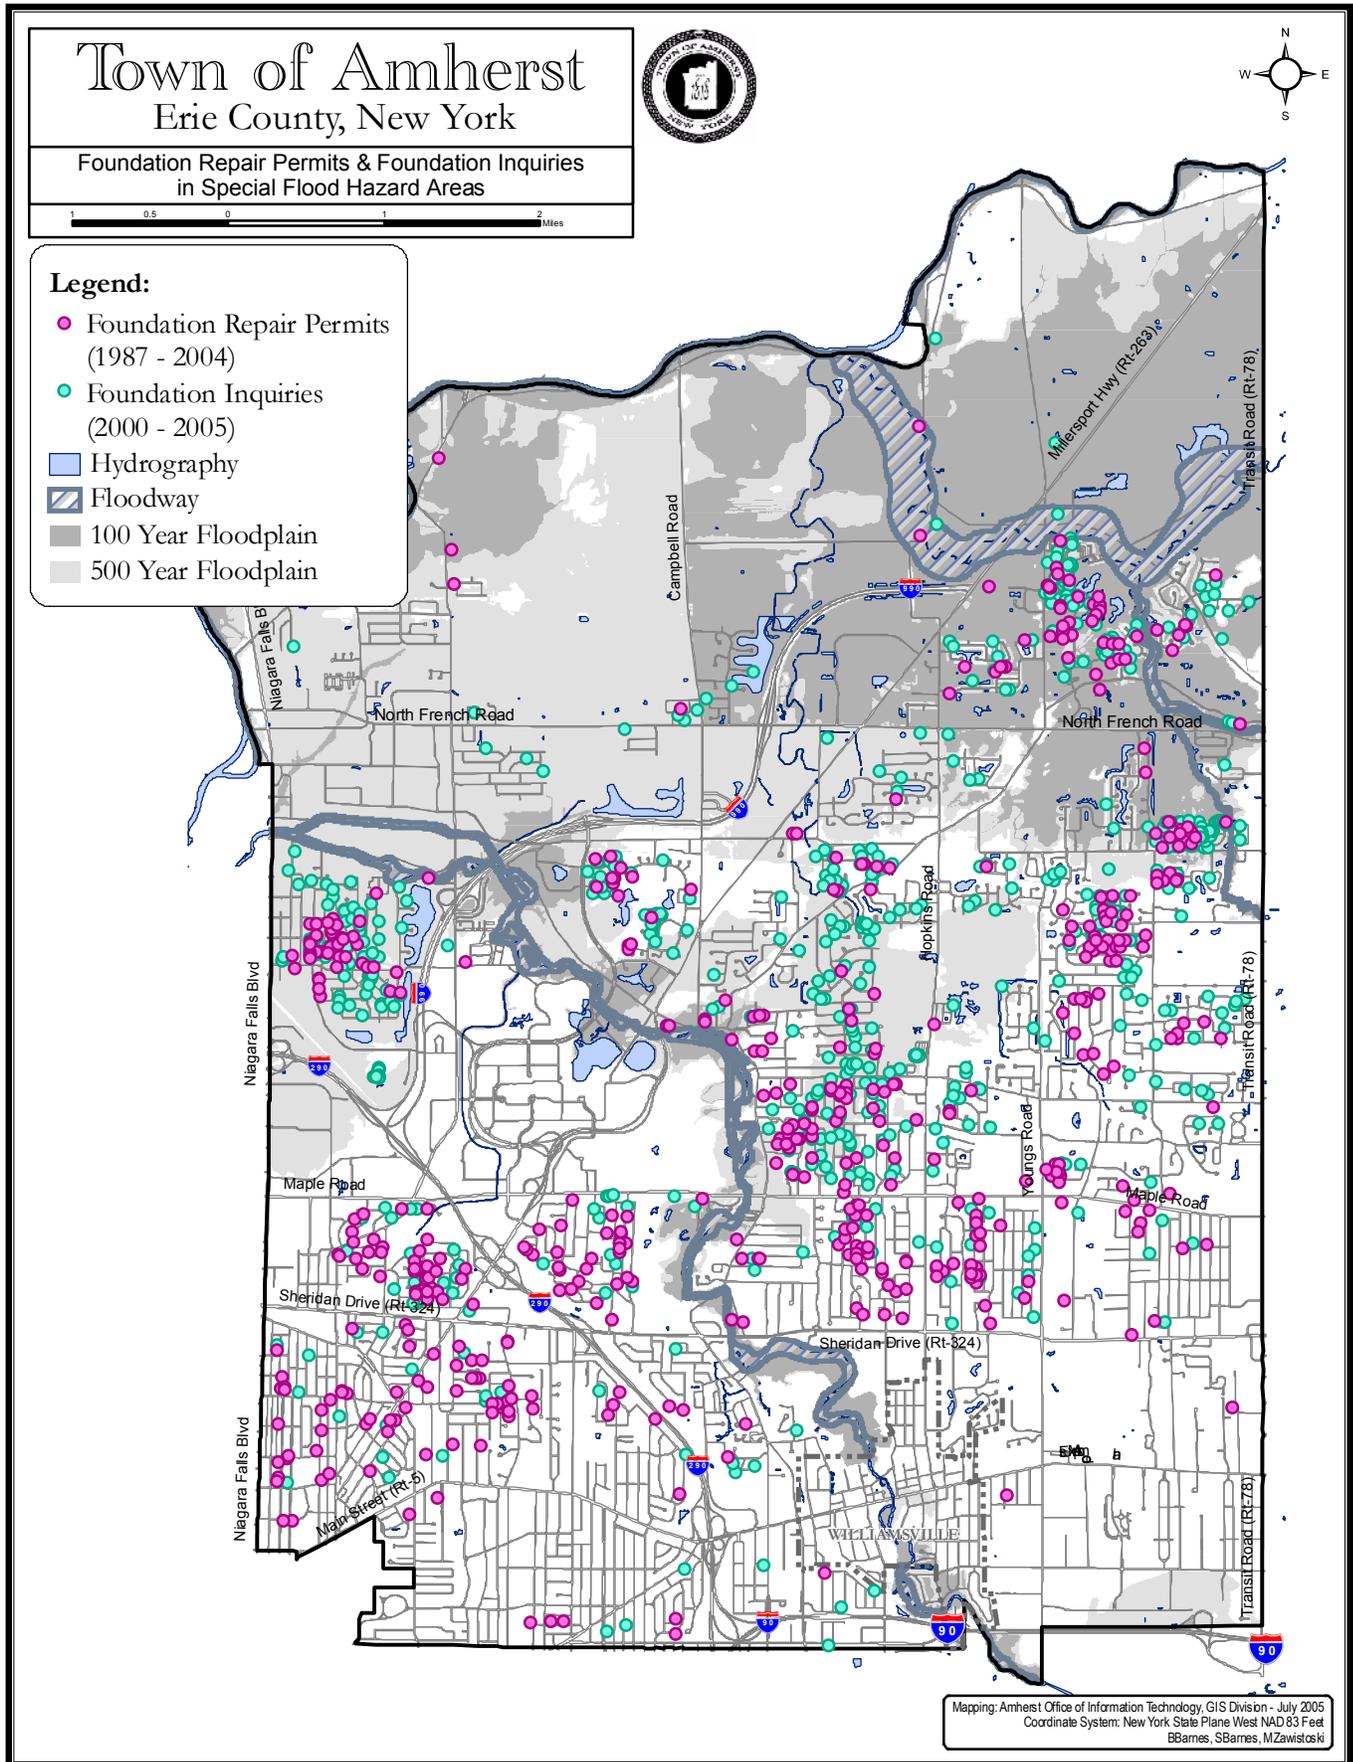
Figure 26 shows the location of foundation repair permits and complaints in relation to the 100- and 500-year flood plain. Foundation-related problems are both within and outside the flood plain boundary. Potentially interesting, is the near coincidence of the floodplain boundary and soft stratum areas (c.f., Figure 6).

Figure 26: Relationship of foundation-related repair permits and inquiries to most recent special flood hazard areas. Note the floodplain maps for Amherst have been revised several times since 1977, and the 1984 map contained a much larger 100-year floodplain around Ellicott Creek before the Corps completed its diversion channel project in the late 1980s.

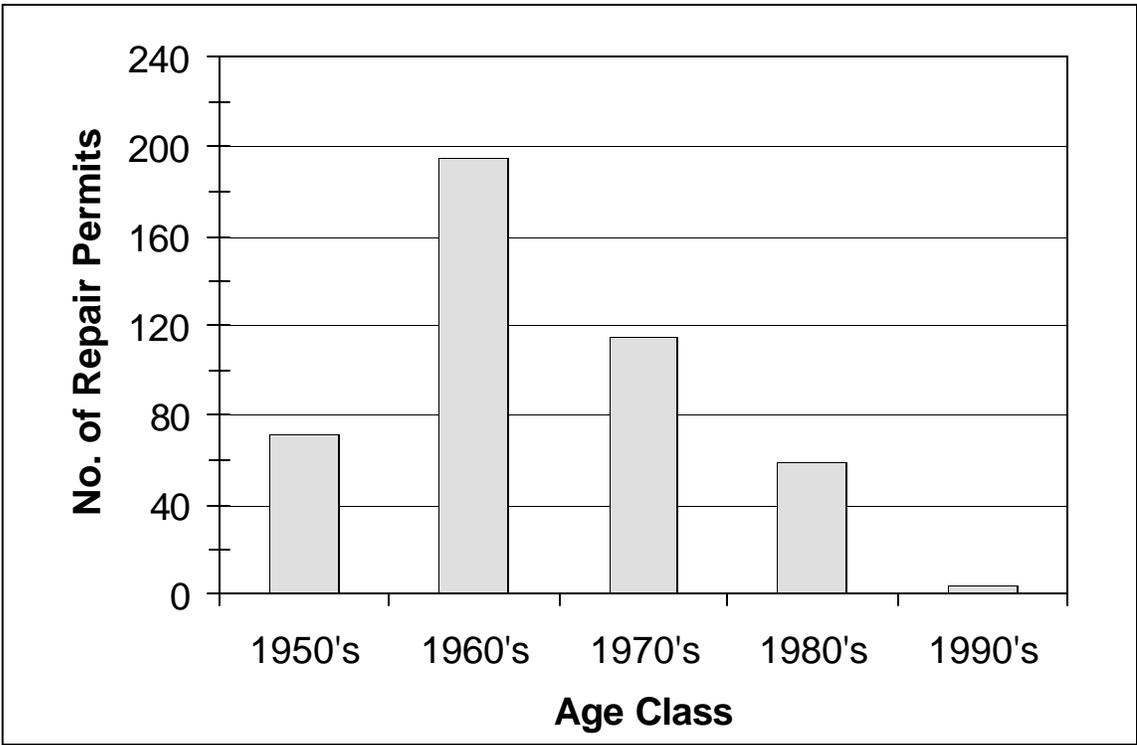
Figure 27 shows the number and the age class of houses that received a foundation repair permit since 1987 (Town data). The average house was built in 1964 ± 15 (1s) but ranges from 1887 to 1996, thus the mean age is about 41 years old ($n=501$). Considering houses built after 1950, the average age drops to 36 years ($n=444$), and the elapsed time from house construction to foundation repair permit is 30.6 ± 9.9 . These statistics are not particularly meaningful because they are biased by the total number of houses built (different for each decade) and foundation repair permits were not issued prior to 1987.

Figure 27. Number of repair permits issued by age class.
